# Bridgeport Condominiums

## BUILDING ENVELOPE CONDITIONS ASSESSMENT

**Bridgeport Condominiums  
1000 North Holiday Blvd.  
Seaside, OR 97138**

**June 14, 2017**

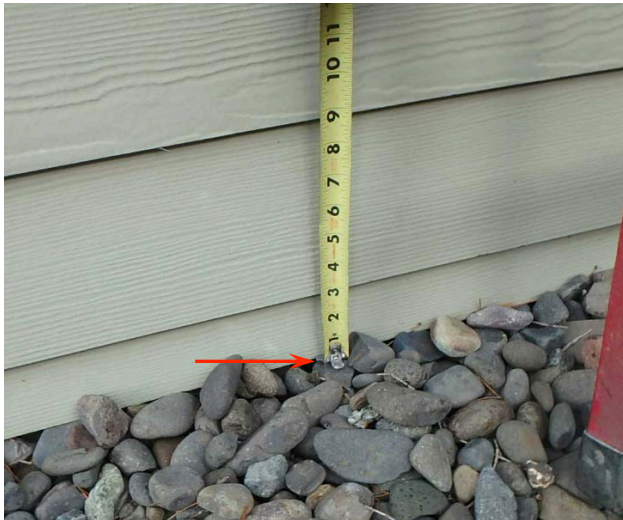
### 1.4.1. Less than 6" clearance between siding and soil finish grade

Condition impedes incidental water egress and facilitates moisture accumulation within exterior wall assembly.

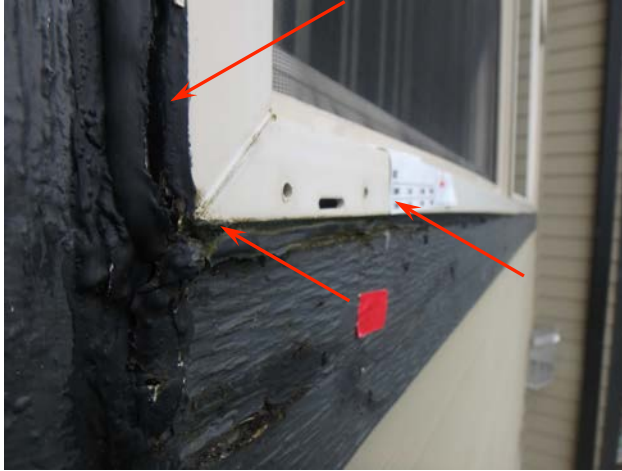
**2.1.1. Improperly-constructed and subsequently-failed sealant joint application**

**2.1.2. Deteriorated trim member**

This condition was observed at IO 2. These conditions were observed to be systemic throughout the building

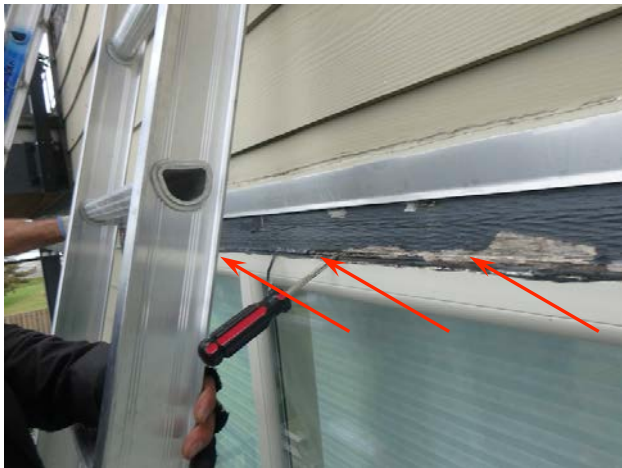
Additional example of condition shown previously, illustrating a similar condition at IO 3

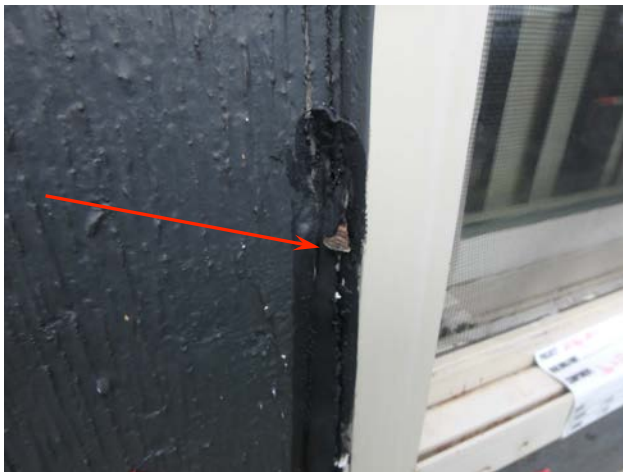
**2.1.4. Fungal-affected wall assembly components**

Damage results from sustained presence of moisture due to water leakage and/or moisture accumulation within exterior wall assembly. IO 2

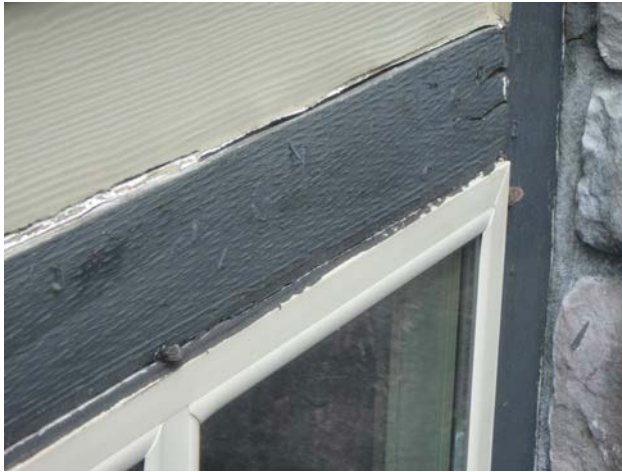
Additional example of condition shown previously, illustrating the condition at IO 6 at the window head

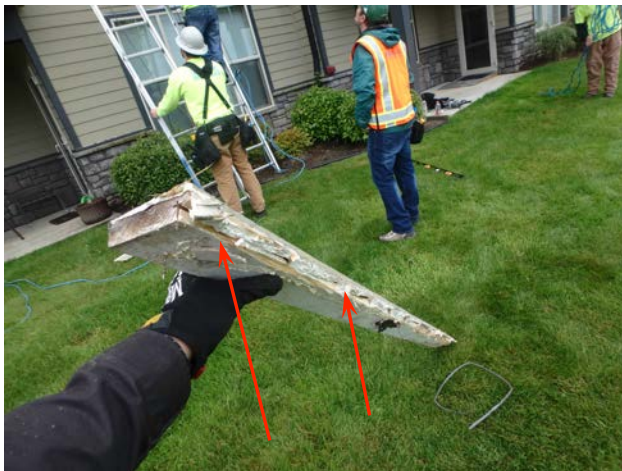
**2.1.5. Rabbet-cut trim board**

Condition relies on an unmaintainable sealant joint and is prone to failure. This condition was observed at all trims at lap siding IOs

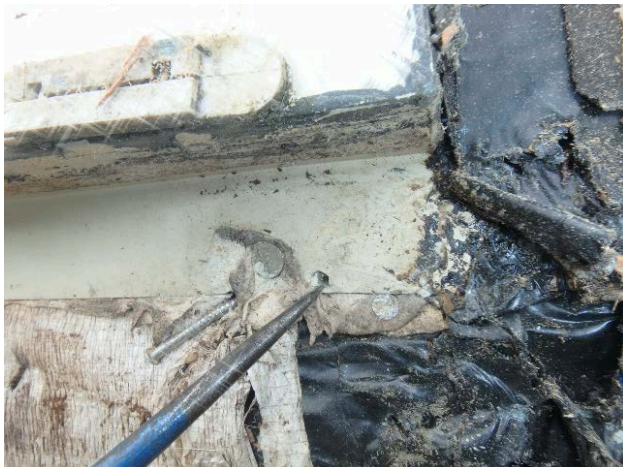
**2.1.10. Trim fasteners penetrate underlying vinyl fenestration mounting flange**

Condition facilitates cracking of fenestration mounting flange. IO 1

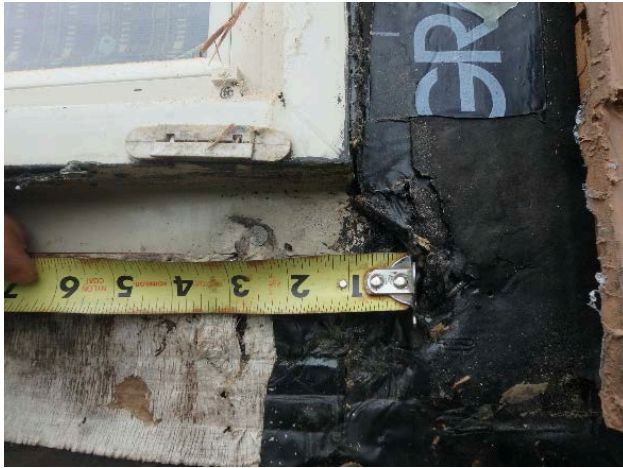
**2.1.11. Less than 3" spacing between fastener and mounting flange corner**

Condition facilitates deflection and cracking of fenestration unit. IO 1

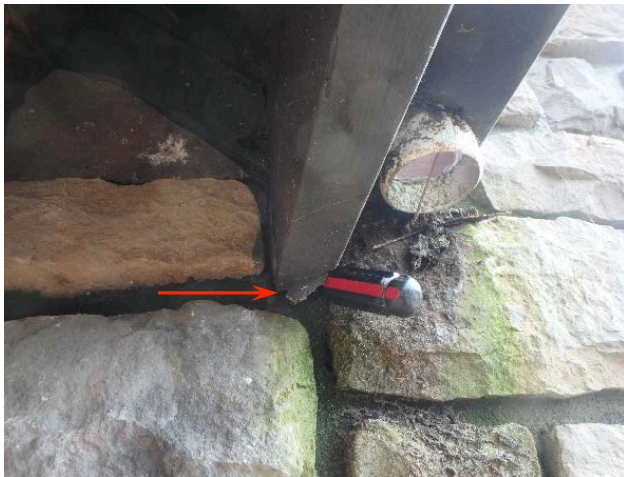
**2.2.11. Moisture-deteriorated fascia board**

Damage results from sustained presence of moisture due to water leakage and/or moisture accumulation within exterior wall assembly.

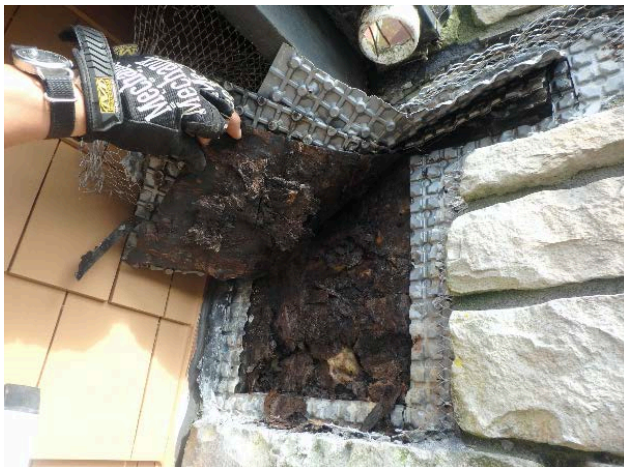
**2.2.12. Moisture-deteriorated OSB sheathing**

Damage results from sustained presence of moisture due to water leakage and/or moisture accumulation within exterior wall assembly.

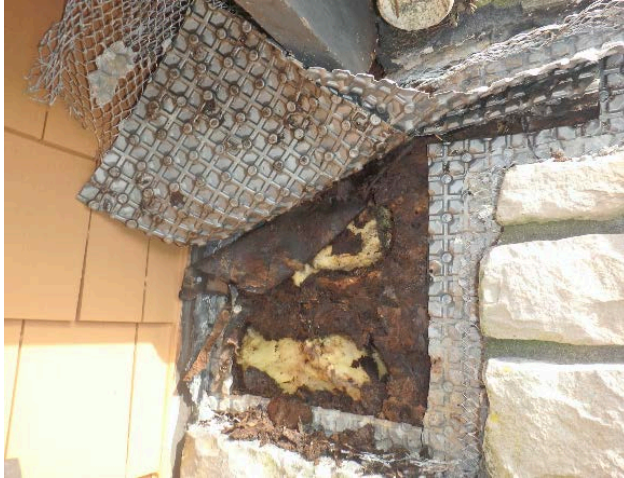
Close-up of location shown previously, illustrating the severity of the deterioration and moisture damage

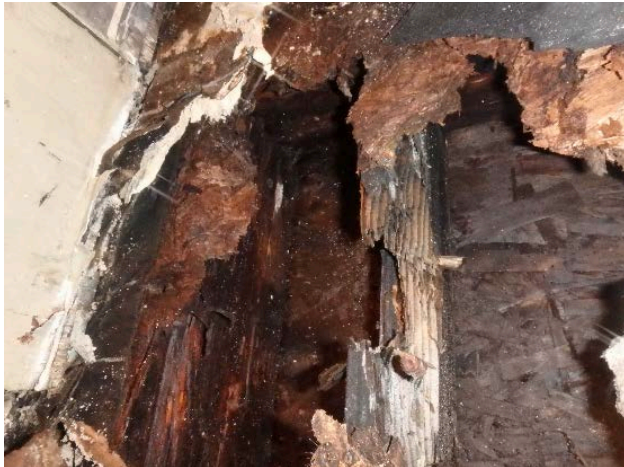
**2.2.25. Moisture-deteriorated framing components**

Framing member exhibits damage at below the louver rough opening

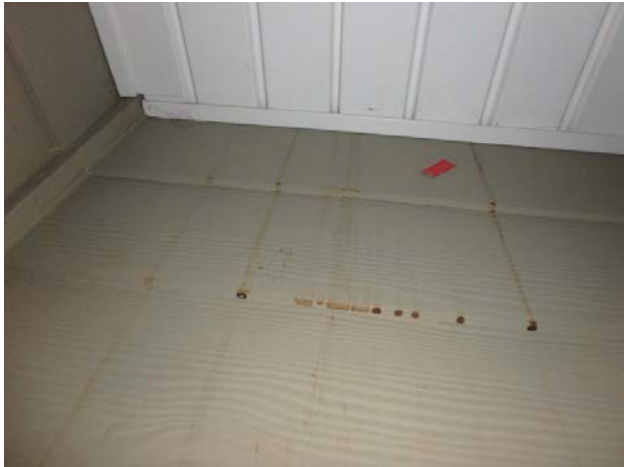
**2.2.35. Moisture staining emanating from within wall assembly**

Condition likely results from moisture egress from within exterior wall assembly.

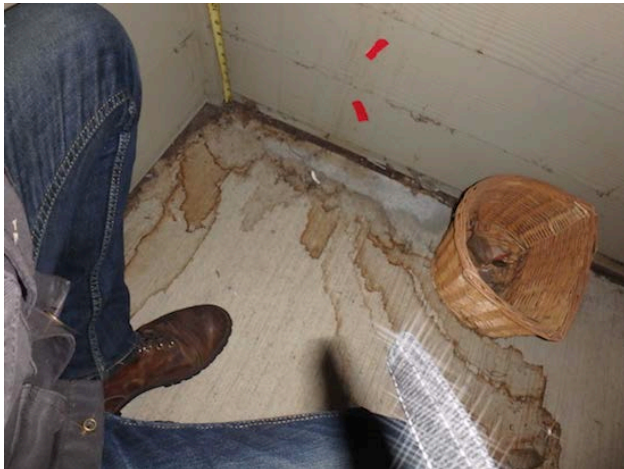
Additional example of condition shown previously, illustrating the extent or the staining

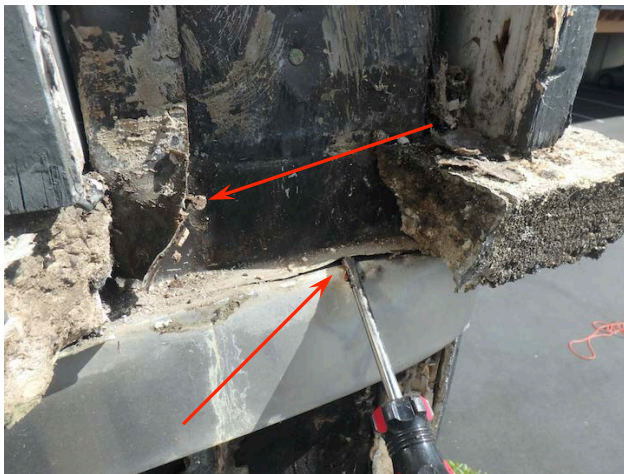
Additional example of condition shown previously, illustrating the unsealed seams at both the vertical and horizontal seams

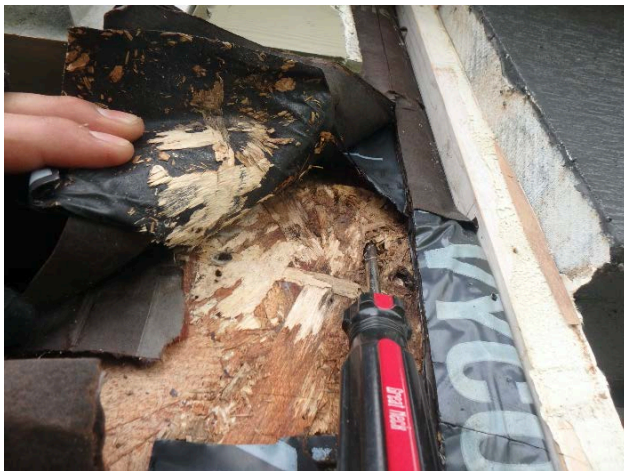
Close-up of location shown previously, illustrating the extent of the damage
