BRIDGEPORT CONDOMINIUMS

1000 N Holladay Drive
Seaside, OR 97138

PRELIMINARY BUILDING ENCLOSURE AND LIMITED STRUCTURAL ASSESSMENT

J2 Project #5151201

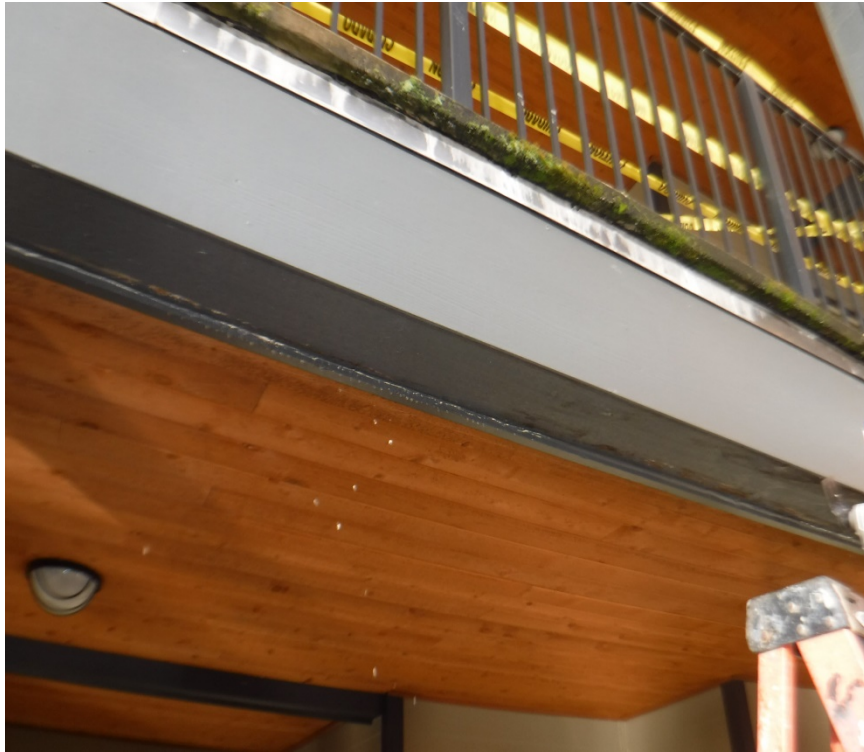
1.2 – Opening #1

Water dripping out of beam wrap after sealant was cut open.

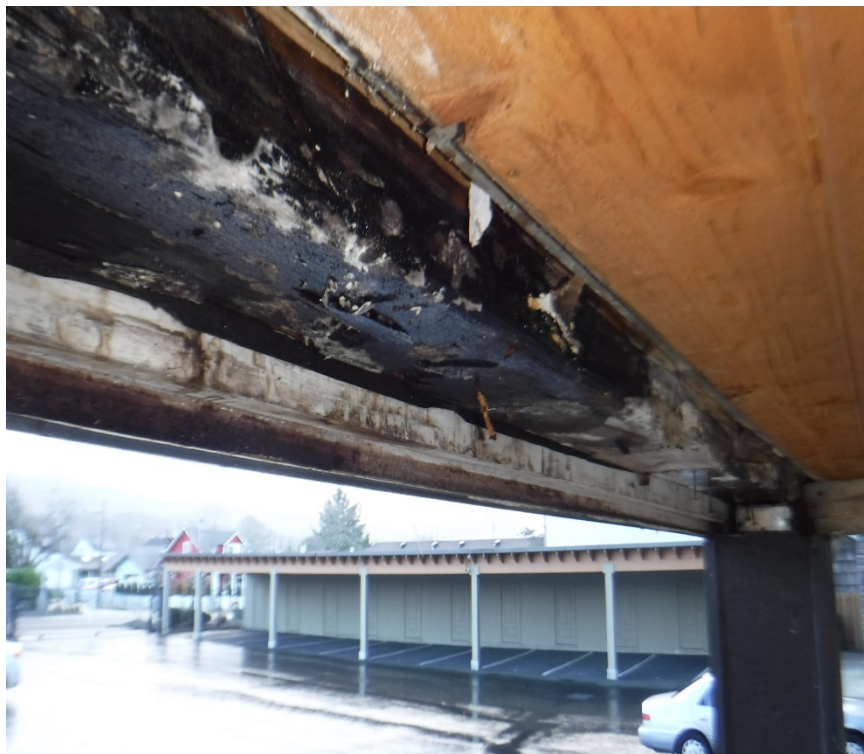
1.3 – Opening #1

Beam wrapped in GWB is severely deteriorated and saturated.

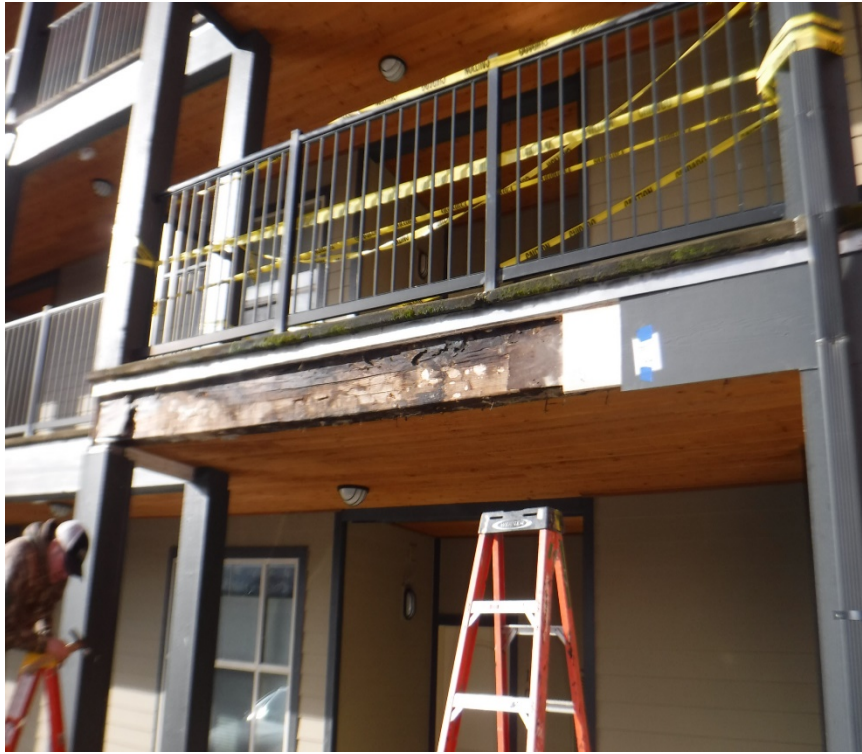
1.4 – Opening #1

Wood decay in landing beam. Note that the beam is distinctively more wet at guardrail base locations and column base locations.

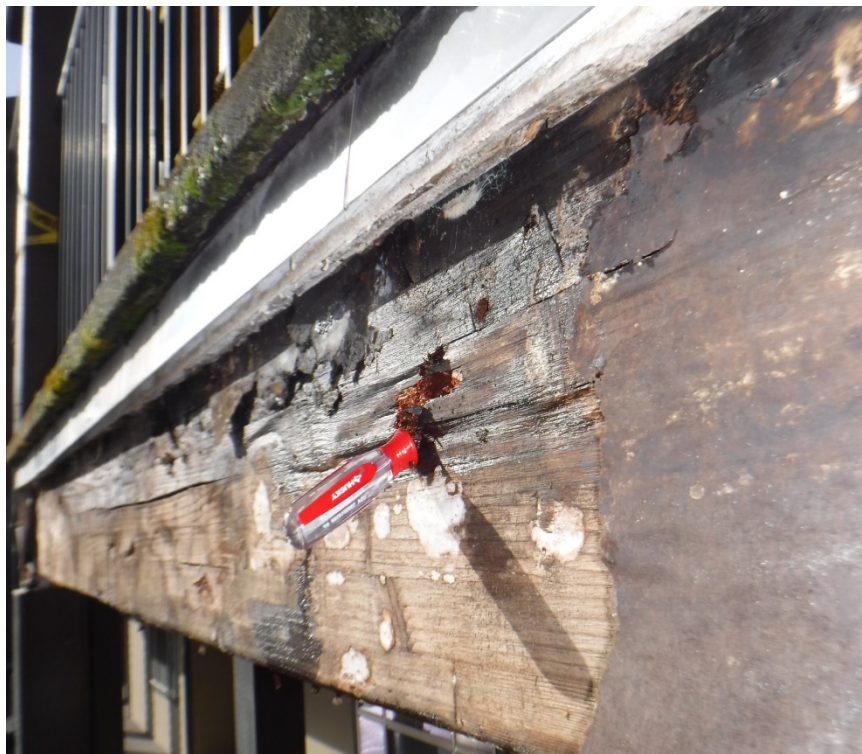
1.5 – Opening #1

Severe wood decay. This is currently an unsafe condition.

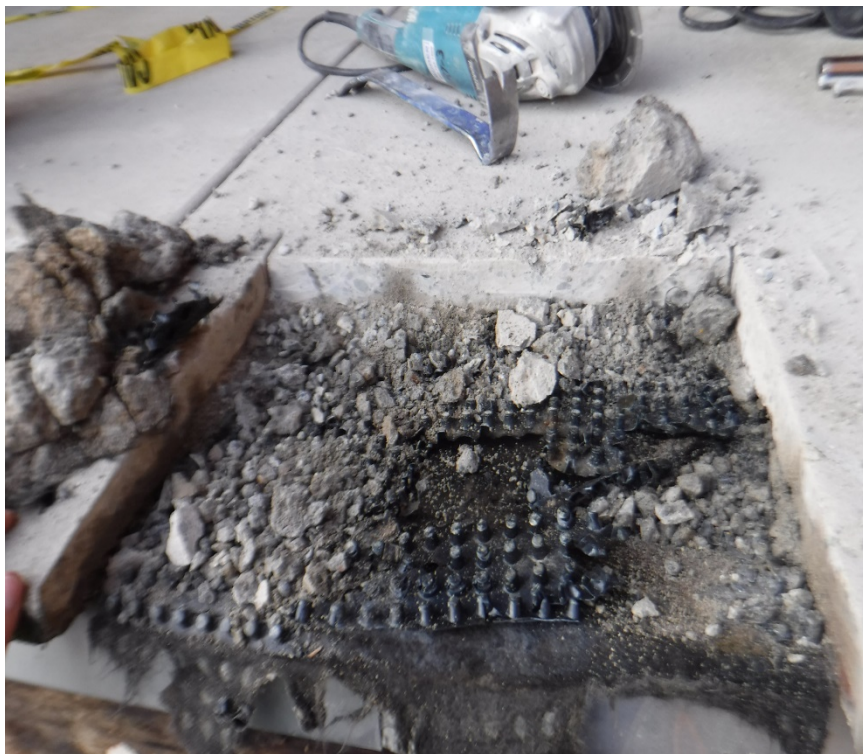
1.7 – Opening #1

Drain mat is installed upside down.

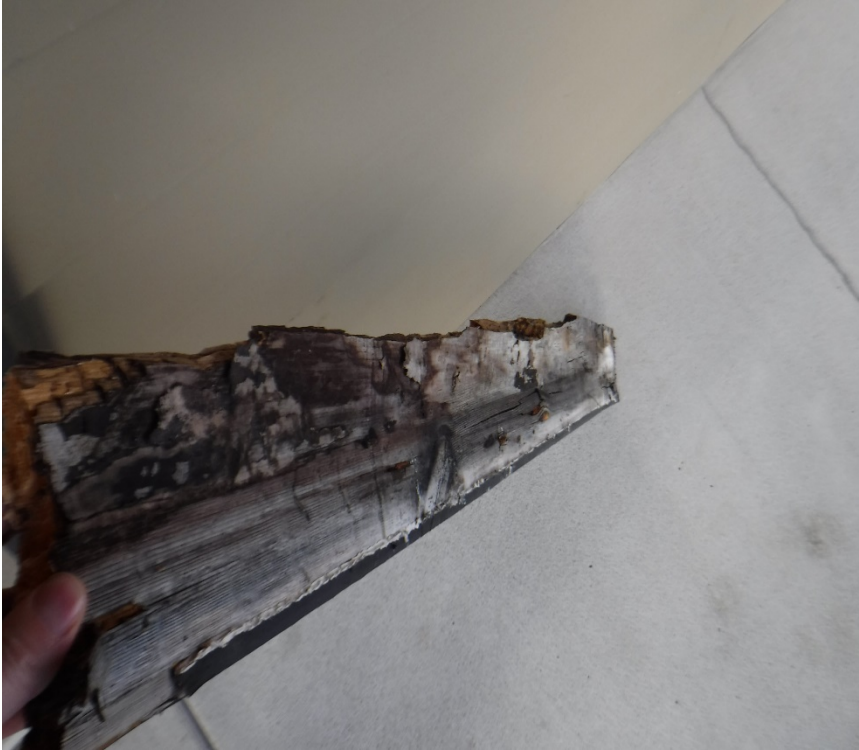
2.2 – Opening #2

Interior face of column wrap trim. Note that the exterior appeared to be in good condition.

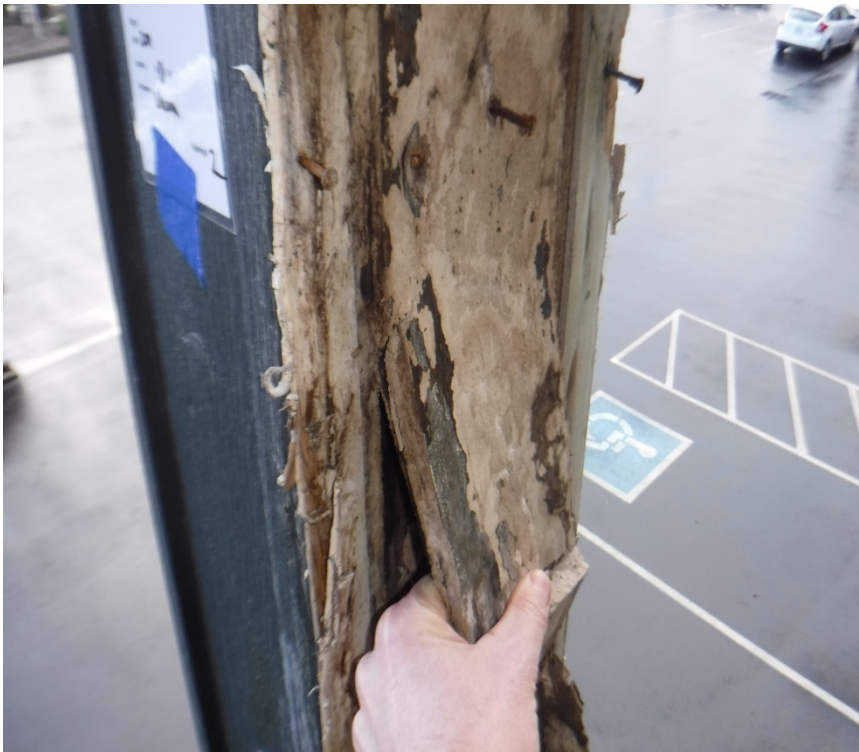
2.3 – Opening #2

6x column wrapped in GWB is severely deteriorated and saturated.

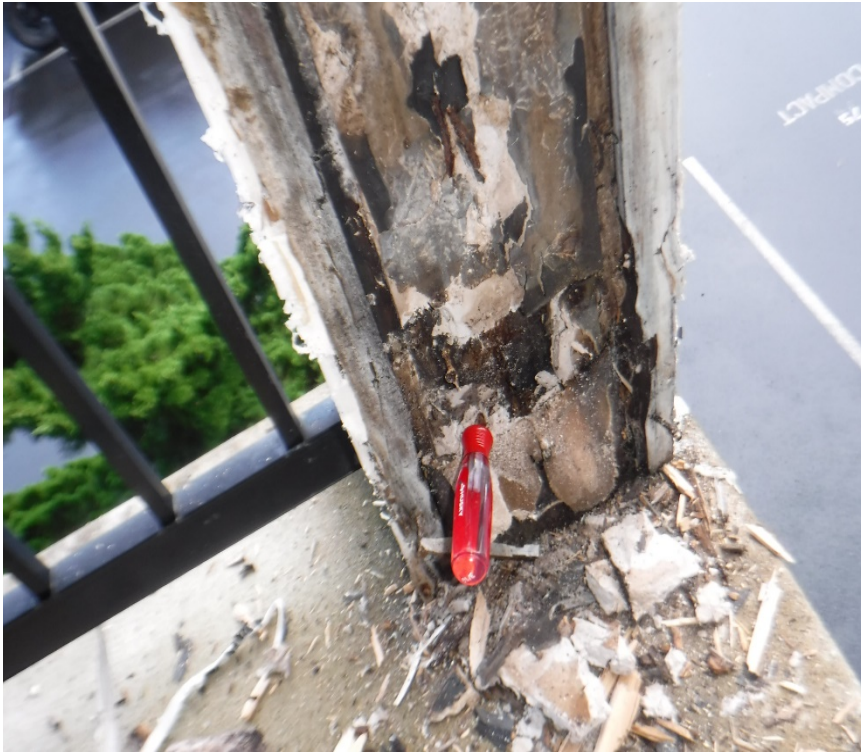
2.4 – Opening #2

Extensive wood decay in 6x column. This is currently an unsafe condition.

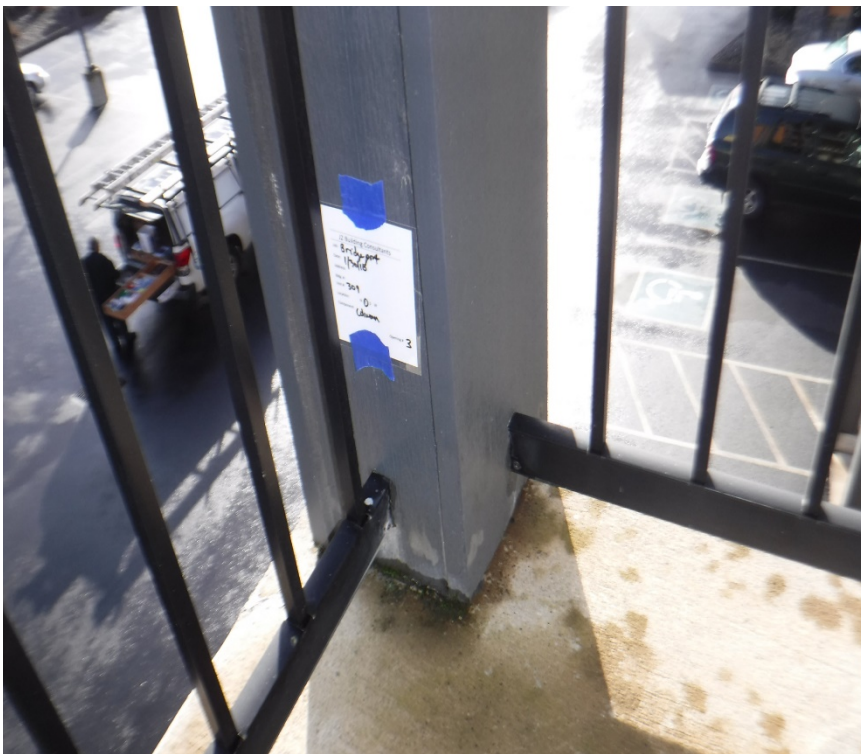
3.1 – Opening #3

Overview of Opening #3 at base of landing column near Unit 309 on east elevation.

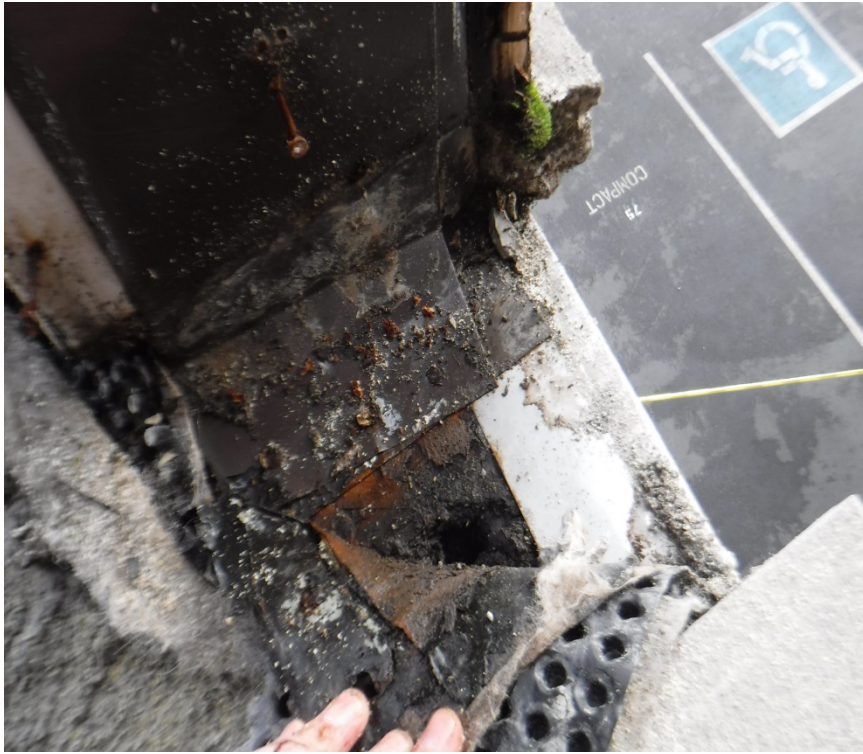
3.2 – Opening #3

Waterproofing is not adhered to edge metal, the drain mat is installed upside down, and the deck sheathing is saturated.

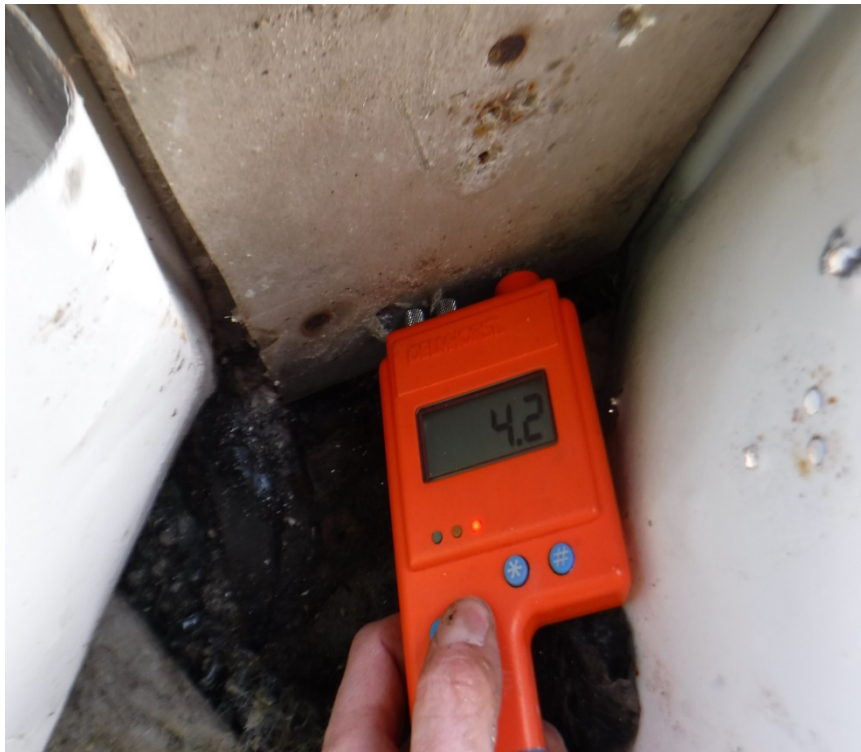
3.4 – Opening #3

GWB is saturated (4.2 mass percent, see Moisture Readings, p. 5) and there is liquid water behind the metal base flashing.

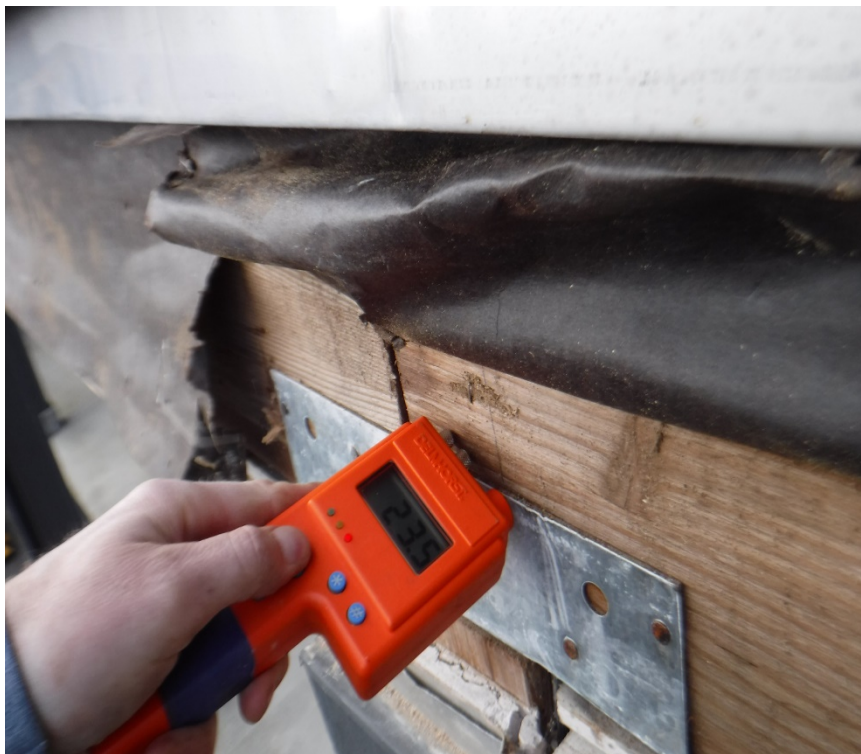
4.2 – Opening #4

Elevated moisture (23.5 mass percent) in deck beam below upper column.

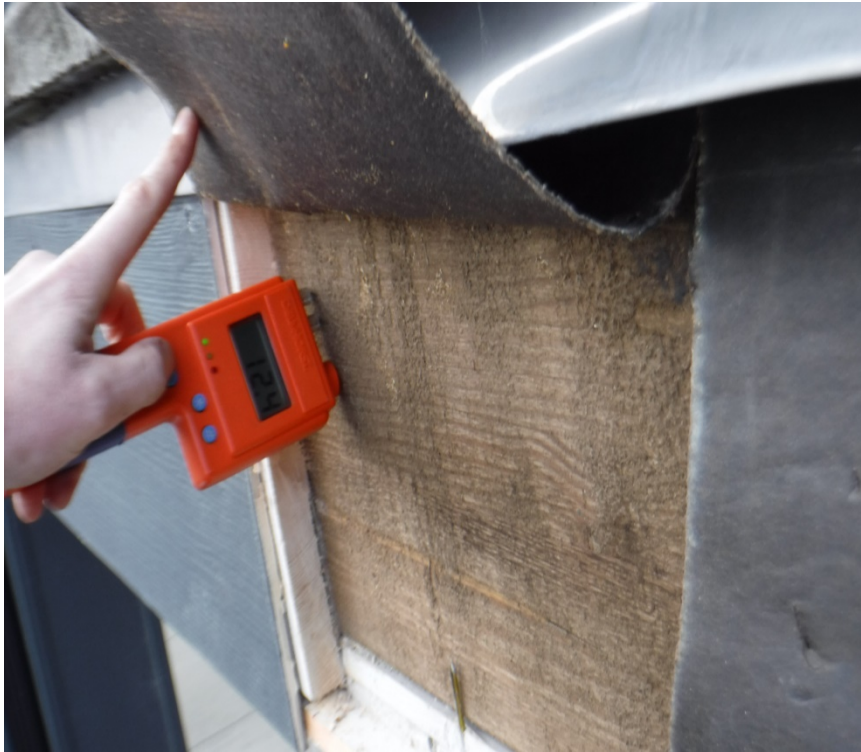
4.3 – Opening #4

Low moisture (12.4 mass percent) in beam not directly below column or guardrail post.

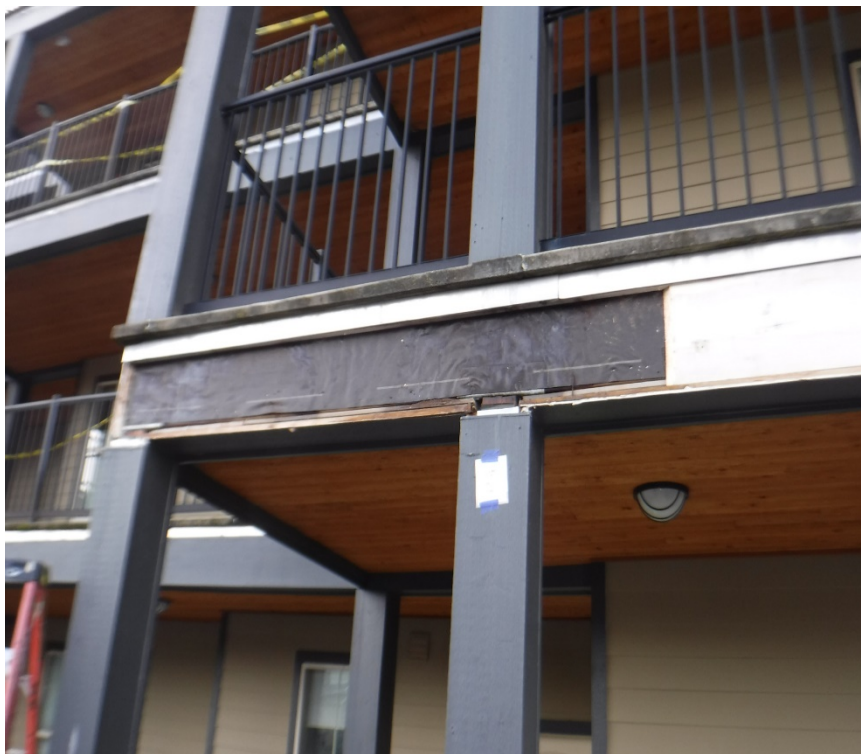
5.1 – Opening #5

Overview of Opening #5 at landing beam above Unit 108 on east elevation.

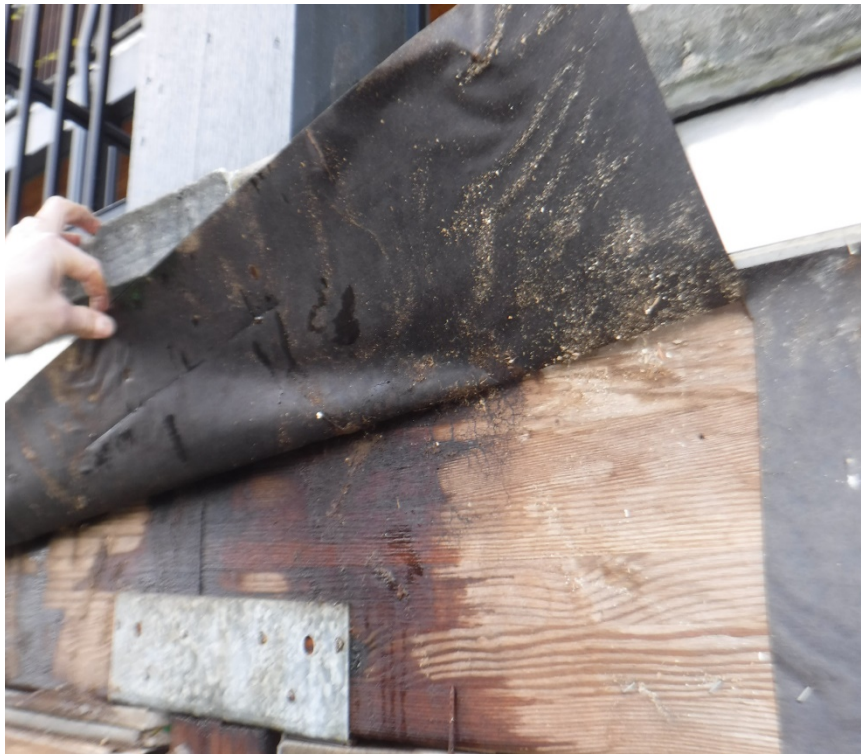
5.3 – Opening #5

Beam below column is saturated.

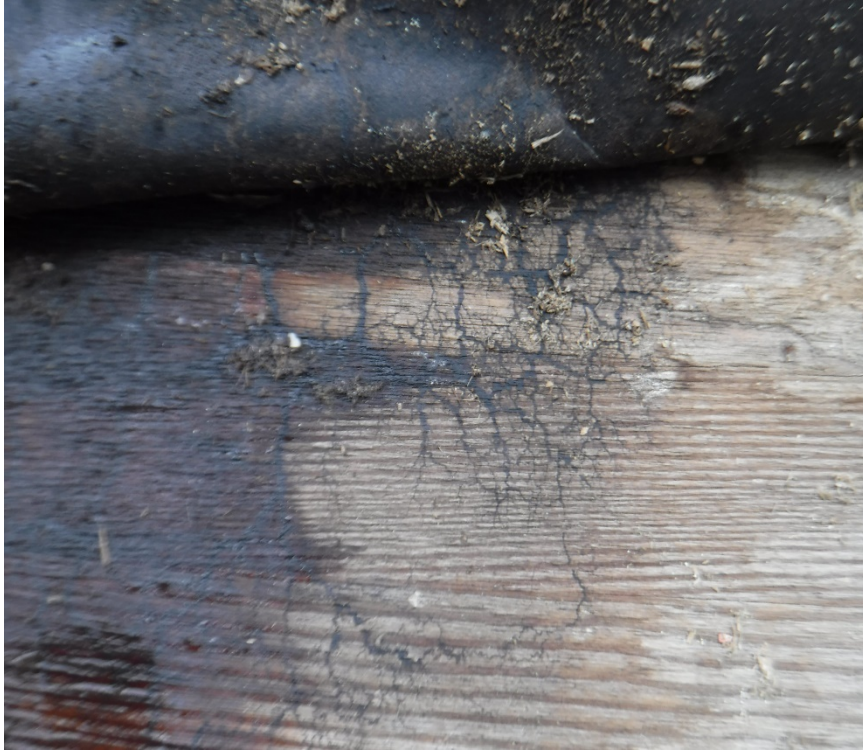
5.4 – Opening #5

Wood decay present at landing beam.

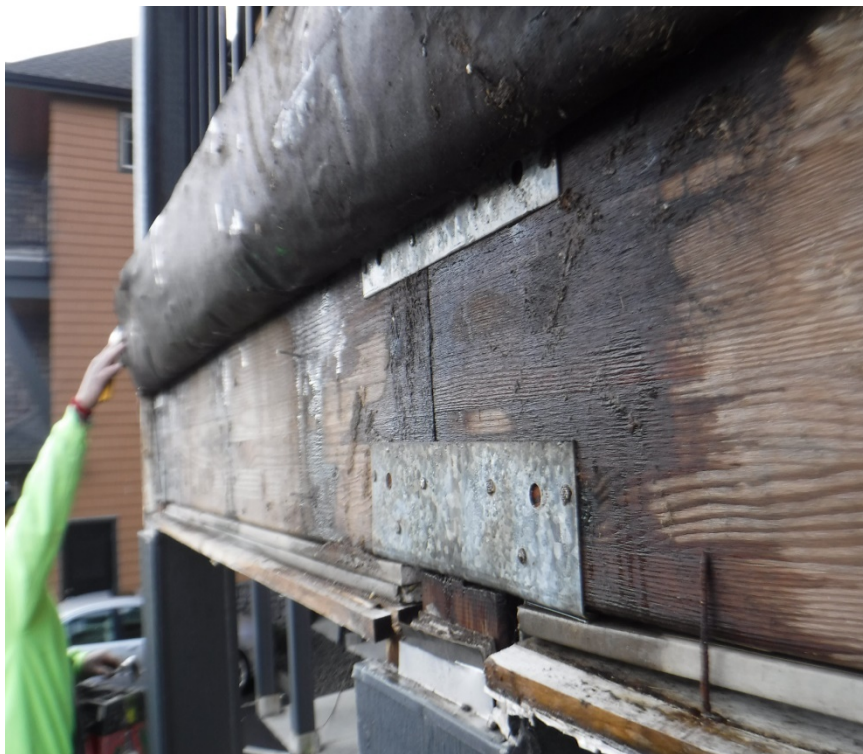
5.5 – Opening #5

Leaks present at column base and guardrail base locations.

3. The unit decks and entry landings are not constructed in a weatherproof manner. Water leaks are occurring where the support columns penetrate the deck waterproofing at the base. Leaks are also occurring at the top mounted guardrail fastener locations.

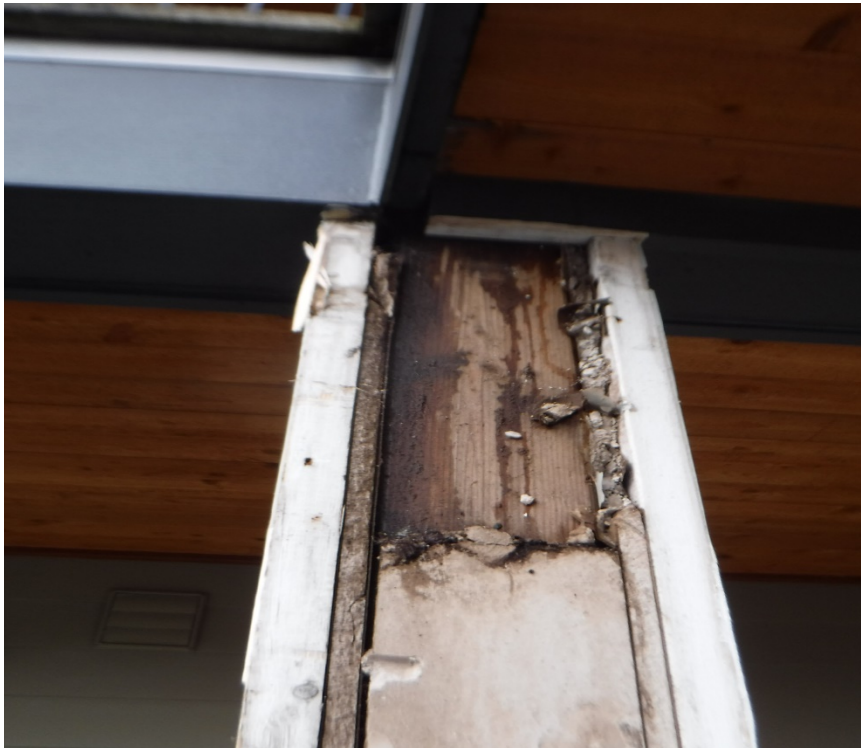
6.2 – Opening #6

Water leaking through deck and down column below.

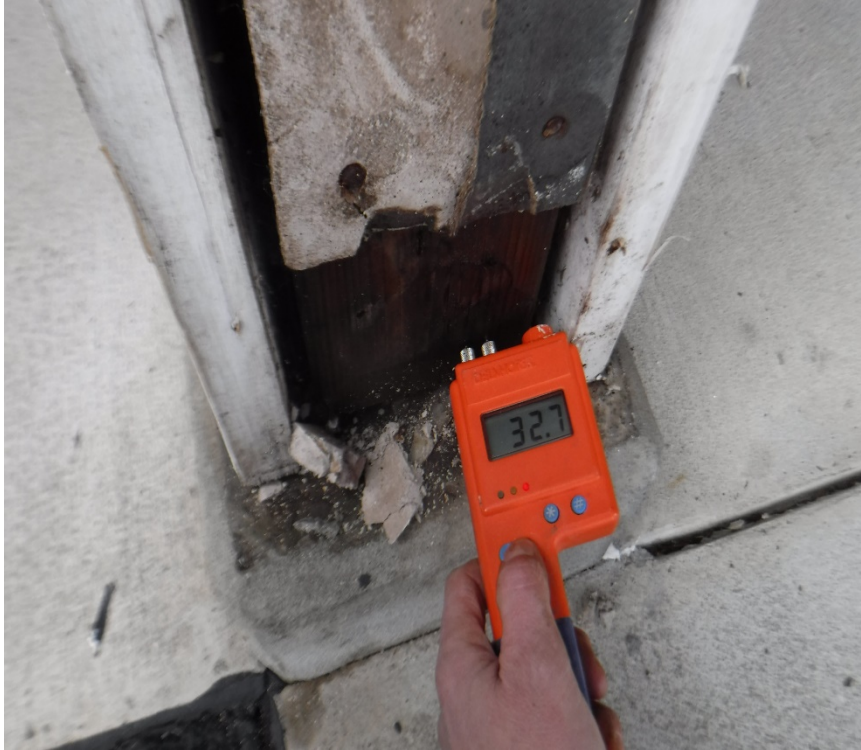
6.3 – Opening #6

High moisture (32.7 mass percent) in wood at base of column.

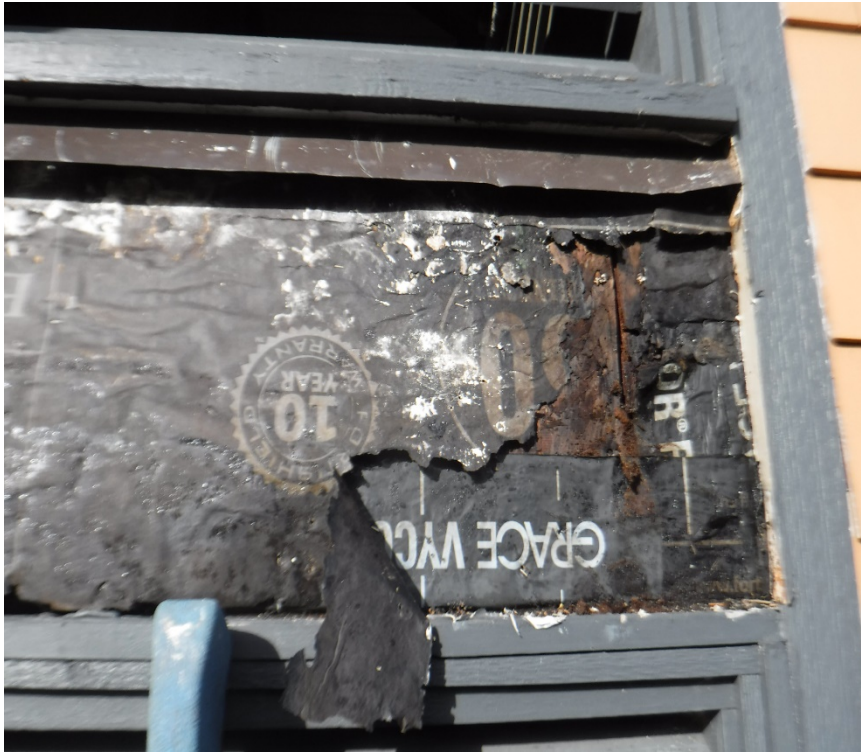
7.2 – Opening #7

WRB is deteriorated and sheathing under louver is decayed.

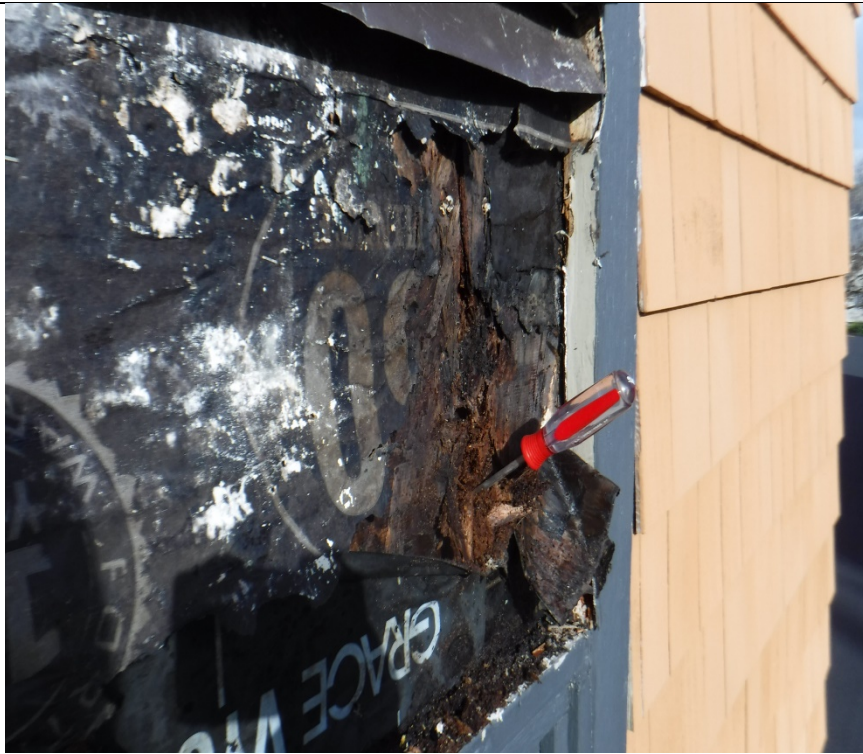
7.4 – Opening #7

WRB is reverse lapped over flexible SAMF. There is an open seam and no saddle at metal flashing above.

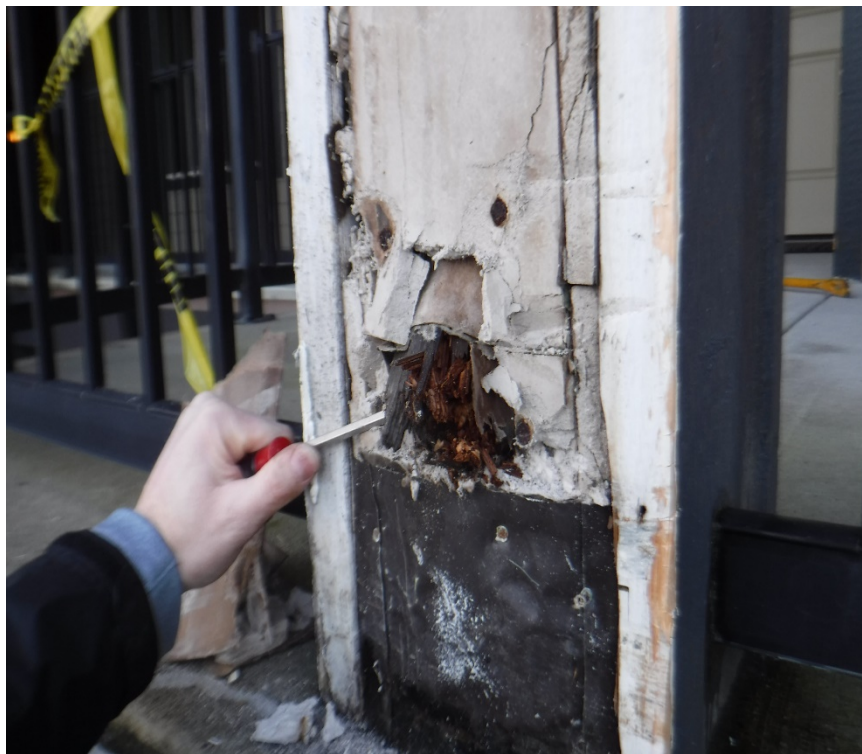
8.2 – Opening #8

6x column is severely decayed, which is a safety concern. GWB is deteriorated and there are open seams in column base flashing.

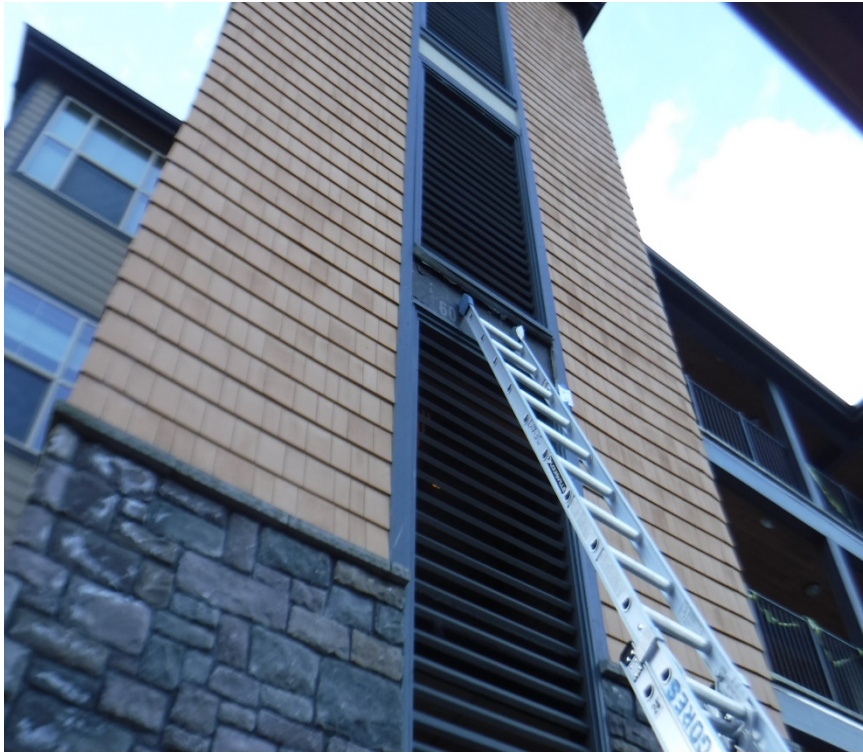
9.1 – Opening #9

Overview of Opening #9 at south stair tower on east elevation.

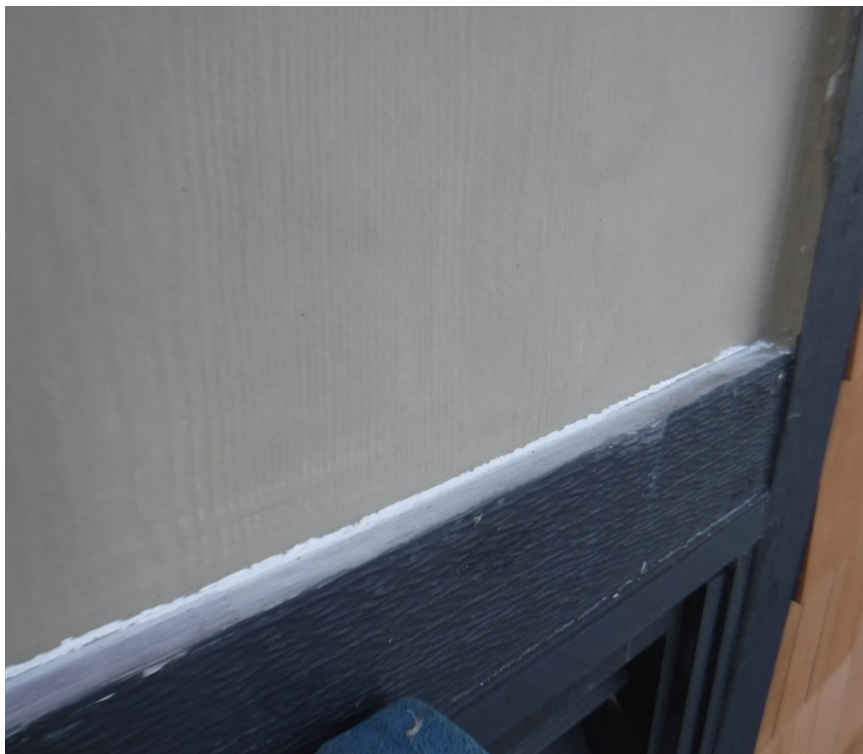
9.2 – Opening #9

Head flashing at wood projection is omitted.

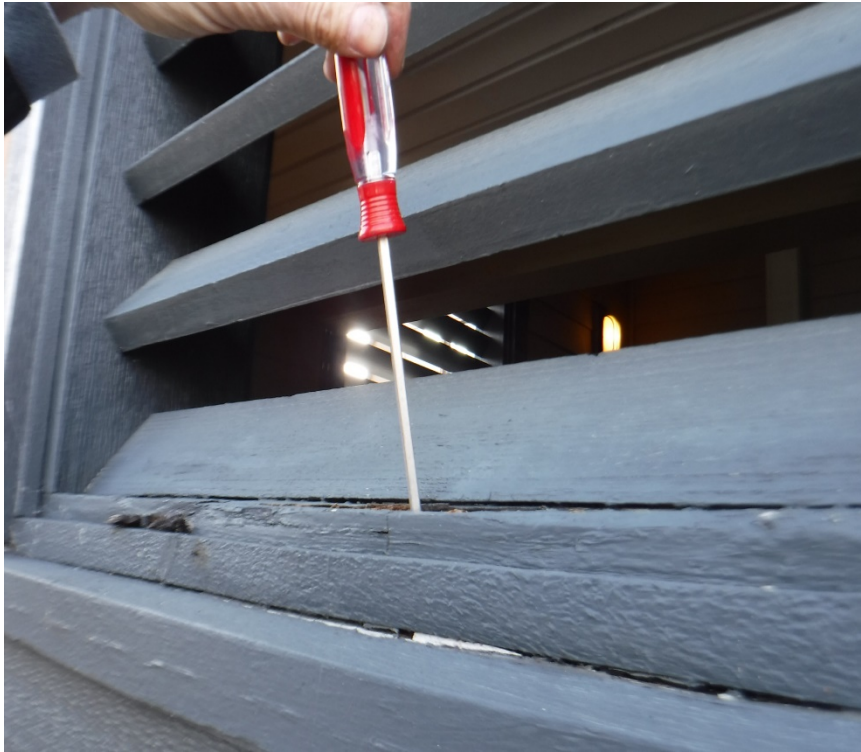
9.3 – Opening #9

Wood trim is decayed and metal flashing on horizontal wood surface is omitted.

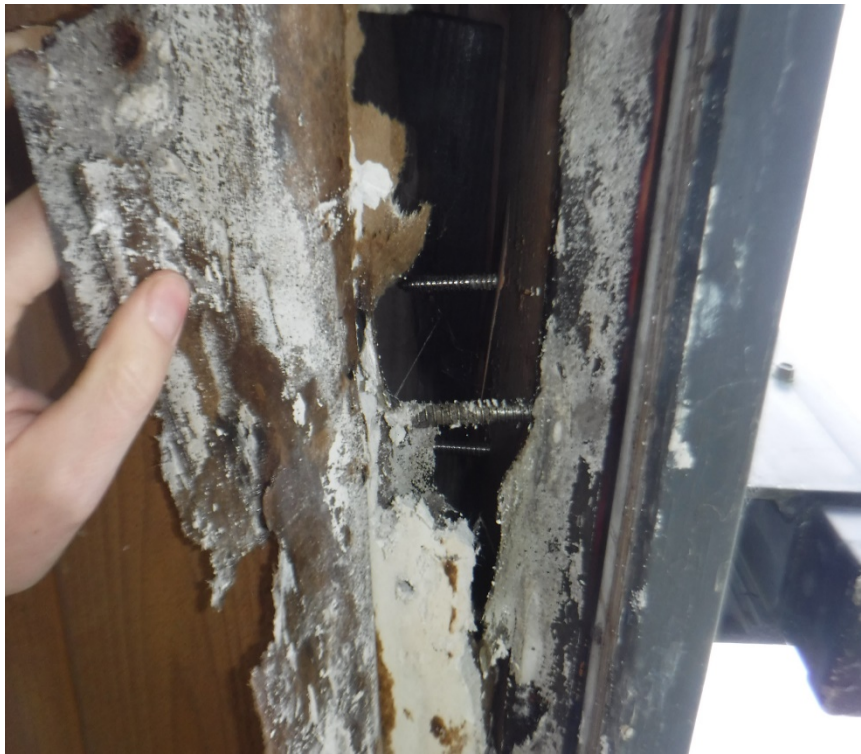
10.2 – Opening #10

GWB under wood soffit is severely deteriorated, wood framing is saturated, and lag bolts from guardrail have full embedment.

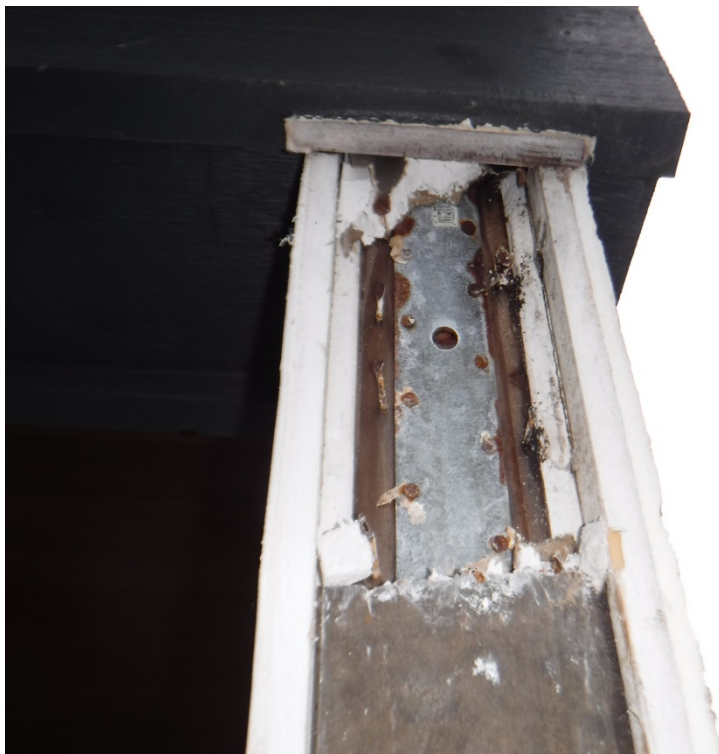
10.4 – Opening #10

GWB is damaged, metal is corroded, and high moisture present in wood at deck column.

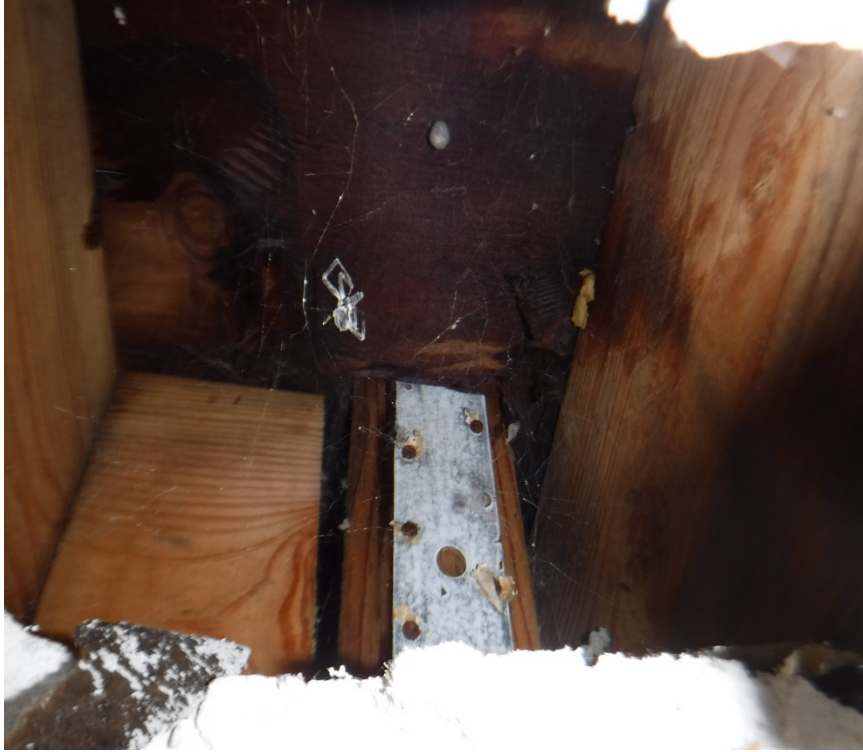
10.5 – Opening #10

Overview of water leaks in deck framing space. Deck sheathing, framing, and soffit material are wet. Deck sheathing is crushed.

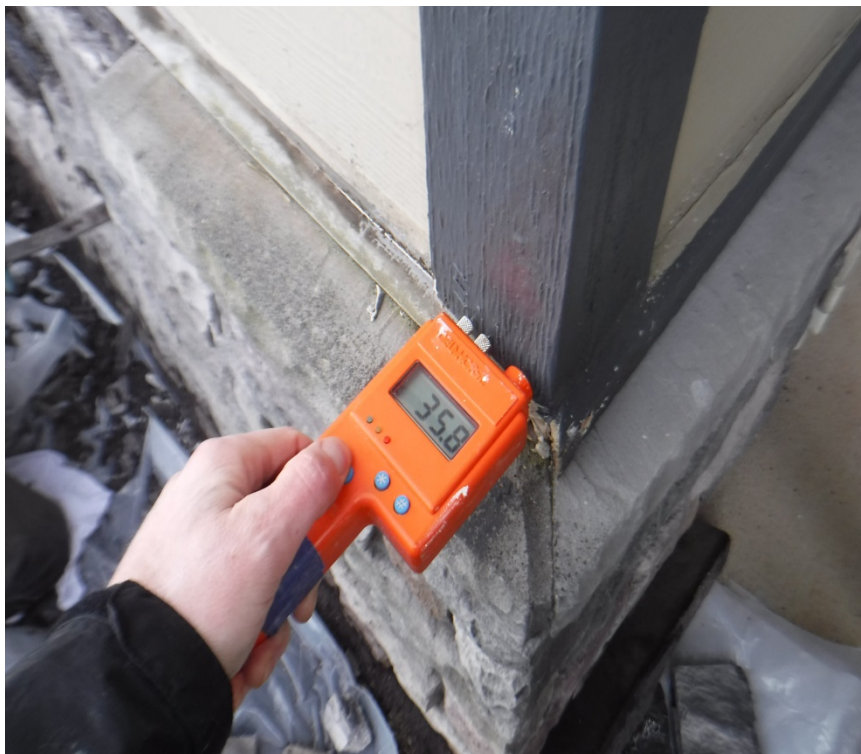
11.2 – Opening #11

High moisture (35.8 mass percent) in corner trim.

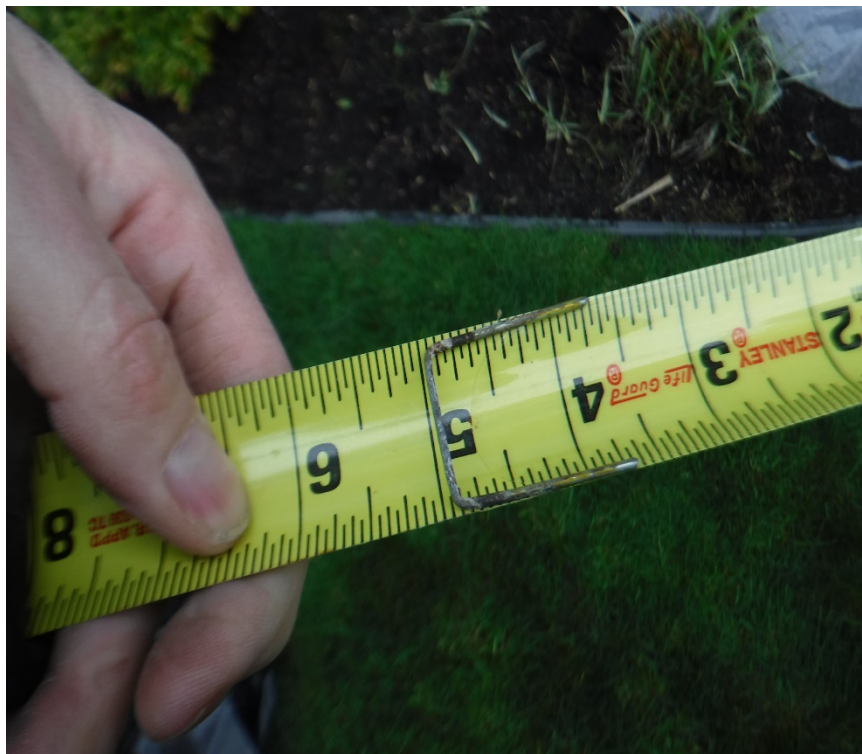
11.4 – Opening #11

1-1/4” lath staples used, which do not penetrate framing as required per manufacturer’s instructions.

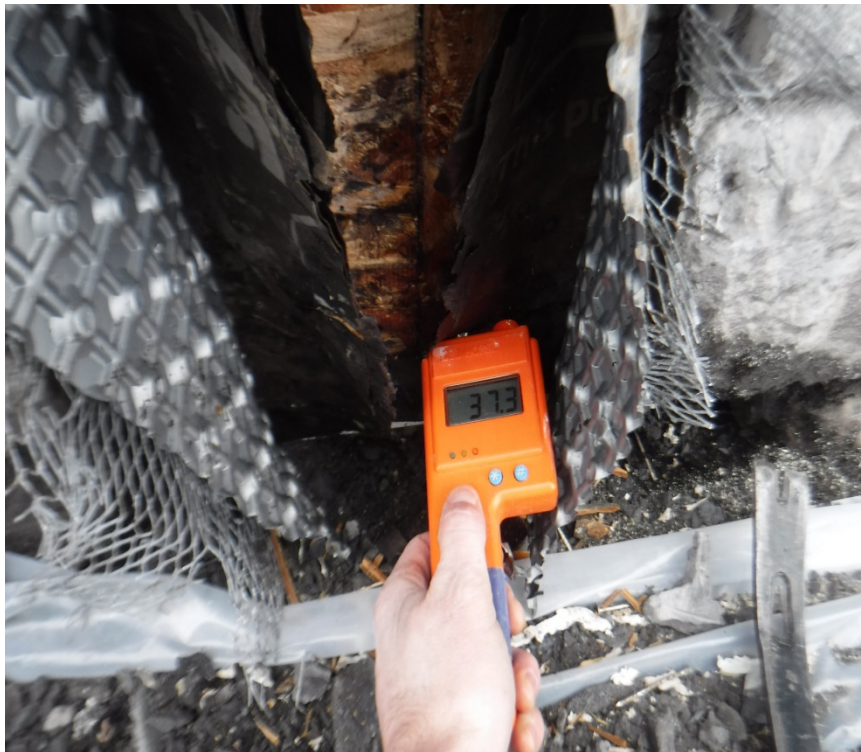
11.6 – Opening #11

OSB sheathing at base of wall is wet (37.3 mass percent) and decayed.

9. Sheathing damage has occurred at the base of wall under the adhered concrete masonry veneer. There is no separation between grade and veneer as required by the manufacturer.

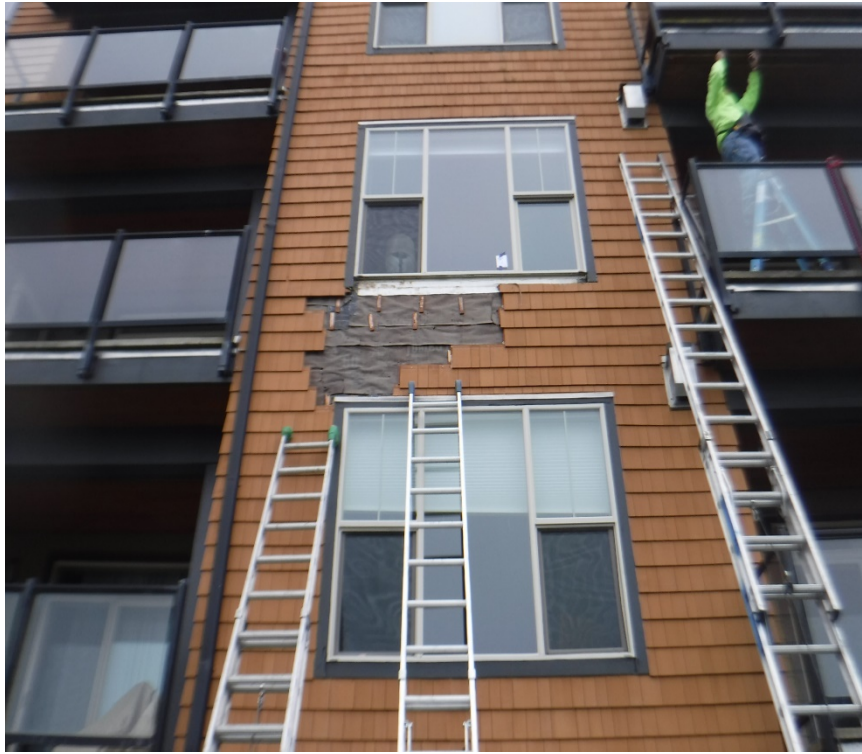
12.1 – Opening #12

Overview of Opening #12 between second and third floor windows at Units 201/301 on west elevation.

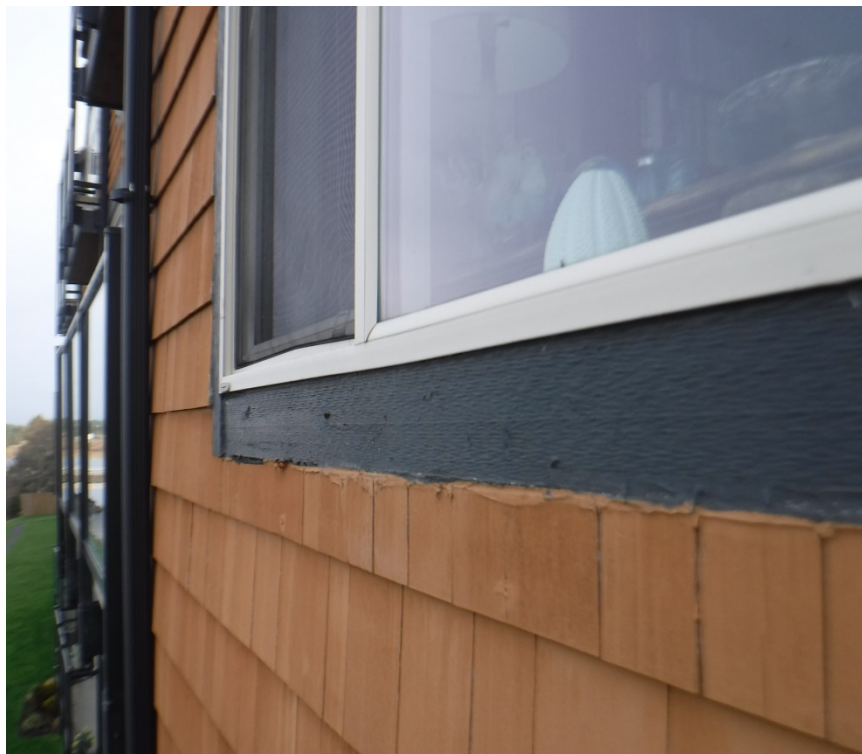
12.2 – Opening #12

Overview of window sill prior to opening. Siding sits proud of trim.

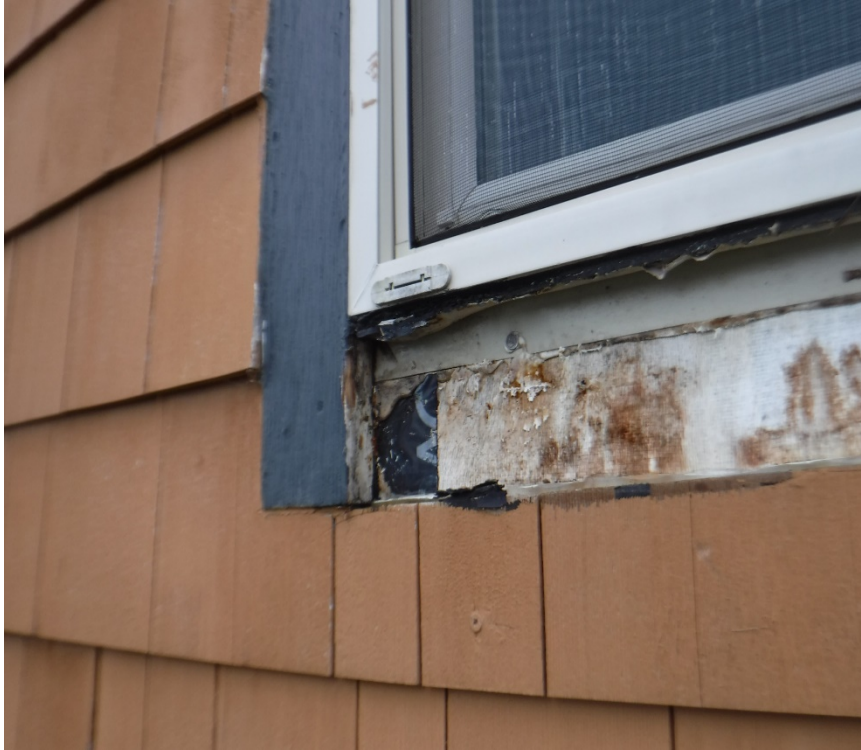
12.3 – Opening #12

SAMF under window is stained, and there is continuous sealant under window flange at sill.
