BRIDGEPORT CONDOMINIUMS

1000 N Holladay Drive
Seaside, OR 97138

PRELIMINARY BUILDING ENCLOSURE AND LIMITED STRUCTURAL ASSESSMENT

J2 Project #5151201

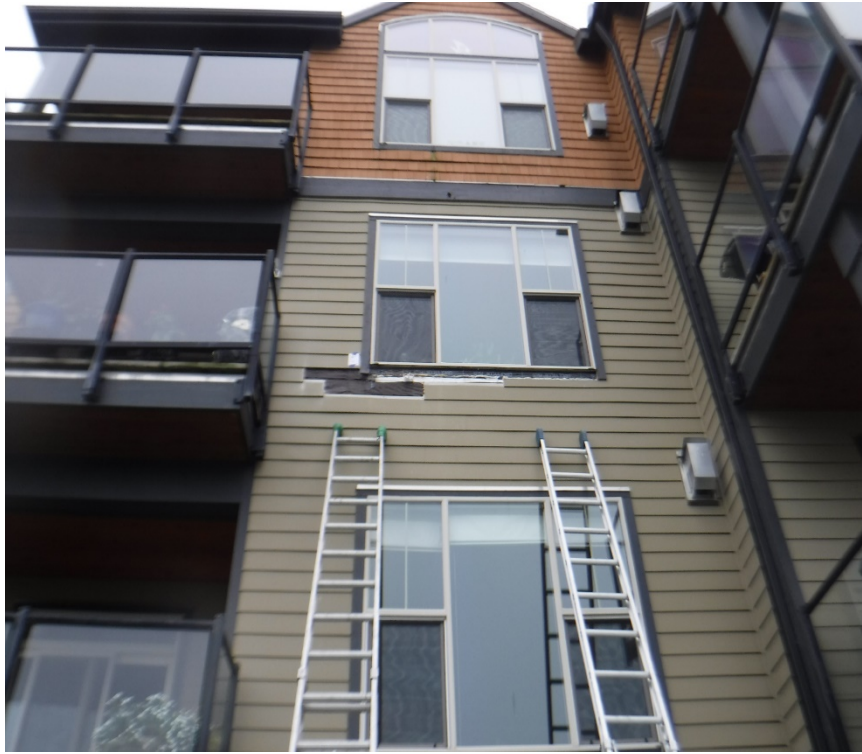
13.1 – Opening #13

Overview of Opening #13 below third floor window at Unit 308 on west elevation.

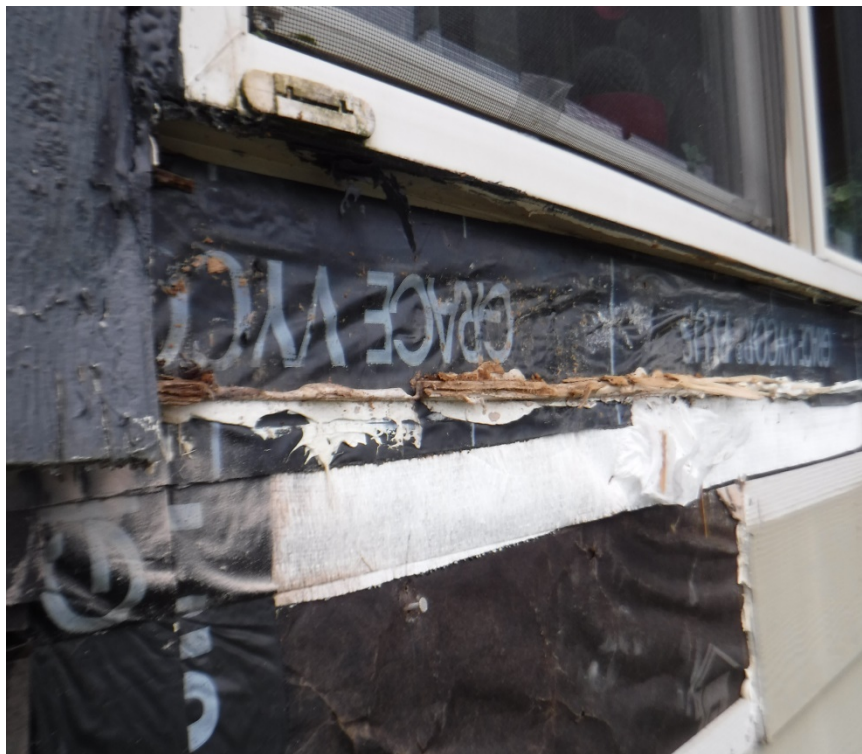
13.2 – Opening #13

Wood trim at sill and jamb is severely deteriorated.

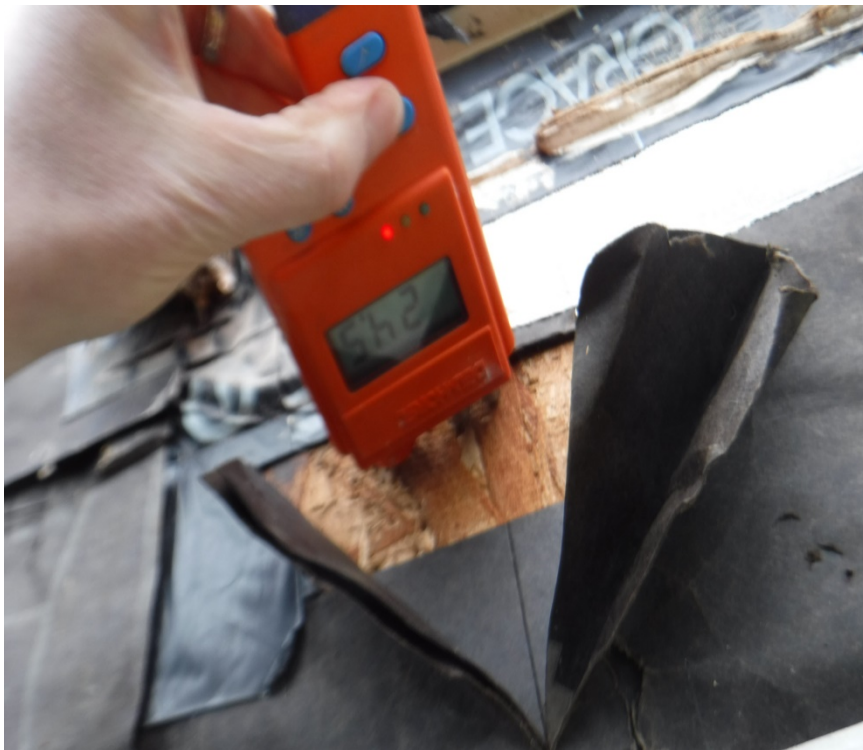
13.3 – Opening #13

Elevated moisture (24.5 mass percent) in OSB sheathing below window.

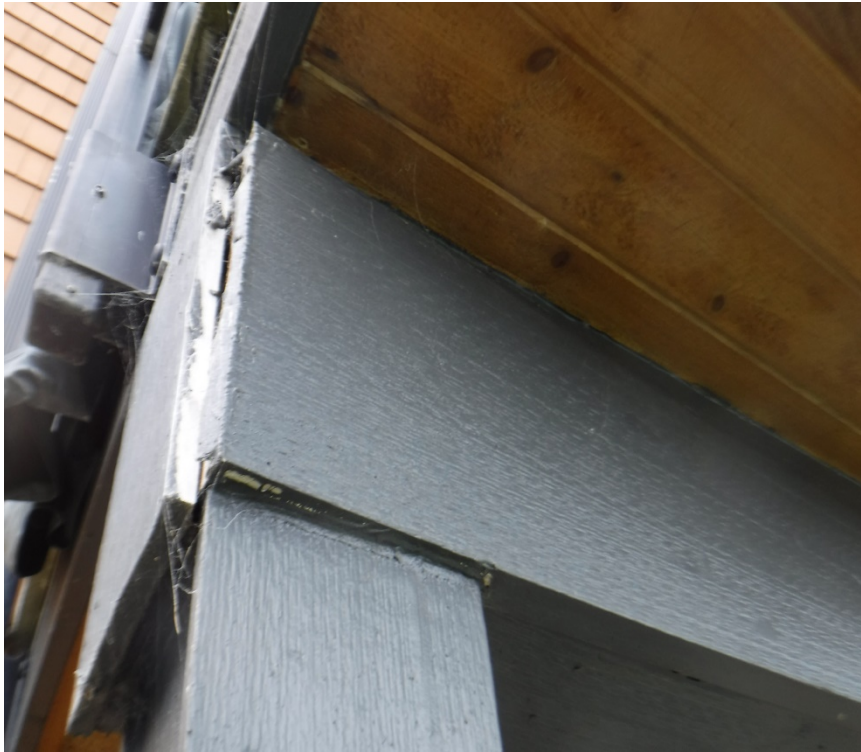
14.1 – Opening #14

Overview of beam wrap prior to Opening #14 at deck beam above Unit 210 on west elevation. Trim is warped, but minimal signs of water staining.

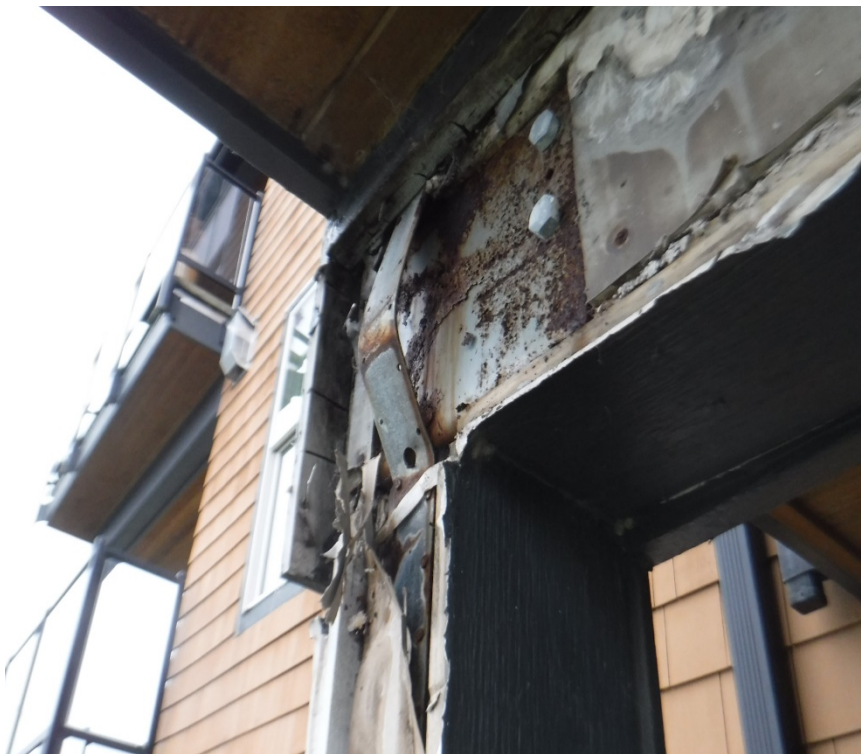
14.2 – Opening #14

Strap between second and third floor column has buckled, and metal is corroded. GWB wrap, column, and beam are severely deteriorated.

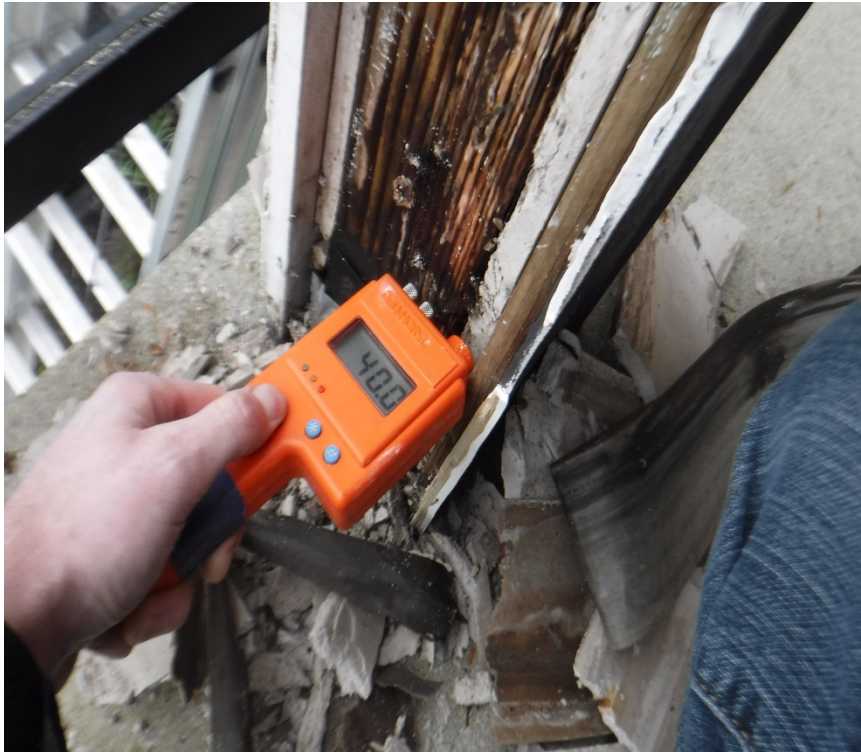
14.3 – Opening #14

Wood column supporting second, third, and fourth floor decks are saturated (40 mass percent) and decayed.

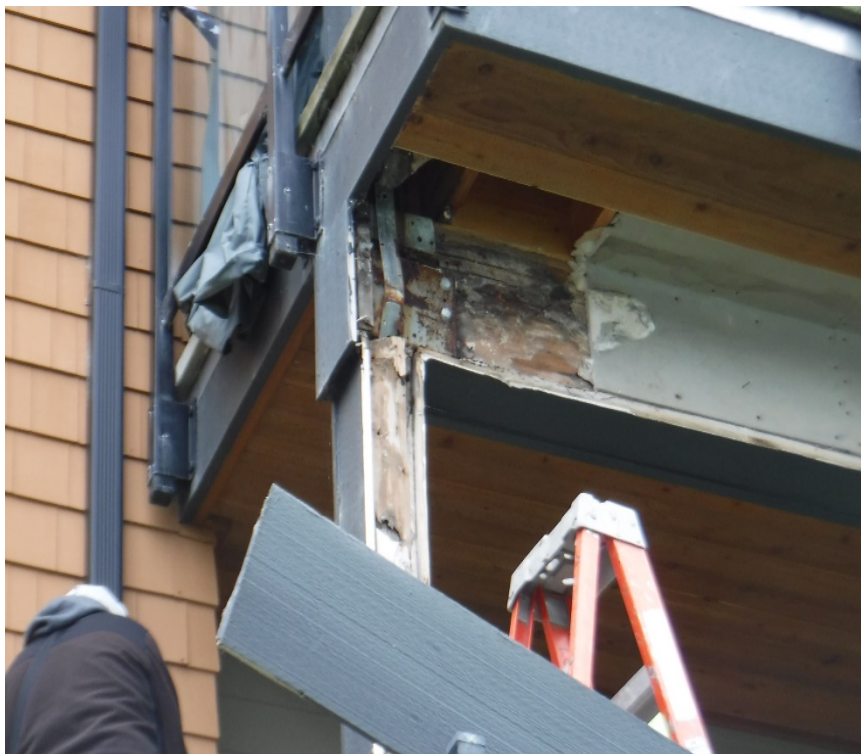
14.4 – Opening #14

GLB supporting second floor deck is severely decayed. Beam has compressed over 1" at support and is currently an unsafe condition.

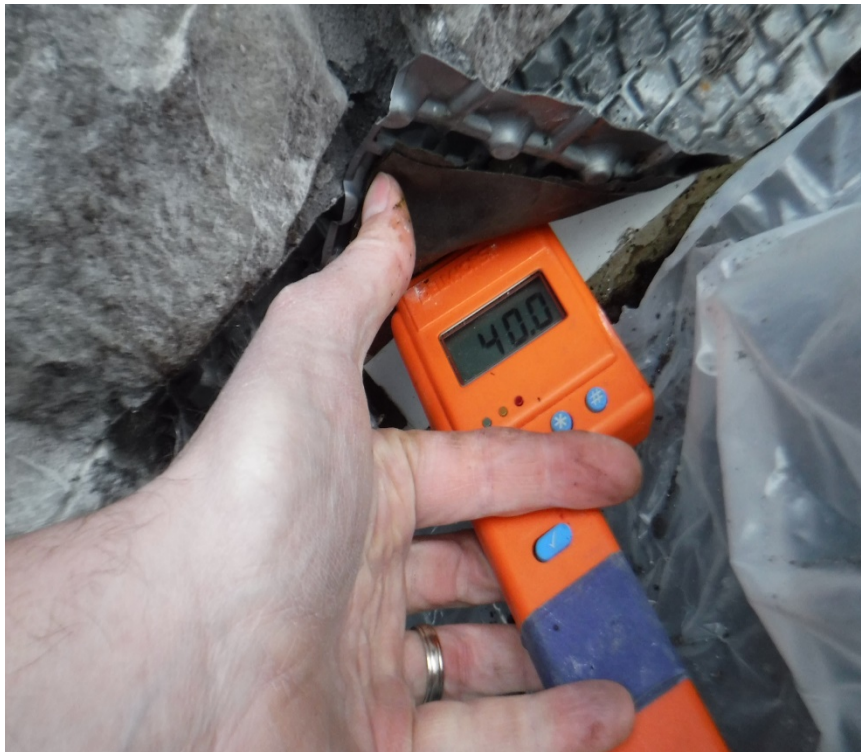
15.2 – Opening #15

Decayed and saturated (40 mass percent) OSB sheathing at base of wall.

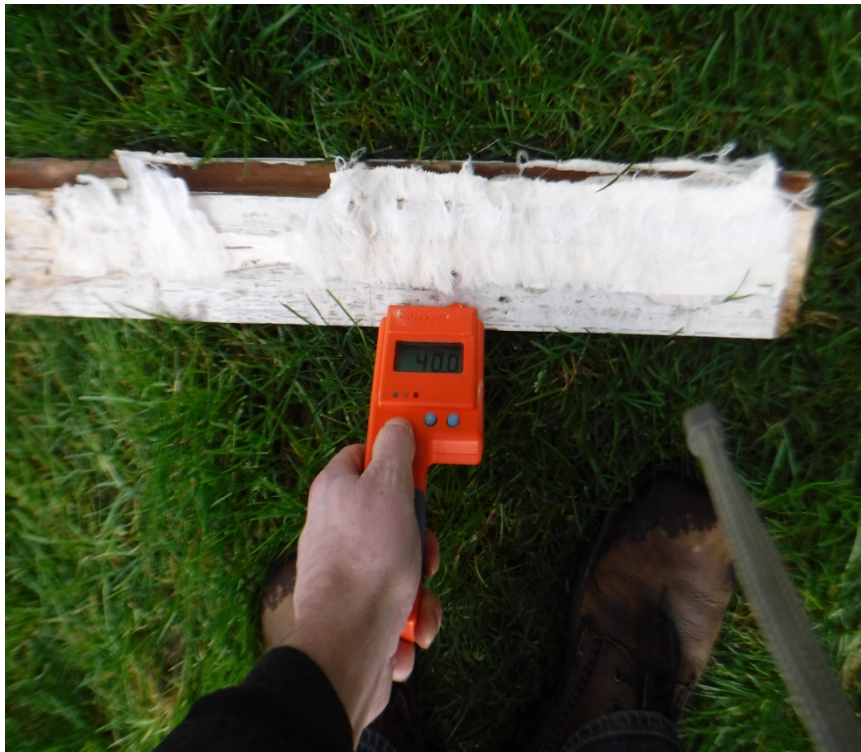
16.2 – Opening #16

Wood trim is decayed and saturated (40 mass percent).

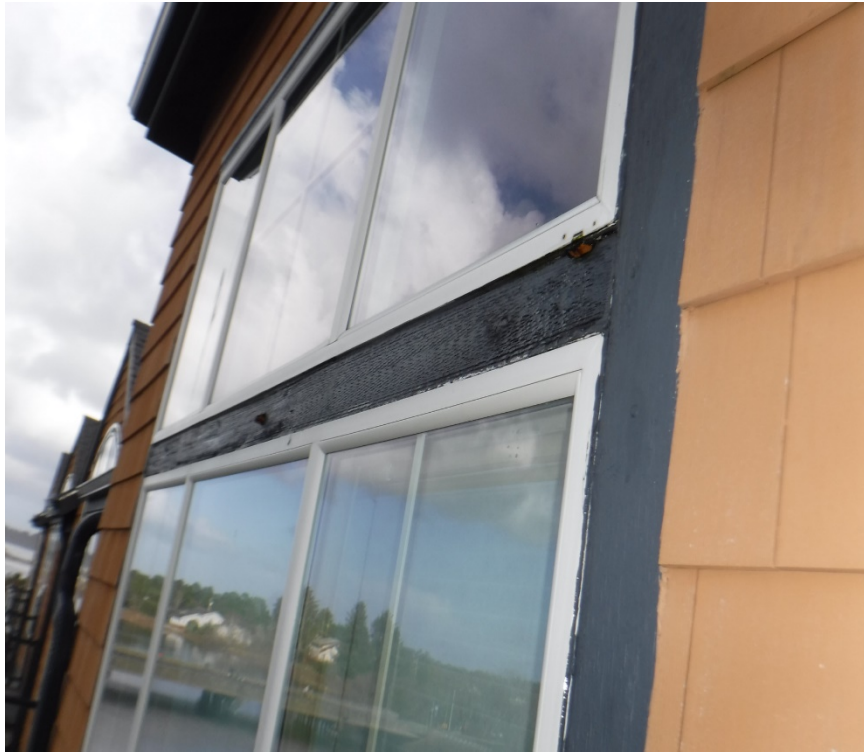
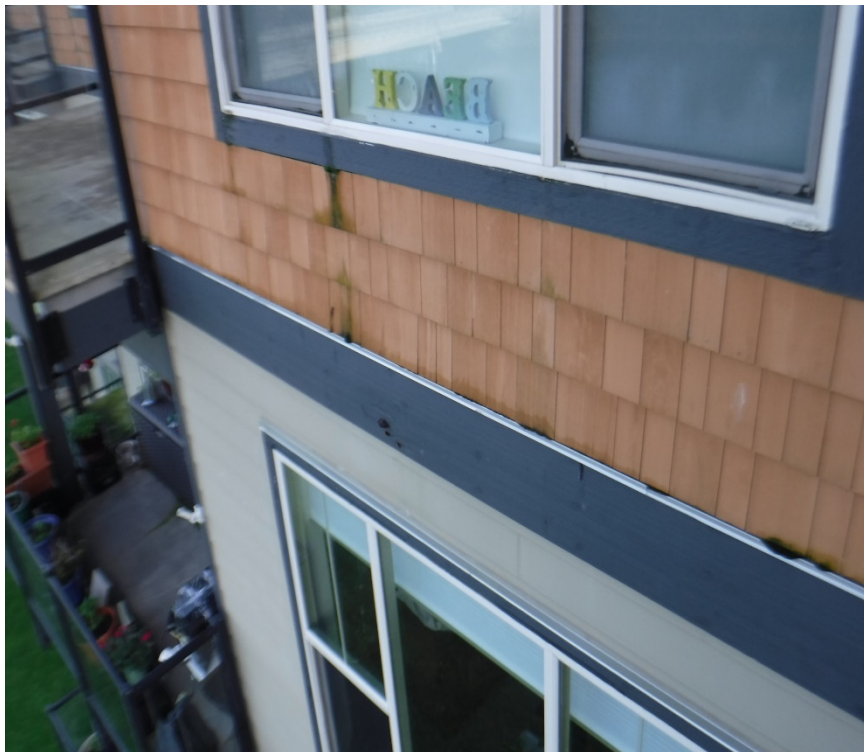
17.2 – Misc.

Trim is deteriorated, and mushroom growth is present.

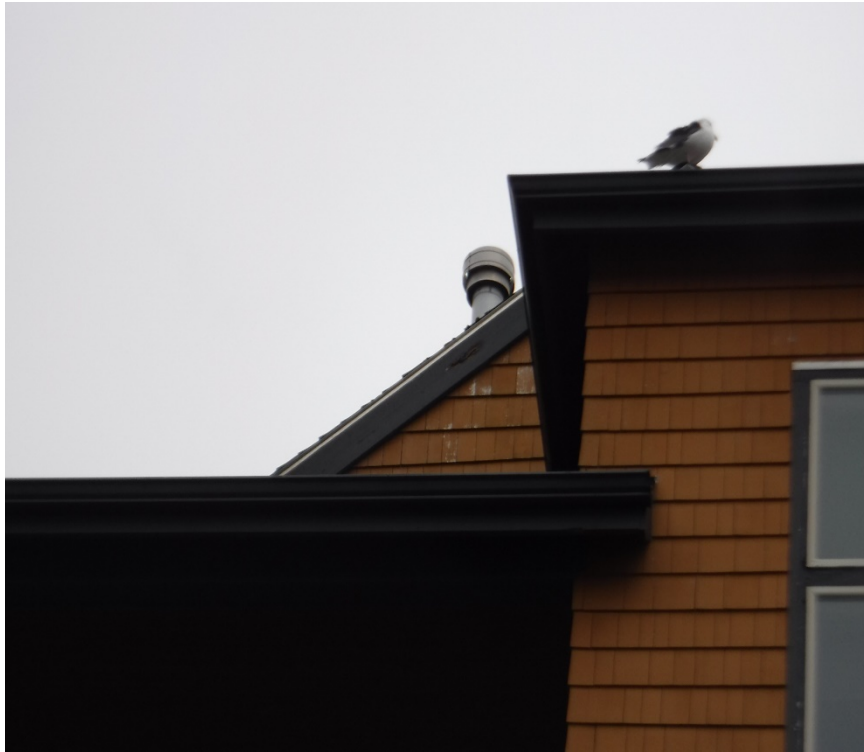
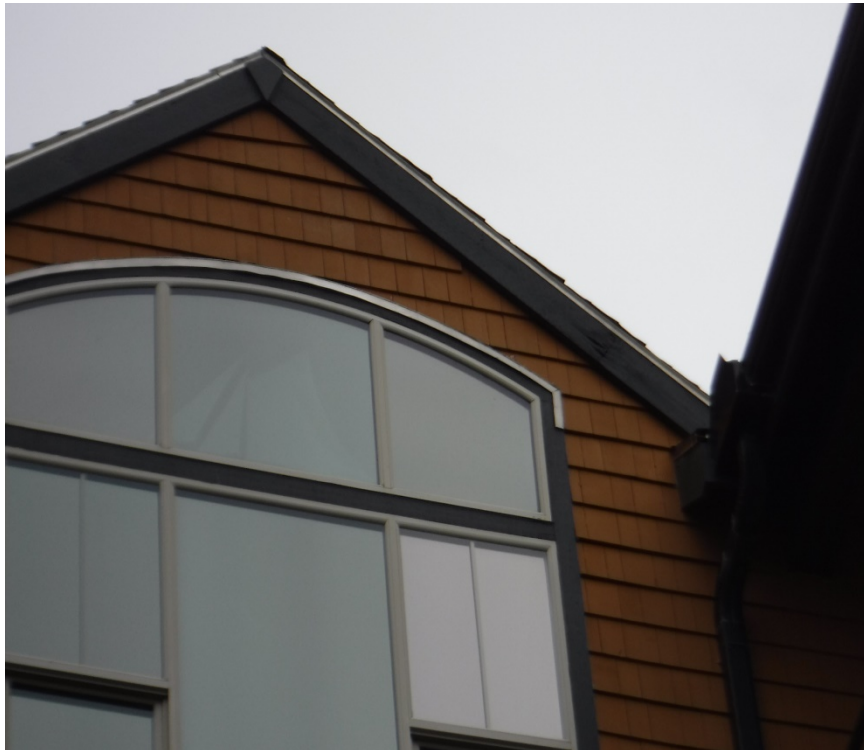
17.3 – Misc.

Barge boards are decayed.

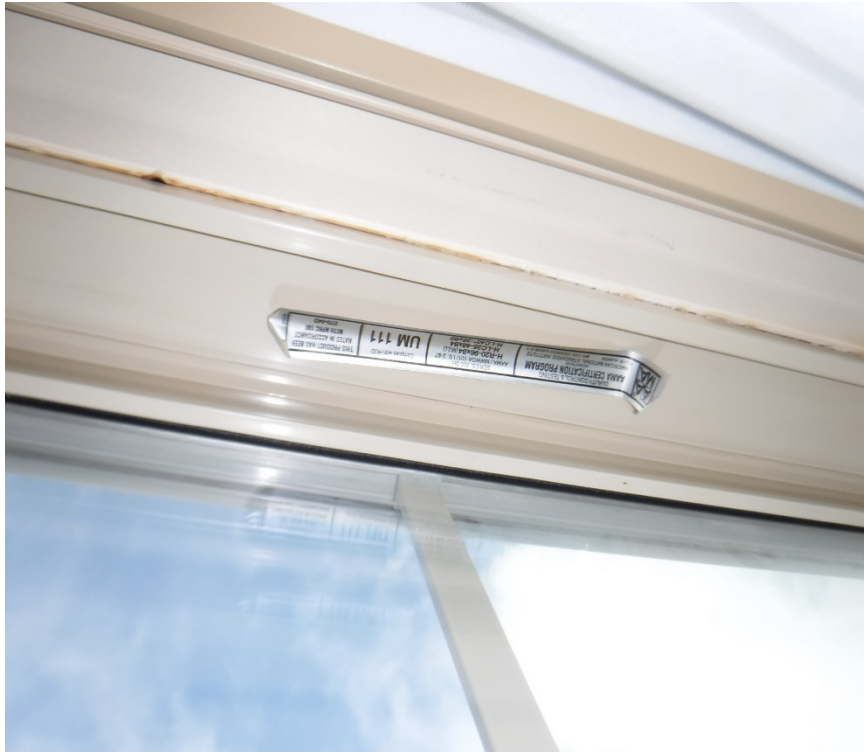
17.4 – Misc.

Large mulled windows are rated R20.

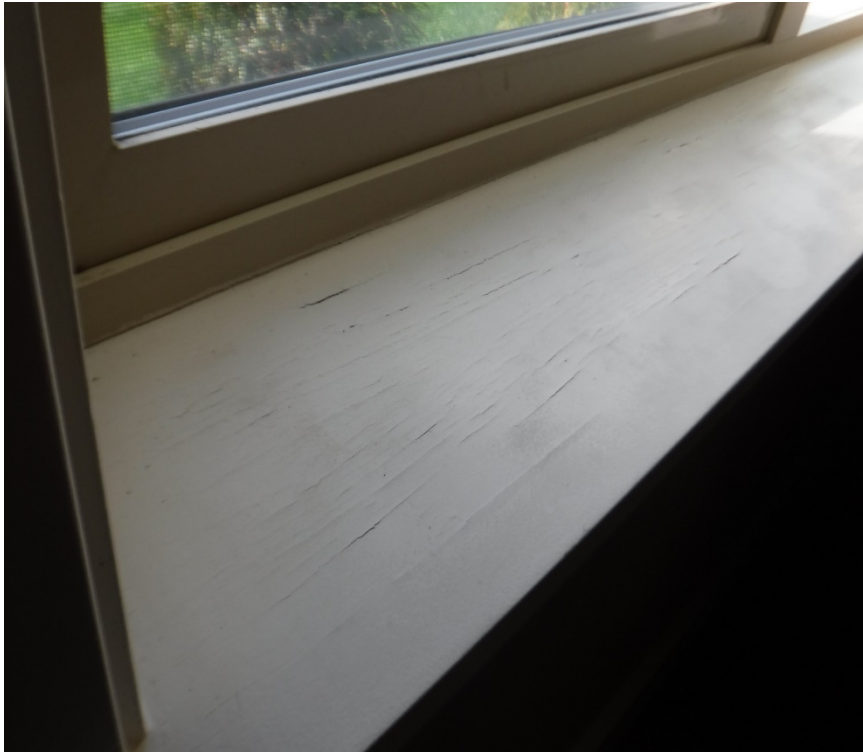
17.6 – Misc.

Interior window sill is water damaged.

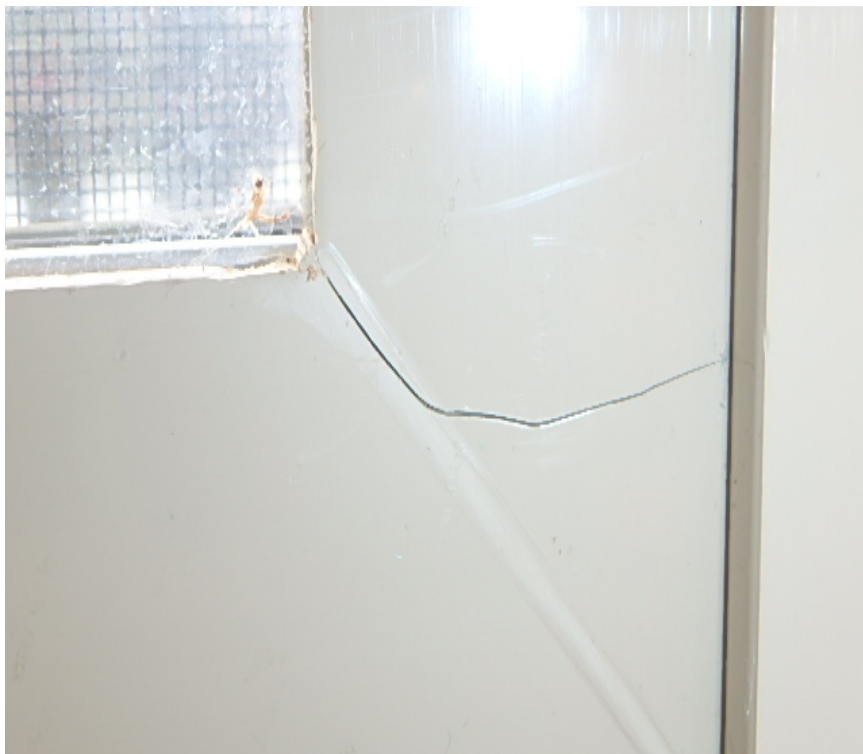
17.7 – Misc.

Window frame is cracked.

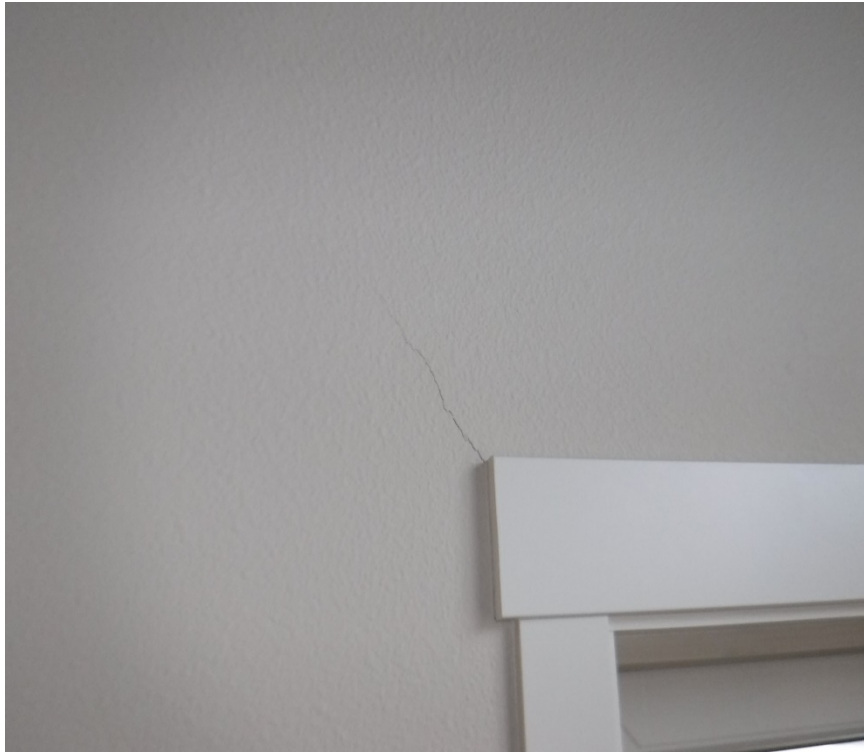
17.8 – Misc.

Crack in drywall at upper corner of door.

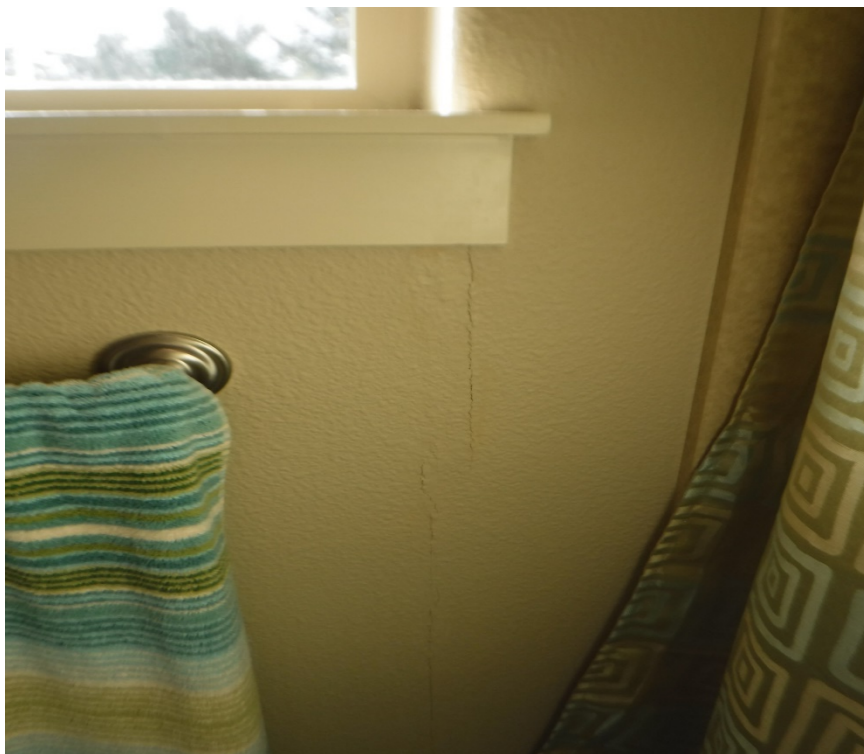
17.9 – Misc.

Crack in drywall at lower corner of window.

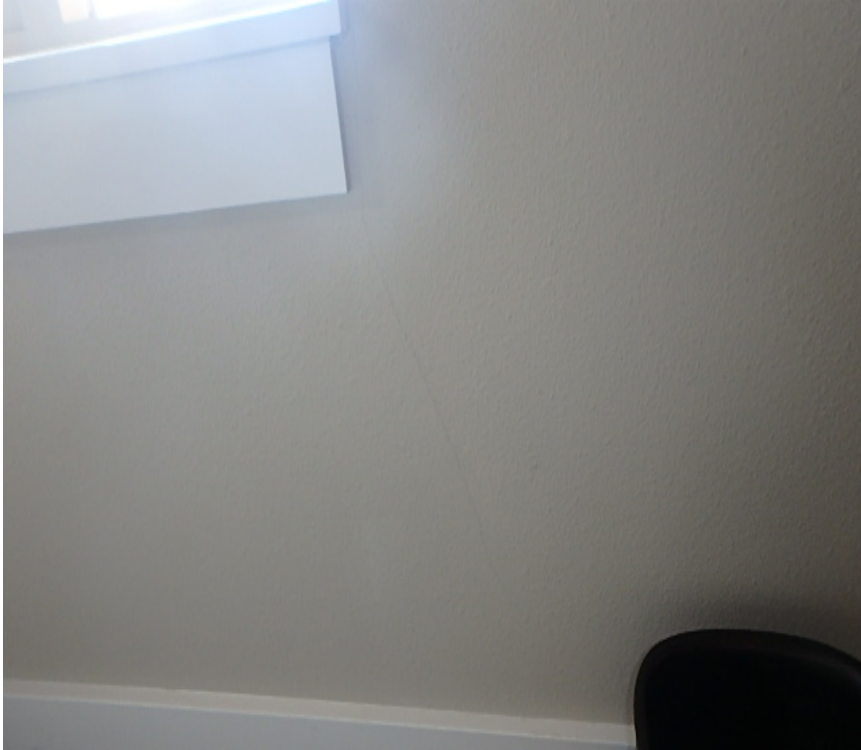
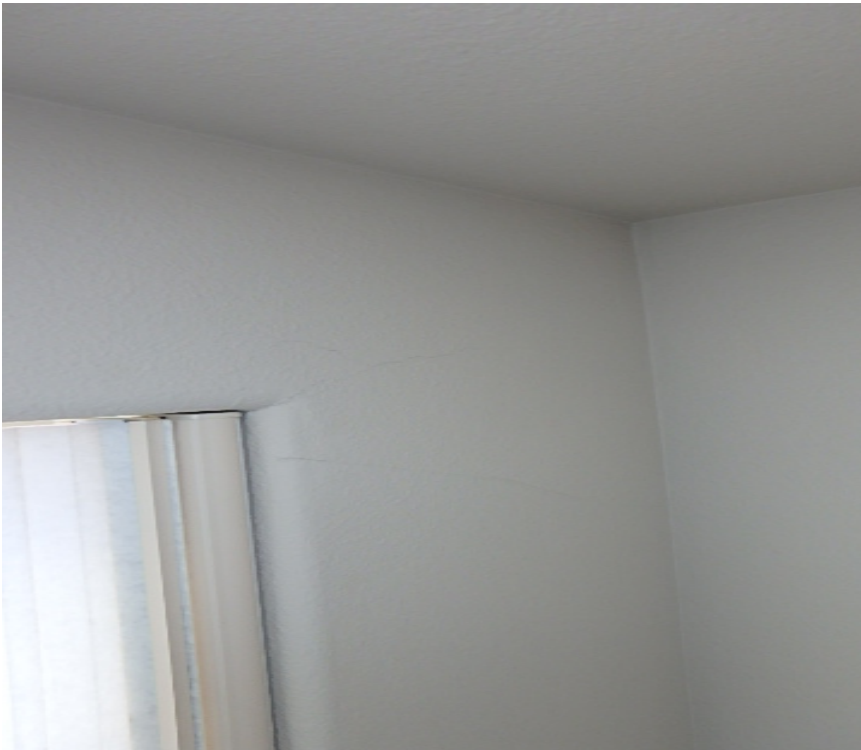
17.10 – Misc.

Drywall is cracking.

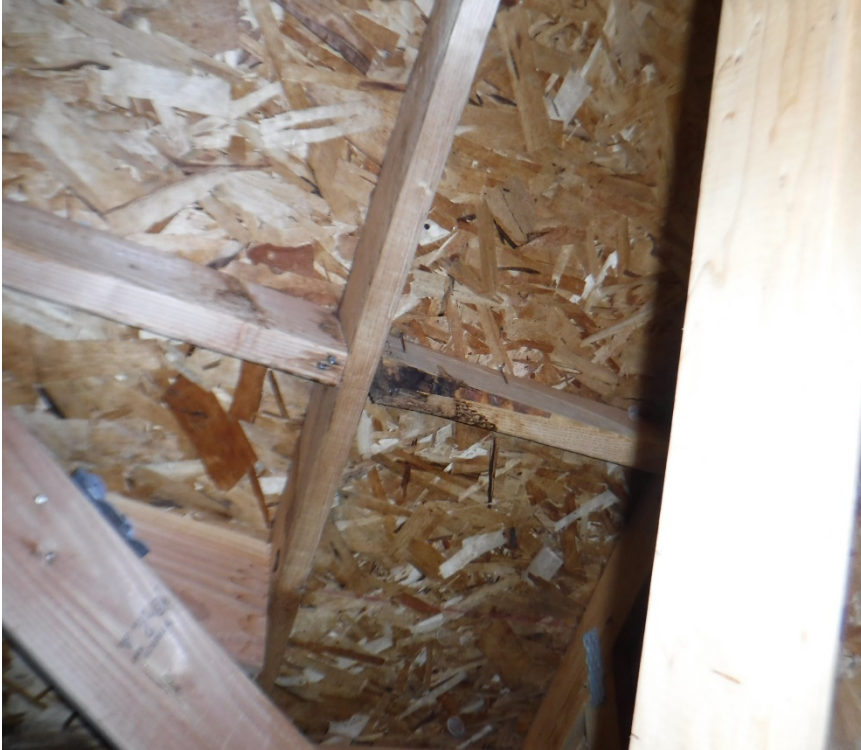
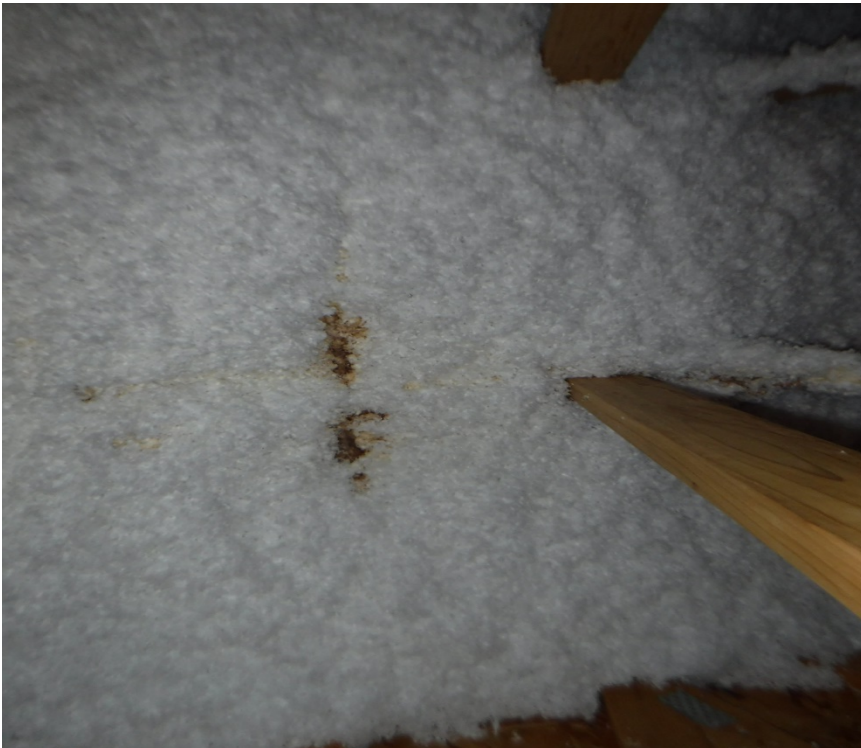
17.11 – Misc.

Active roof leak at roof transition near front of unit.

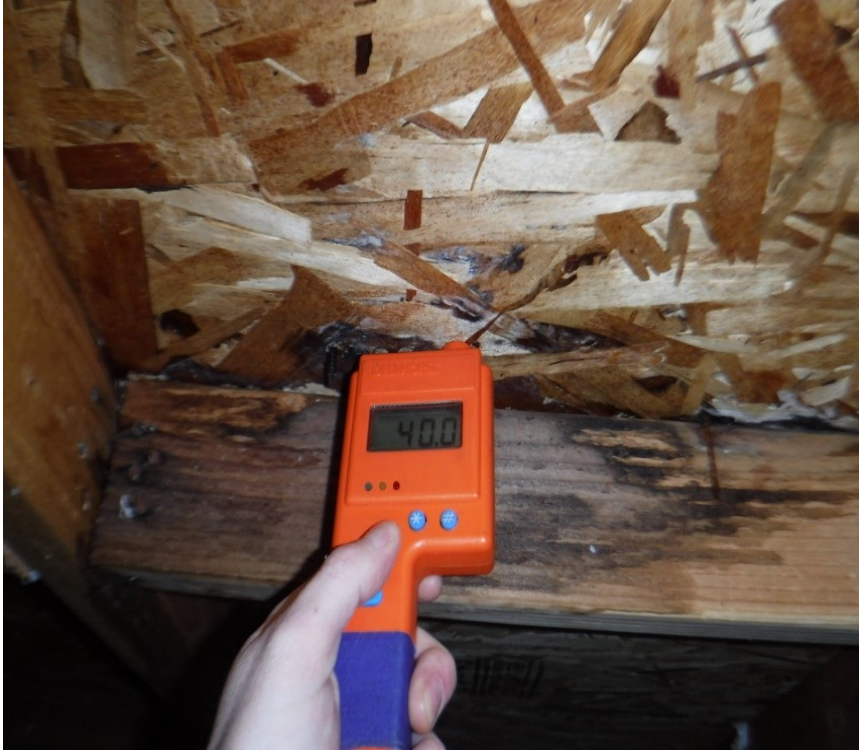
17.12 – Misc.

Active roof leak at roof transition near front of unit.

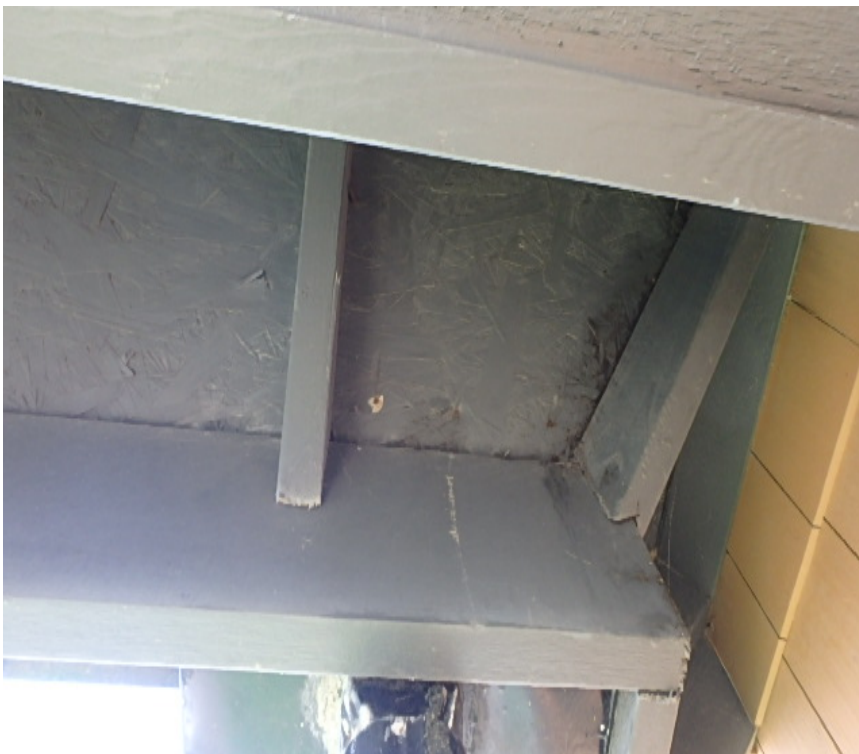
17.15 – Misc.

Apparent leak at roof valley and staining at underside of roof sheathing. Note that OSB was used instead of plywood at overhangs.

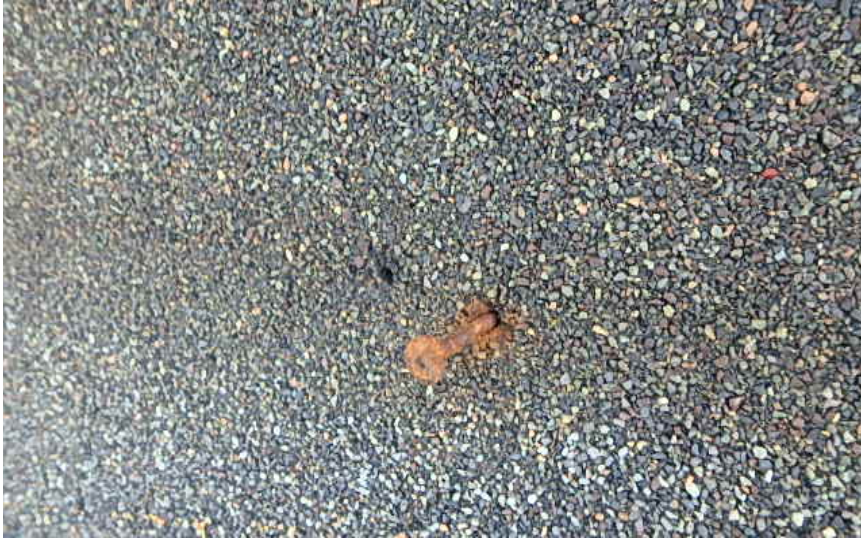
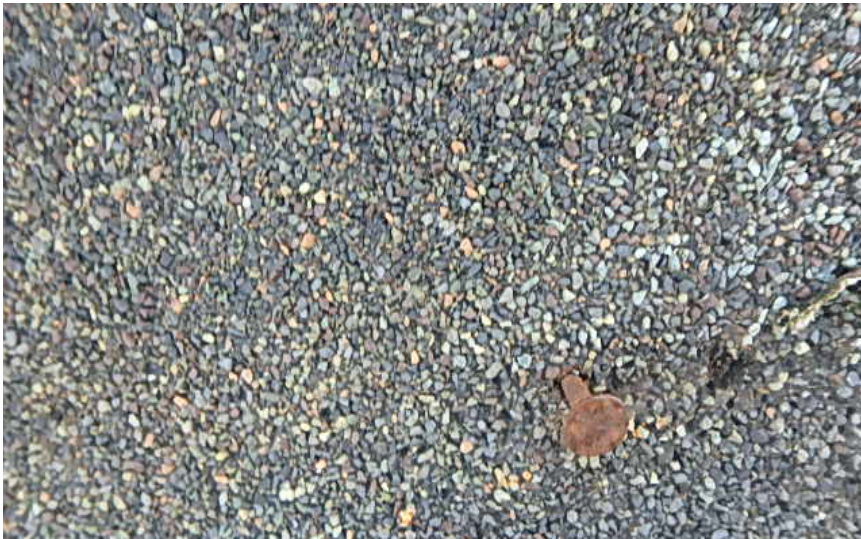
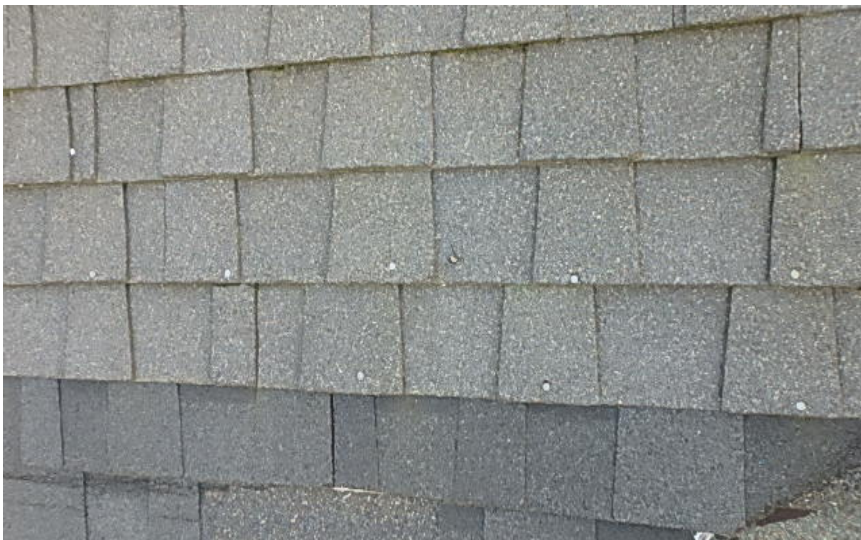
17.20 – Misc.

Fasteners are unsealed and corroded.

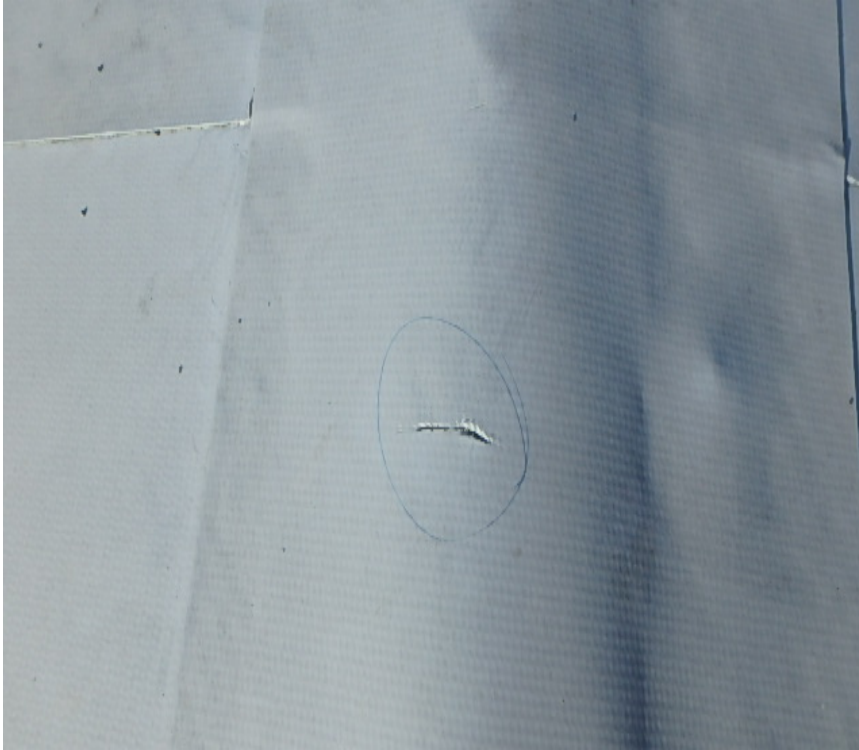
17.21 – Misc.

Single ply low slope roof membrane is damaged.

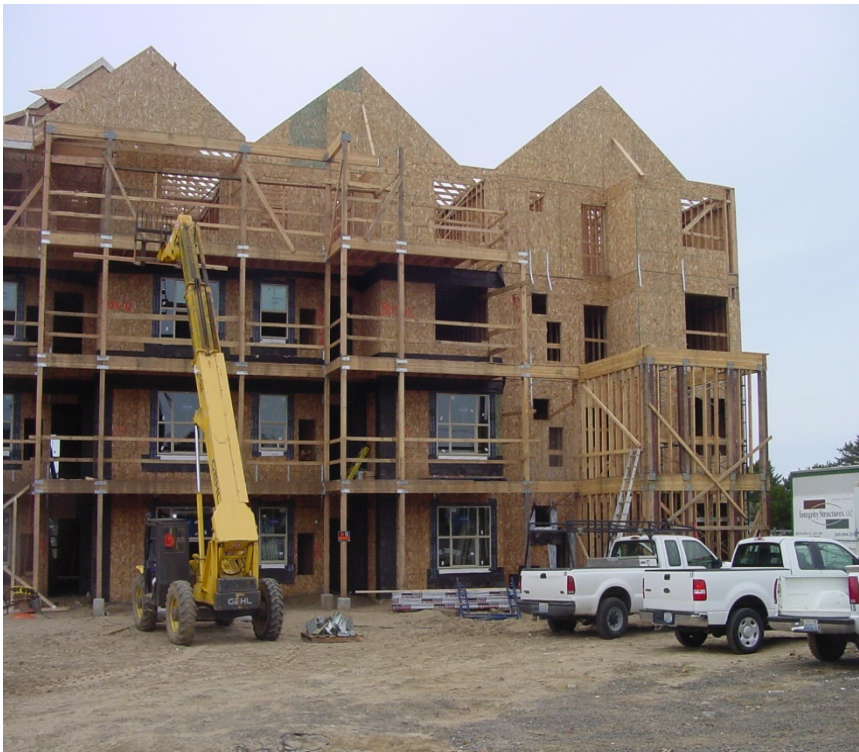
17.22 – Misc.

Note framing configuration at stair towers. Glulam beams are installed as girts due to not having diaphragms at floor lines to allow for stairs. Replacement of GLBs will require extensive framing repairs.
