**Date:** January 26, 2023

**Project:** JAH200 Bridgeview Condominiums  
Stair Assessment

**Location:** 6700-6748 N Richmond Ave  
Portland, OR 97203

**Document:** Exterior Stair Assessment Report

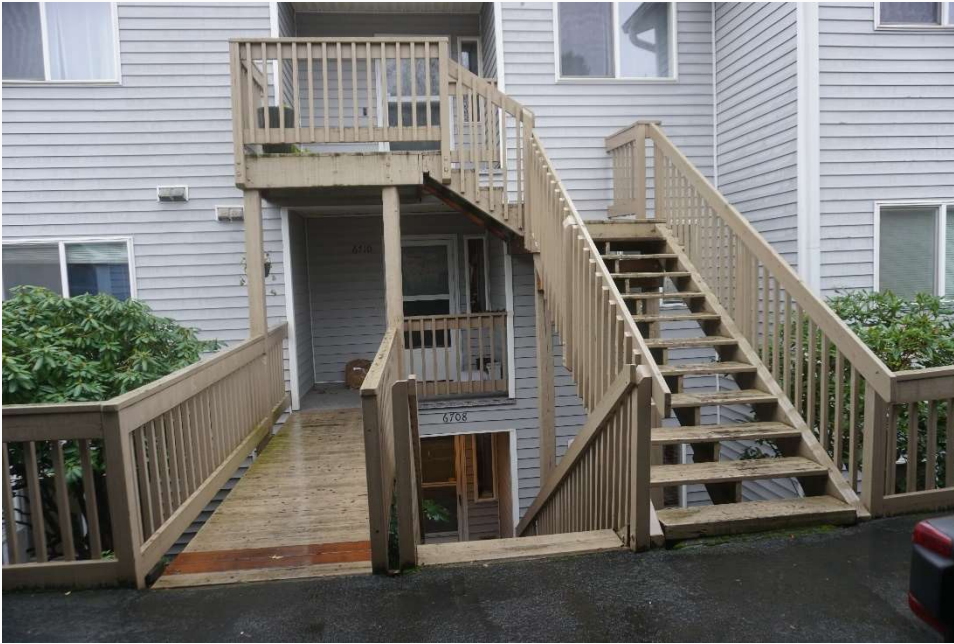
**Photo 1**

**Overall View – Stair Bank #2**

View of typical entry stair, railing, walkway, and landing configuration

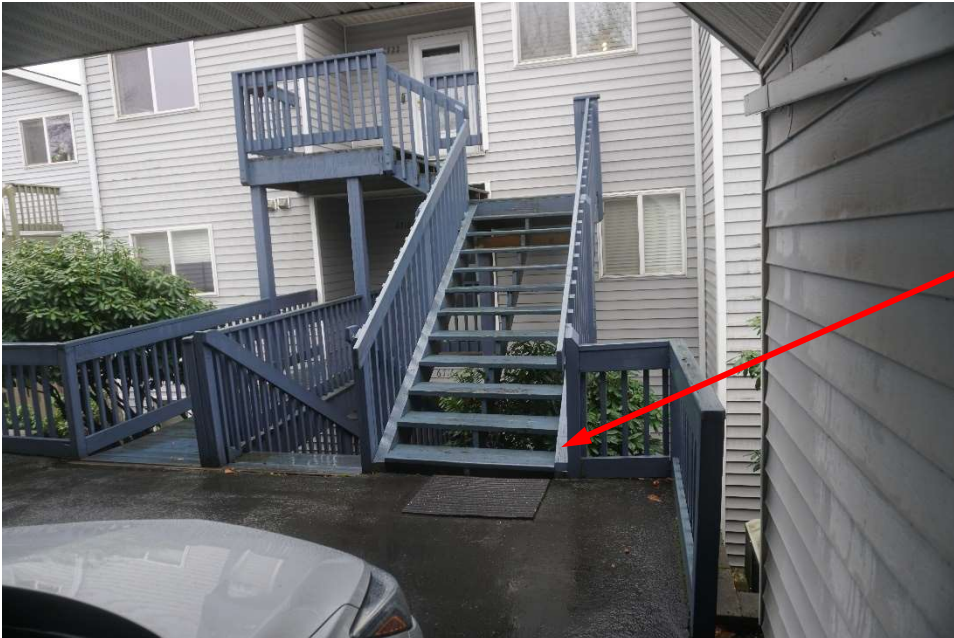
**Photo 2**

**Overall View – Stair Bank #3**

View of typical entry stair, railing, walkway, and landing configuration

Stairs are not level.

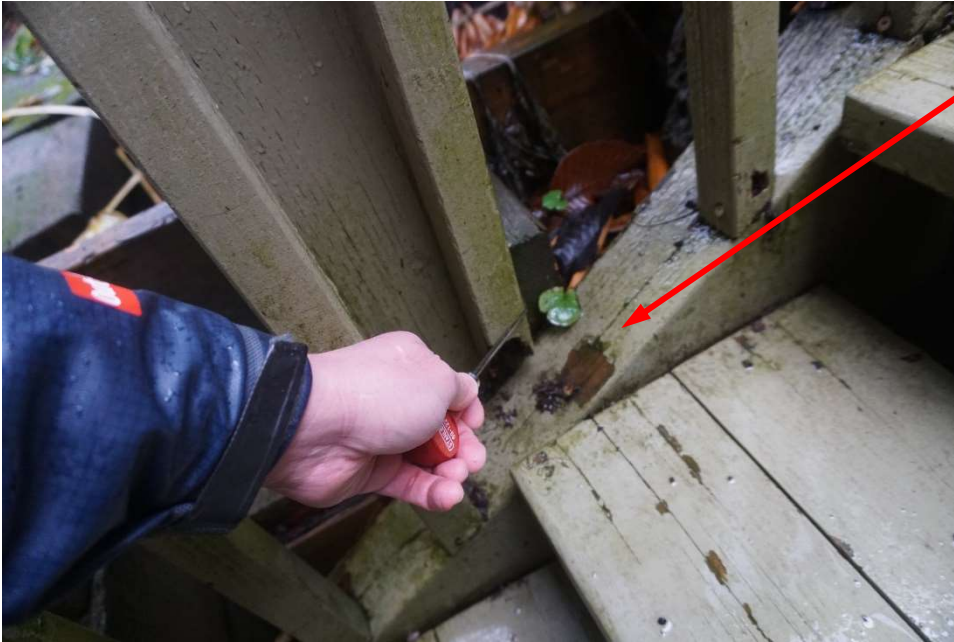
**Photo 3**

**Stair Bank 1**

View of deteriorated railing spindle, fully separated from stair stringer.

This is an unsafe condition.

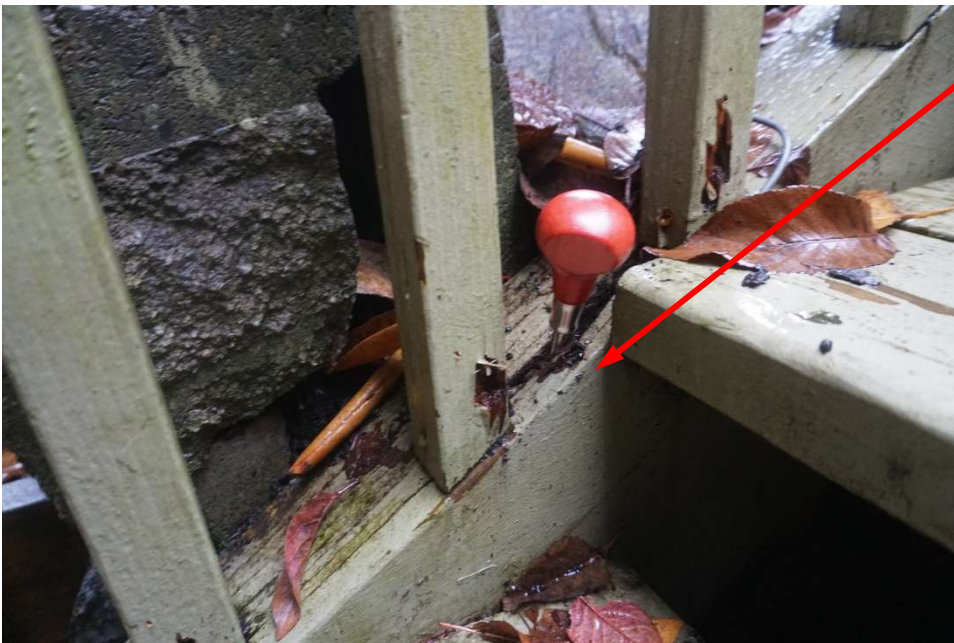
**Photo 4**

**Stair Bank 1**

View of deteriorated stair stringer.

This is a common condition.

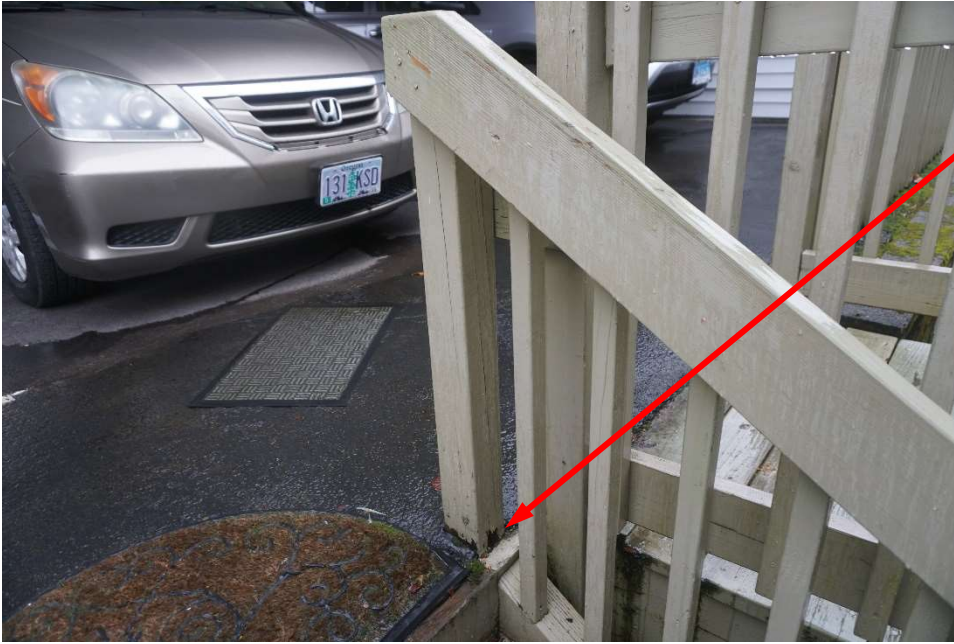
**Photo 5**

**Stair Bank 1**

View of deteriorated railing structural post due to being fully embedded in pavement.

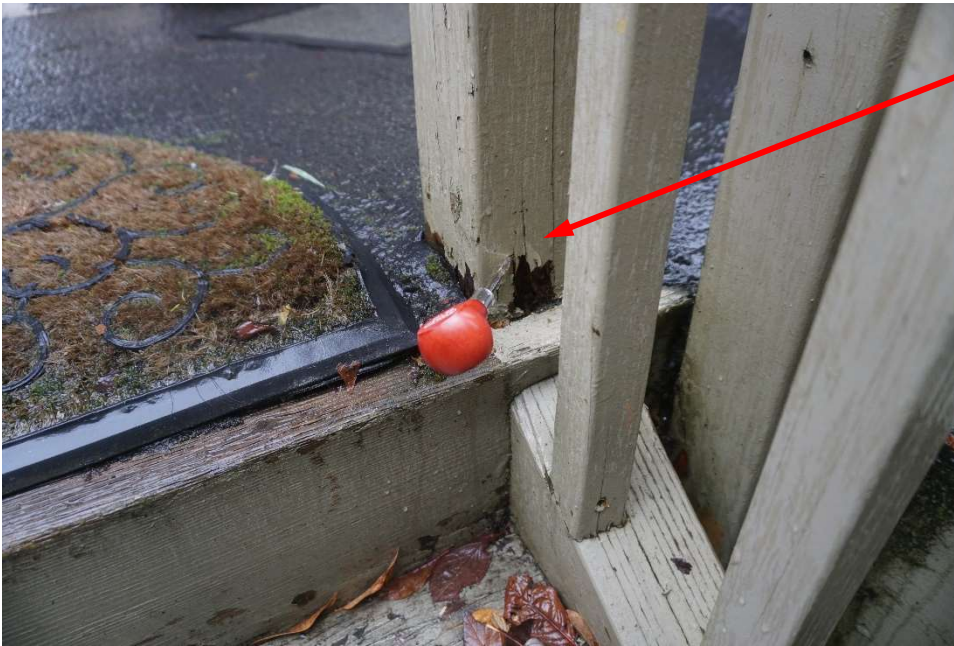
**Photo 6**

**Stair Bank 1**

Close-up view of previous photo, showing deterioration of railing structural post.

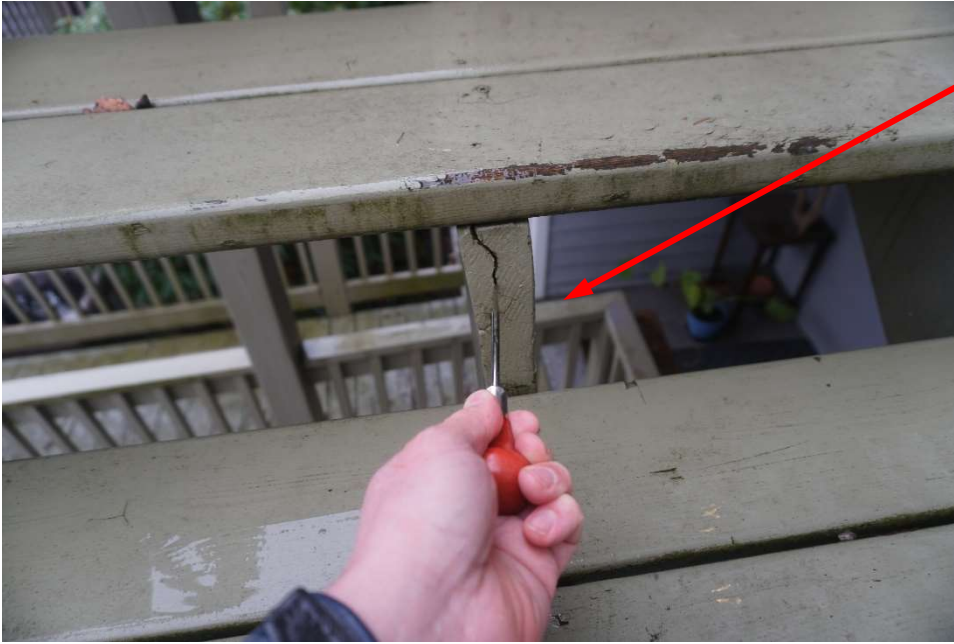
**Photo 7**

**Stair Bank 1**

View of fractured wood stair stringer.

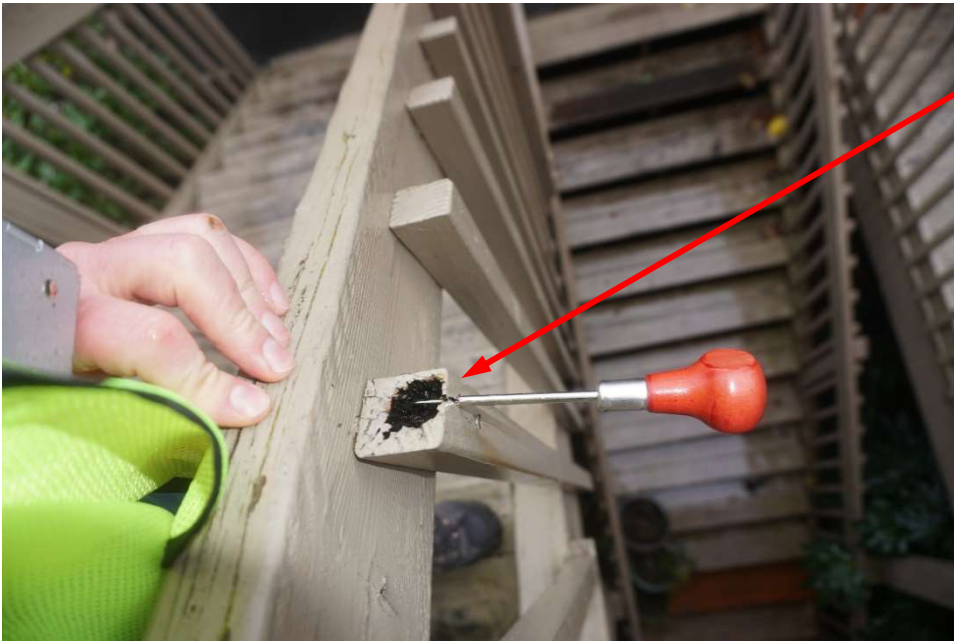
**Photo 8**

**Stair Bank 2**

View of deteriorated railing spindle.

This is a common and unsafe condition.

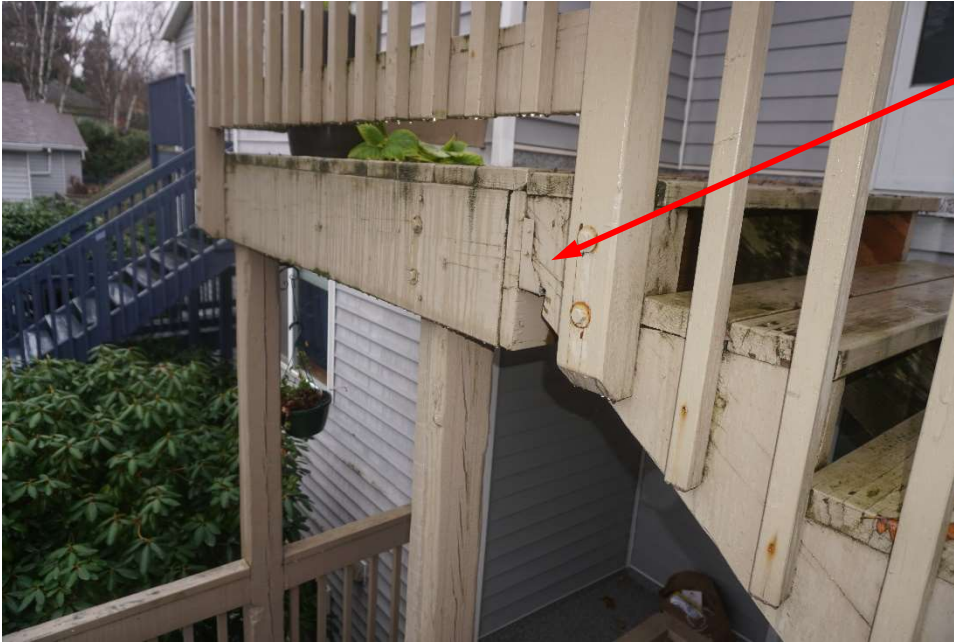
**Photo 9**

**Stair Bank 2**

View of stair stringer at upper landing, which has been improperly notched and installed in an under-sized hanger.

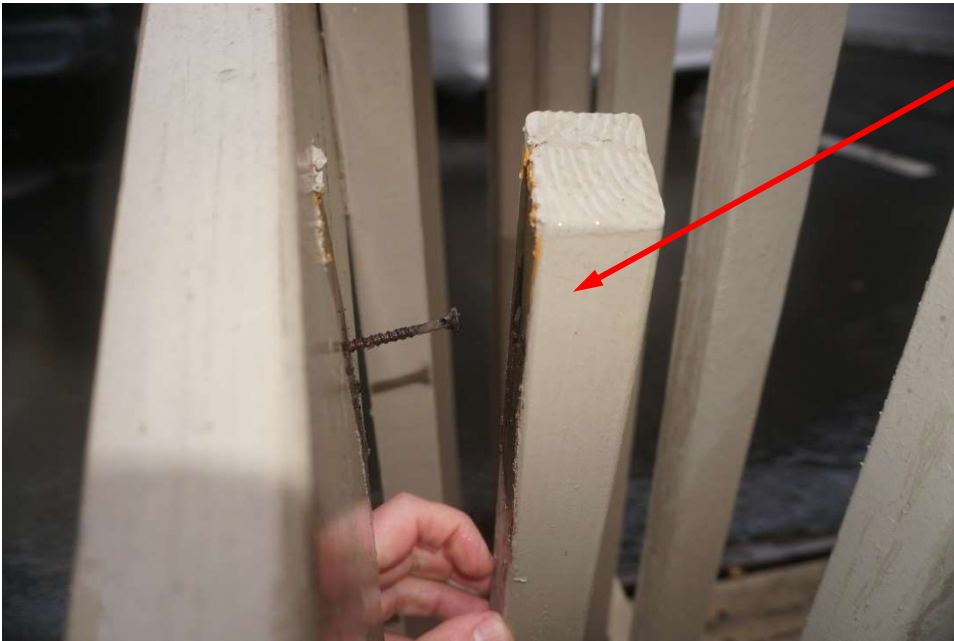
**Photo 10**

**Stair Bank 2**

View of deteriorated railing spindle, fully separated from railing top chord.

This is a common and unsafe condition.

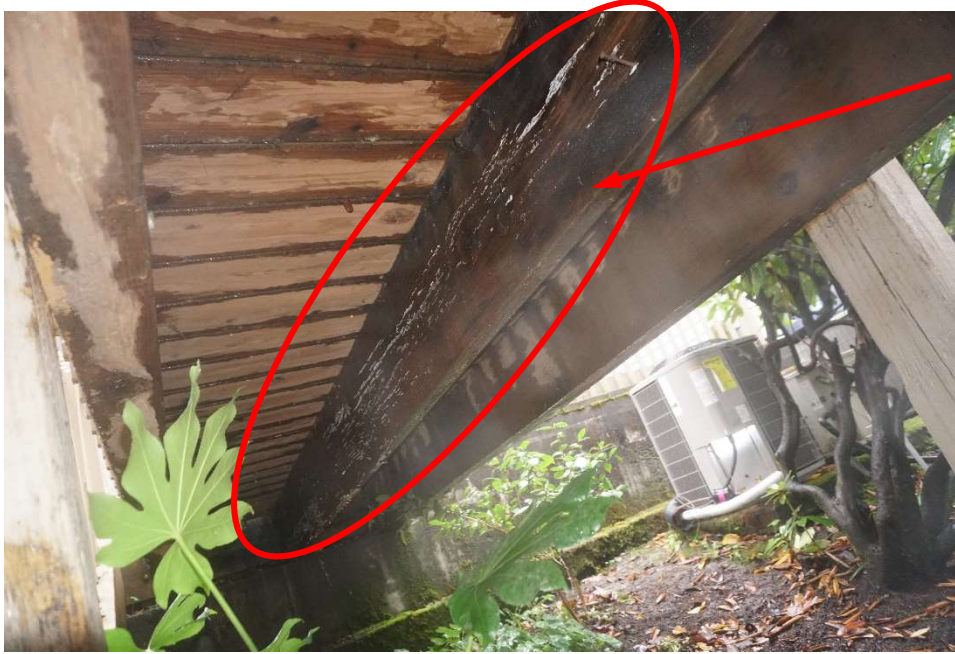
Photo 11

Stair Bank 2

View of severely deteriorated walkway framing member, showing organic growth along its entire length due to prolonged exposure to water.

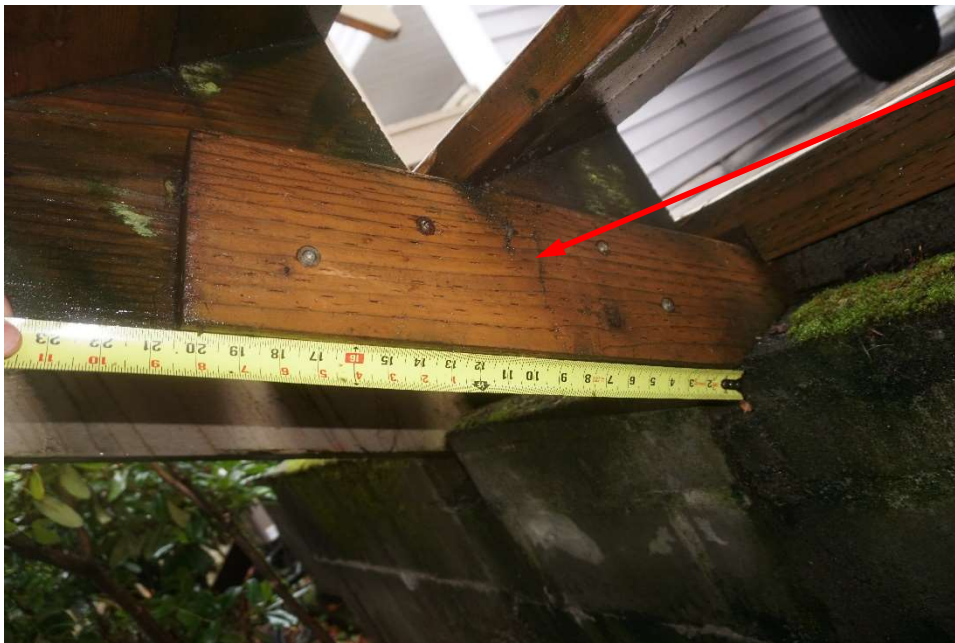
Photo 12

Stair Bank 2

View of improper structural repair to deteriorated stair stringer.

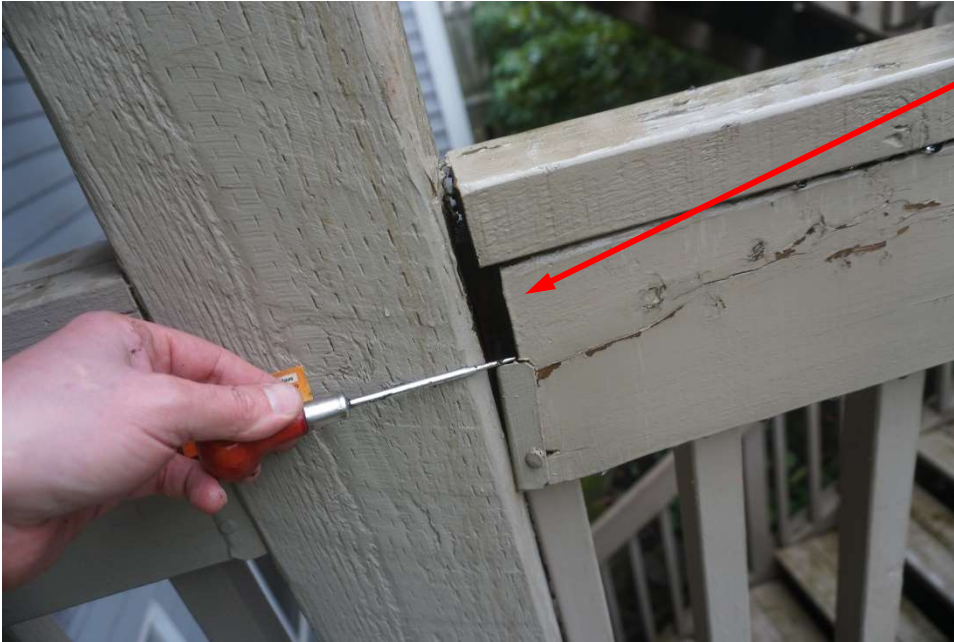
Photo 13

Stair Bank 2

View of handrail separation from structural post.

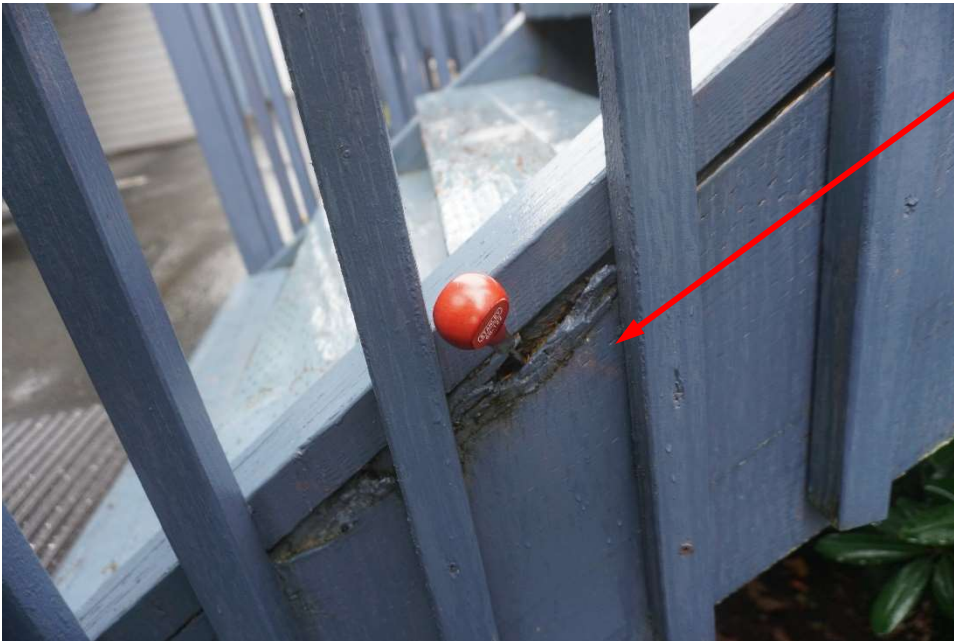
Photo 14

Stair Bank 3

View of deteriorated stair stringer with improper structural repair/strengthening.

This is a common condition.

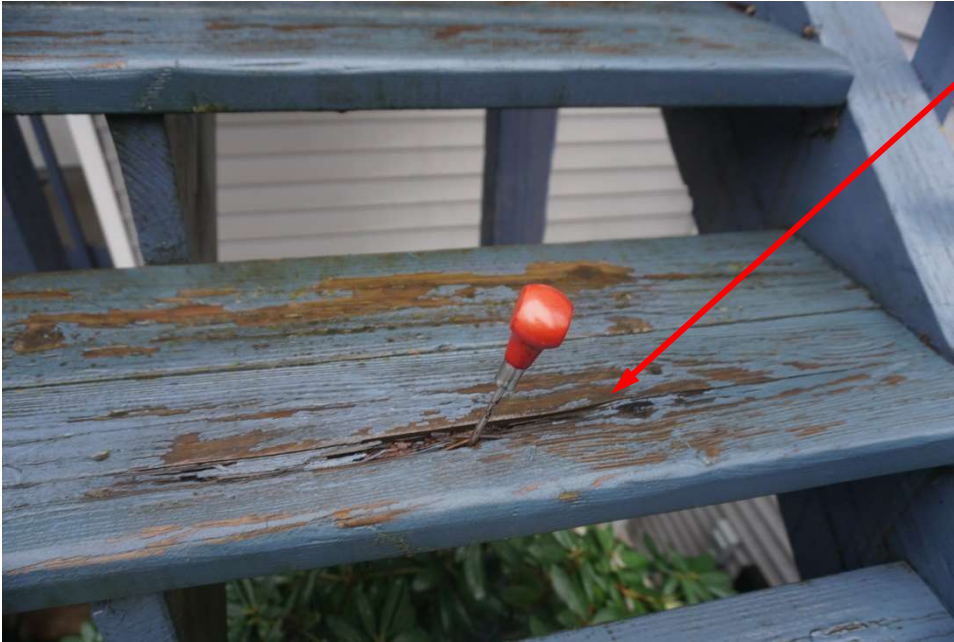
**Photo 15**

**Stair Bank 3**

View of deteriorated stair tread.

This is a common and unsafe condition.

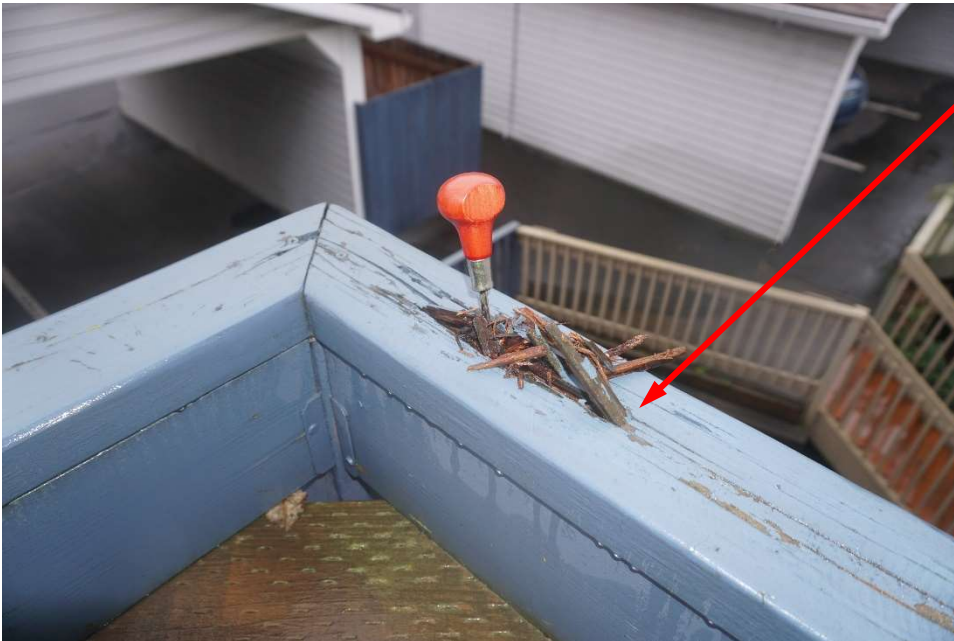
**Photo 16**

**Stair Bank 3**

View of deteriorated handrail

This is a common and unsafe condition.

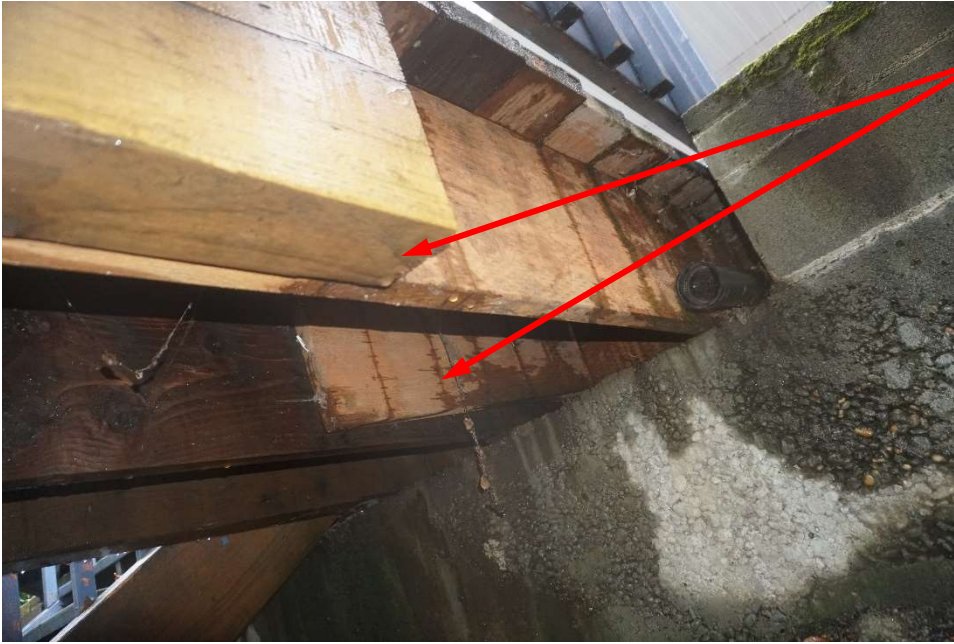
**Photo 17**

**Stair Bank 3**

View of improper structural repairs to deteriorated elevated walkway framing.

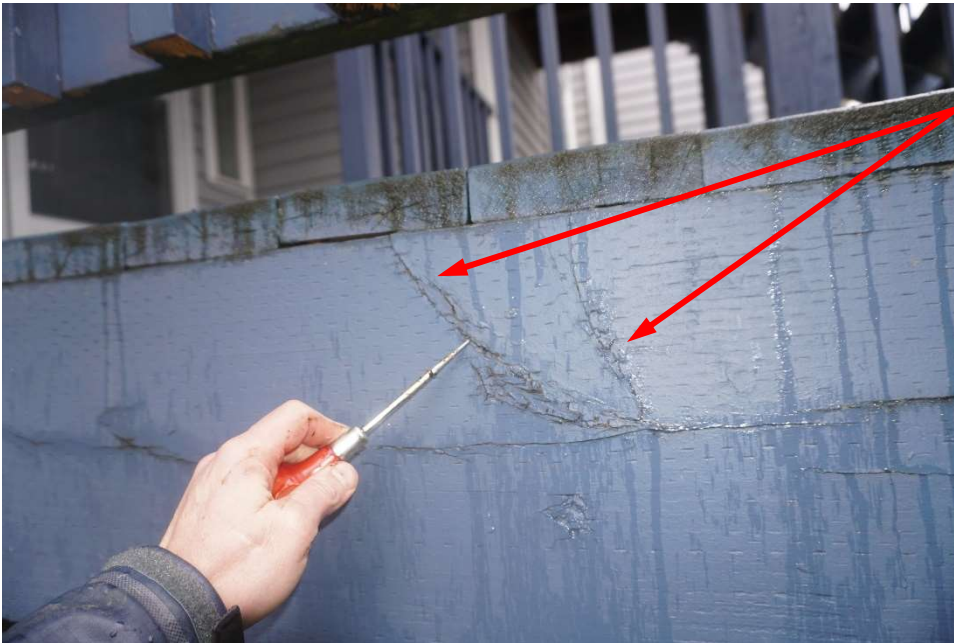
**Photo 18**

**Stair Bank 3**

View of fractured elevated walkway structural member.

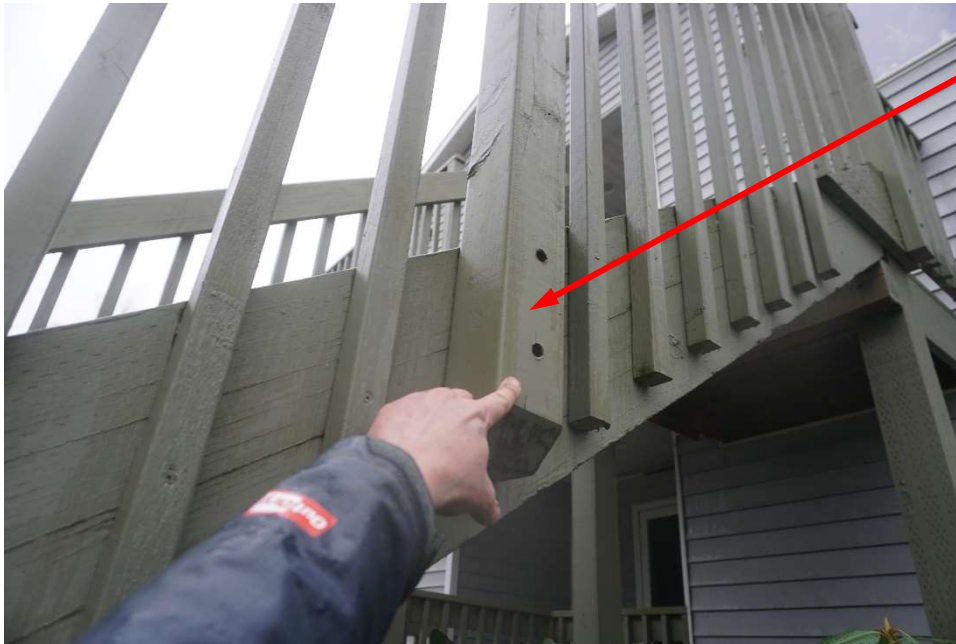
**Photo 19**

**Stair Bank 4**

View of stair handrail post with no fasteners.

This is an unsafe condition.

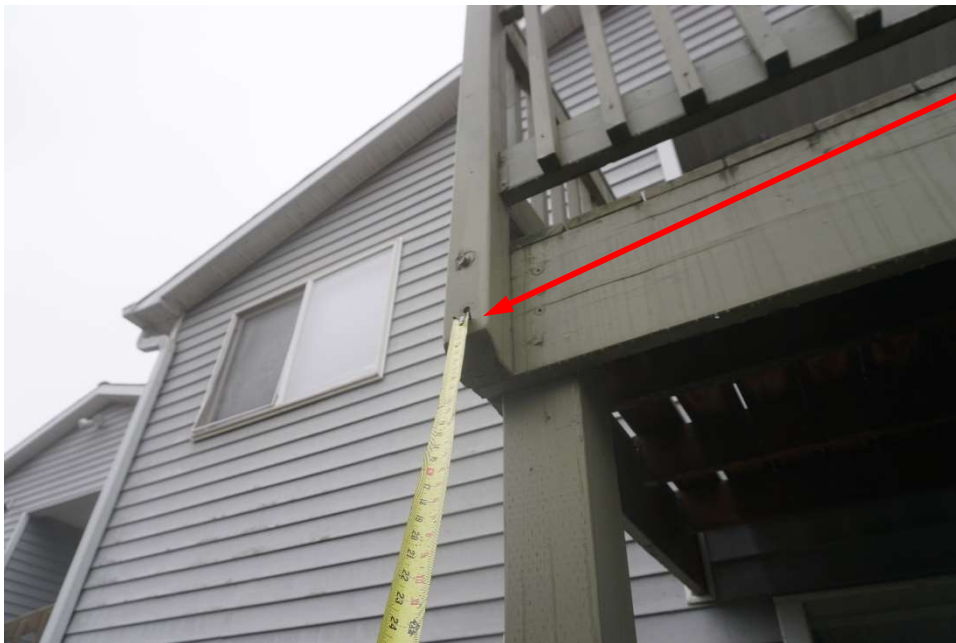
**Photo 20**

**Stair Bank 4**

View of landing handrail post with missing fastener.

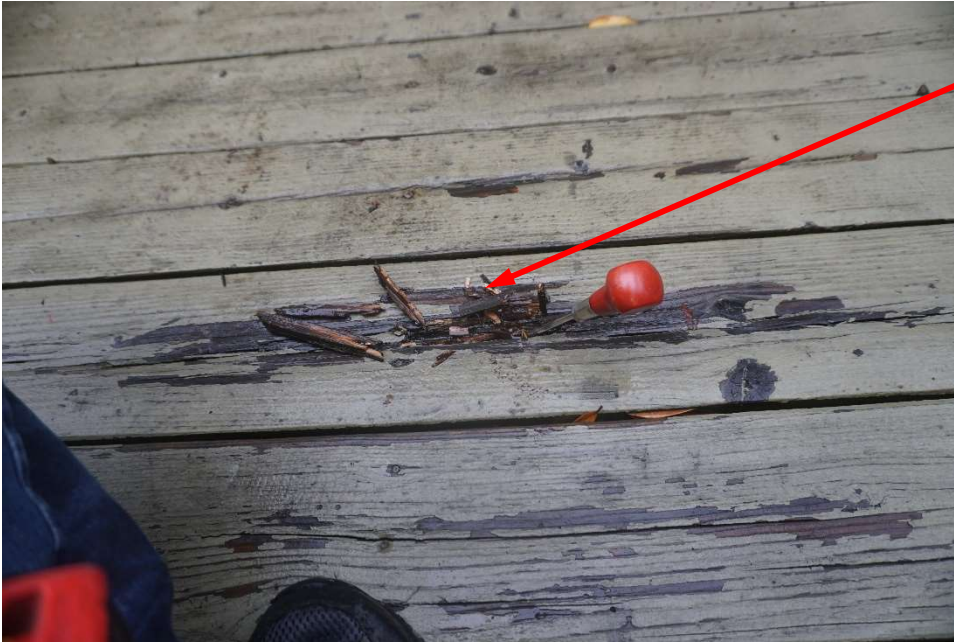
**Photo 21**

**Stair Bank 4**

View of deteriorated elevated walkway tread.

This is a common and unsafe condition.

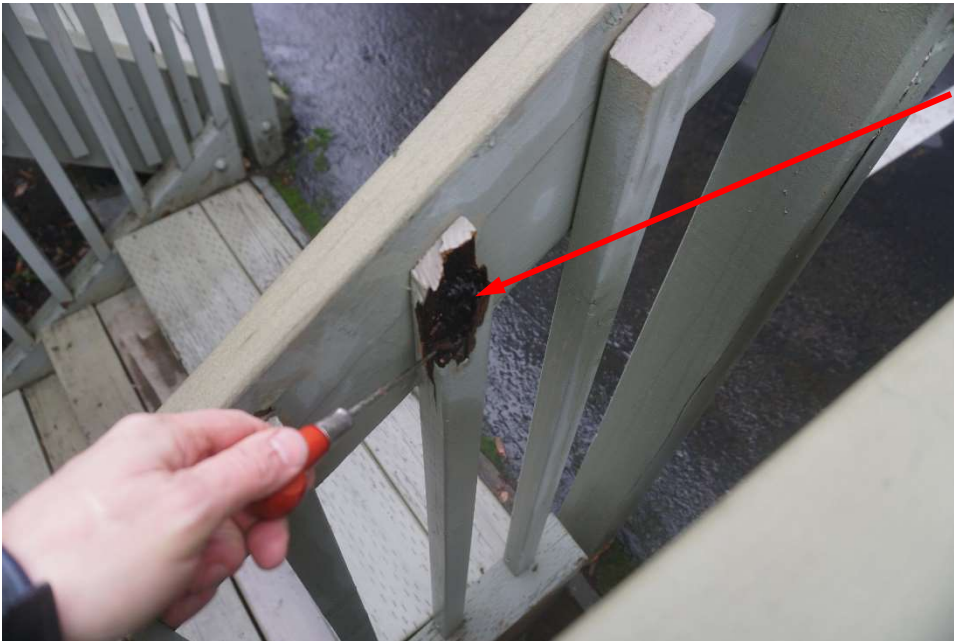
**Photo 22**

**Stair Bank 4**

View of deteriorated railing spindle.

This is a common and unsafe condition.

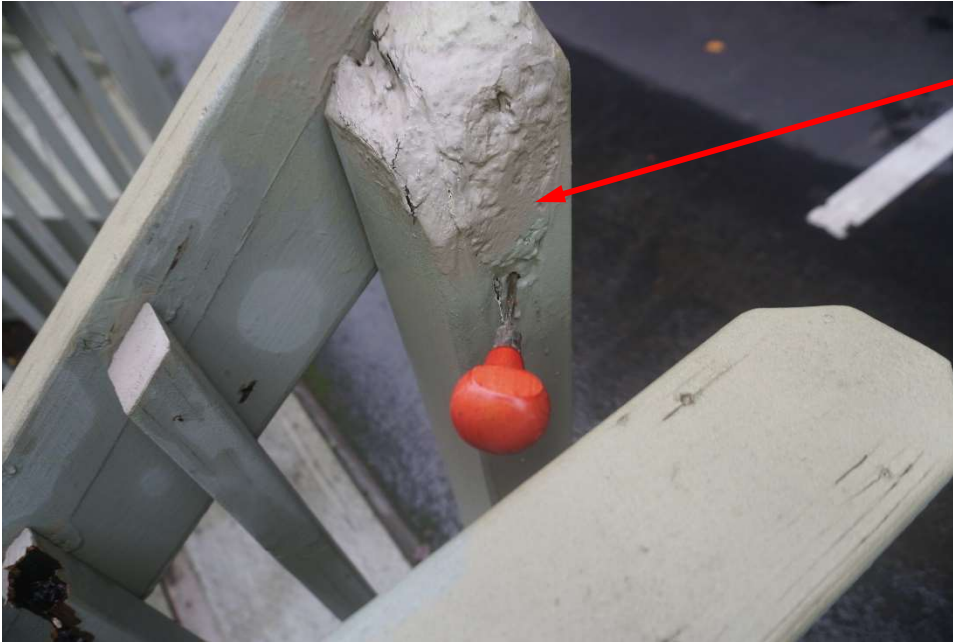
**Photo 23**

**Stair Bank 4**

View of deteriorated railing post, showing previous attempts at maintenance with an unknown putty filler.

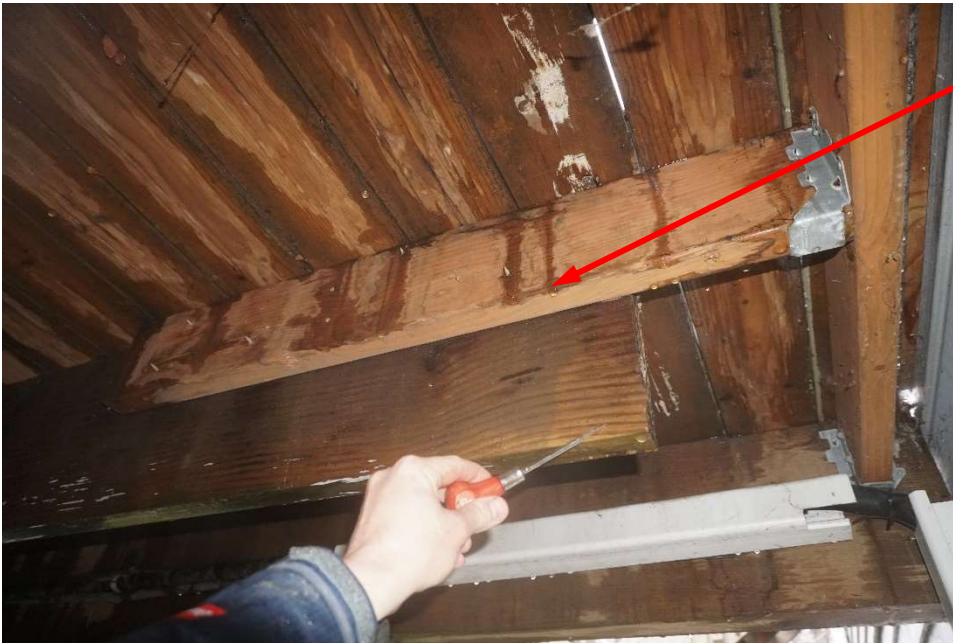
**Photo 24**

**Stair Bank 4**

View of improper structural repairs to deteriorated elevated walkway framing.

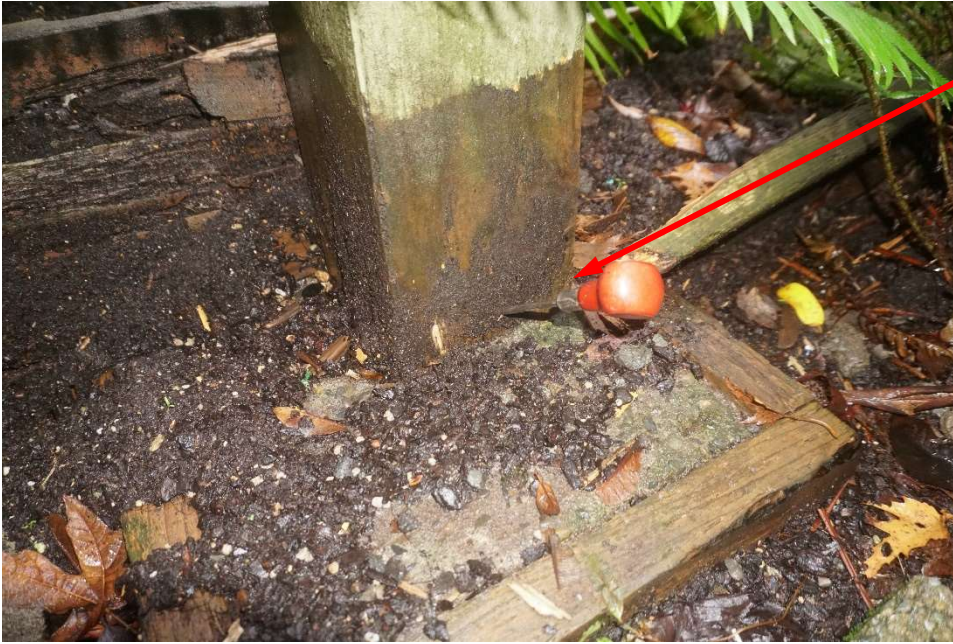
**Photo 25**

**Stair Bank 4**

View of deteriorated structural post resting on a concrete footing.

Note also that the post is offset from the center of the footing.

This is a common condition.

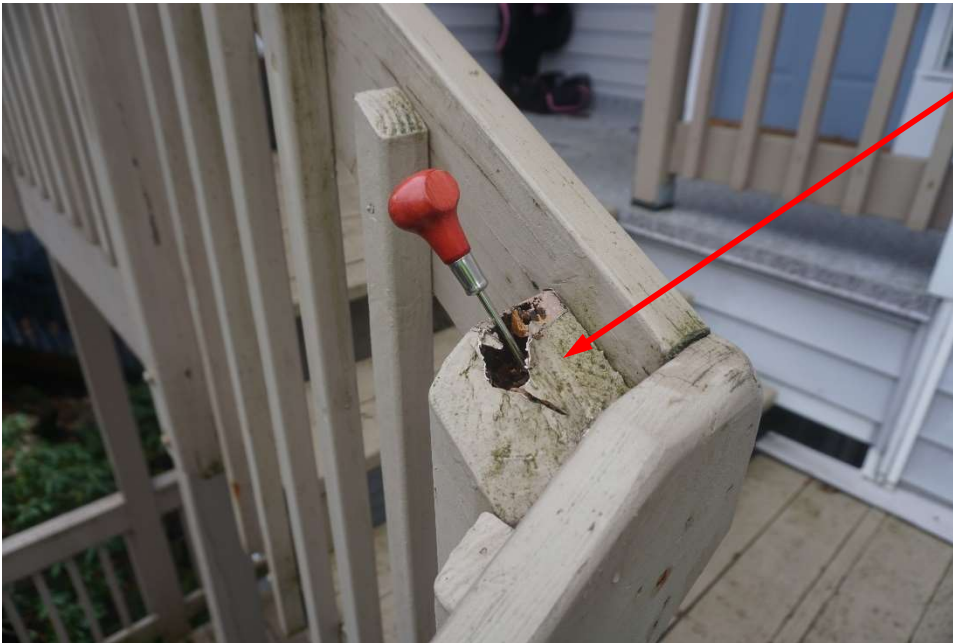
**Photo 26**

**Stair Bank 5**

View of deteriorated railing post, showing previous attempts at maintenance with an unknown putty.

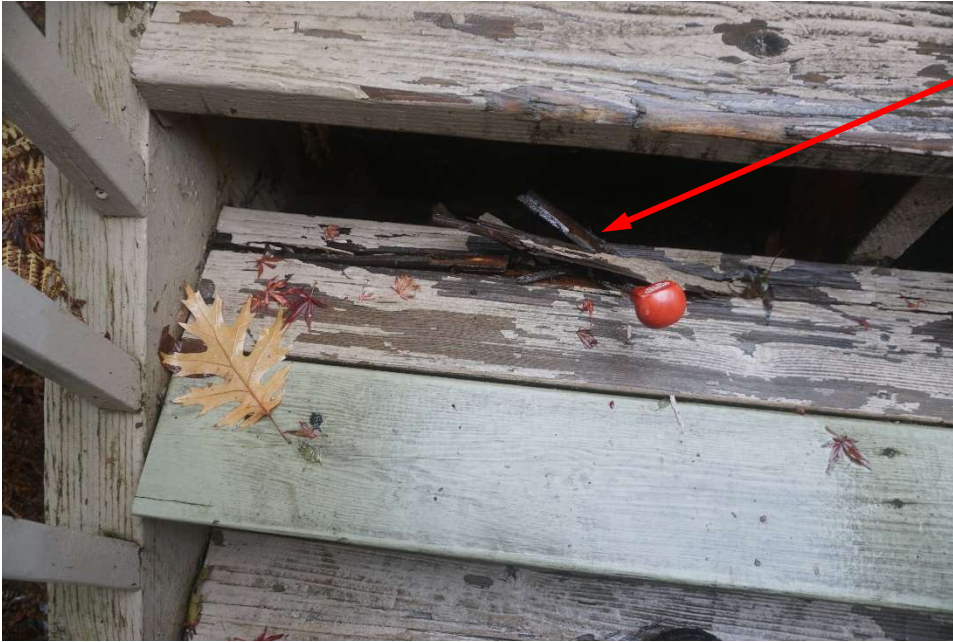
**Photo 27**

**Stair Bank 5**

View of deteriorated stair tread.

This is a common and unsafe condition.

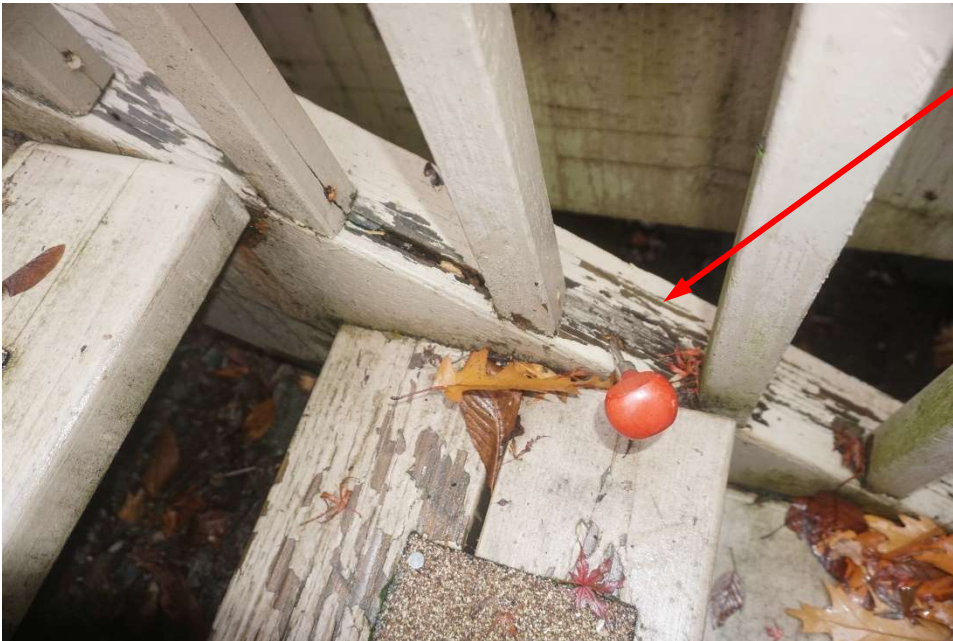
**Photo 28**

**Stair Bank 5**

View of deteriorated stair stringer.

This is a common condition.

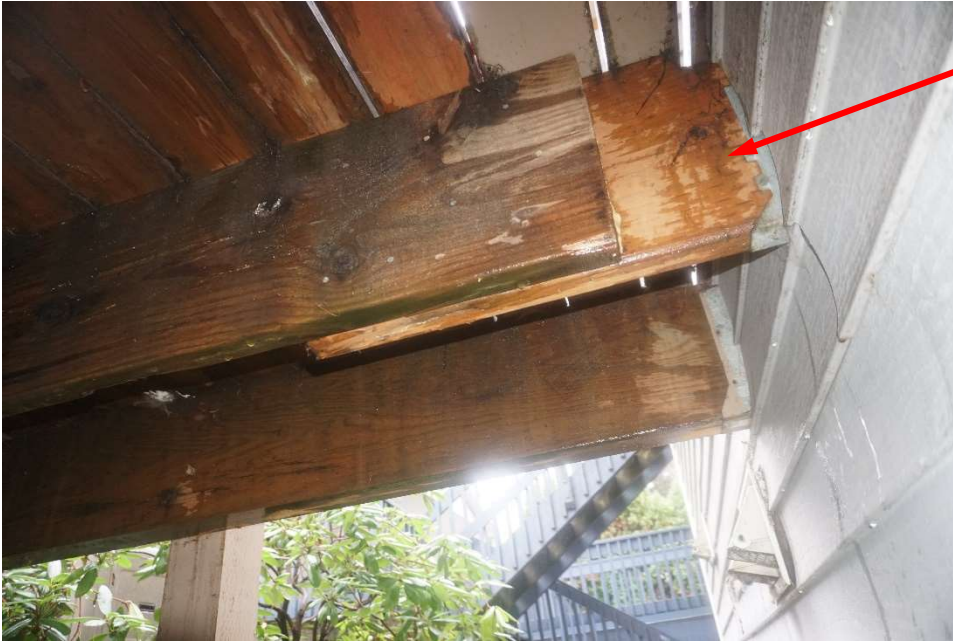
**Photo 29**

**Stair Bank 5**

View of improper structural repairs to deteriorated elevated walkway framing.

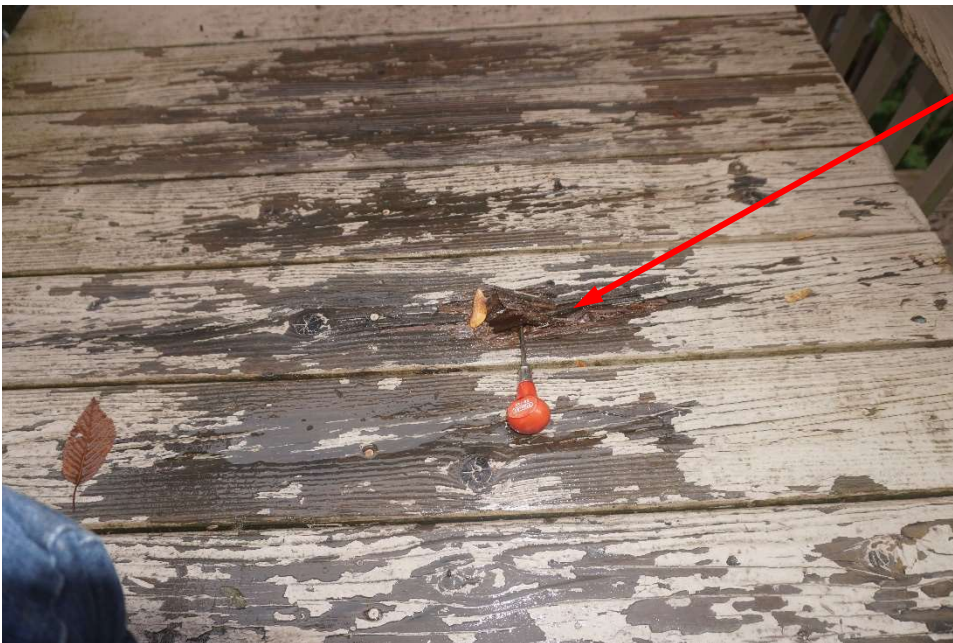
**Photo 30**

**Stair Bank 5**

View of deteriorated elevated walkway tread.

This is a common and unsafe condition.

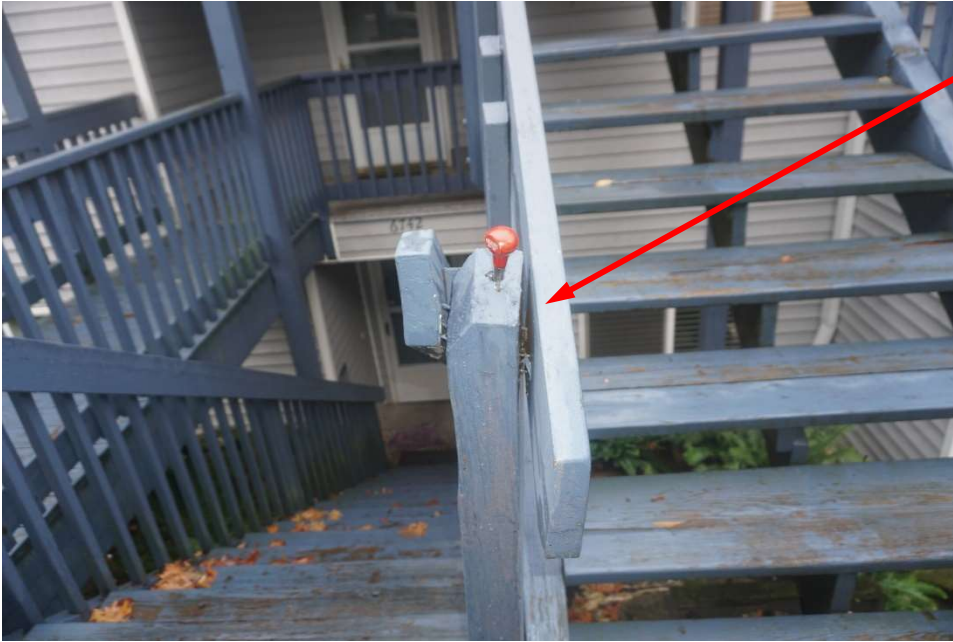
**Photo 31**

**Stair Bank 6**

View of deteriorated handrail post, beveled from previous rot removal, showing separation from handrail top chords.

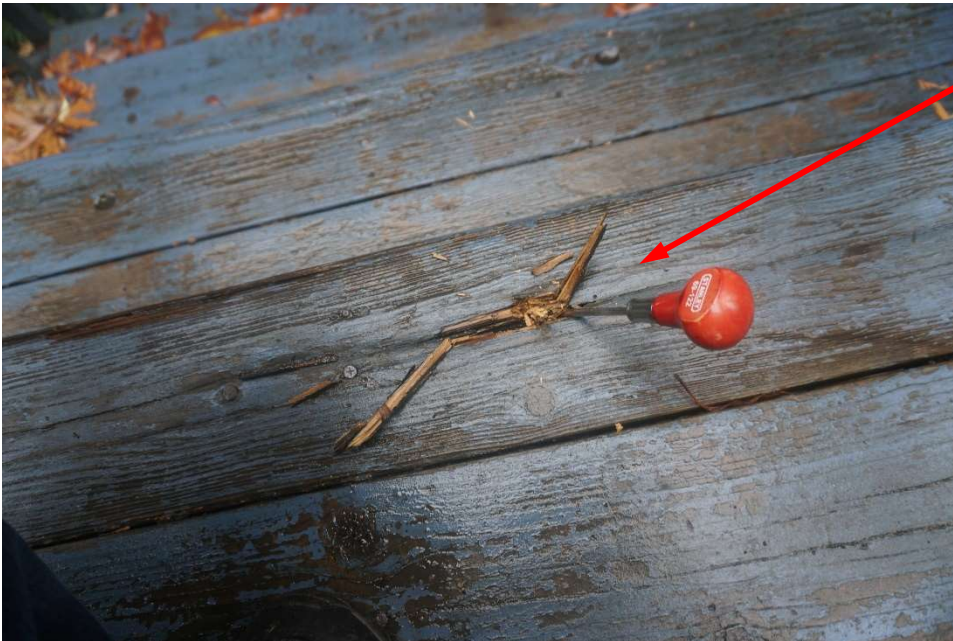
**Photo 32**

**Stair Bank 6**

View of deteriorated elevated walkway tread.

This is a common and unsafe condition.

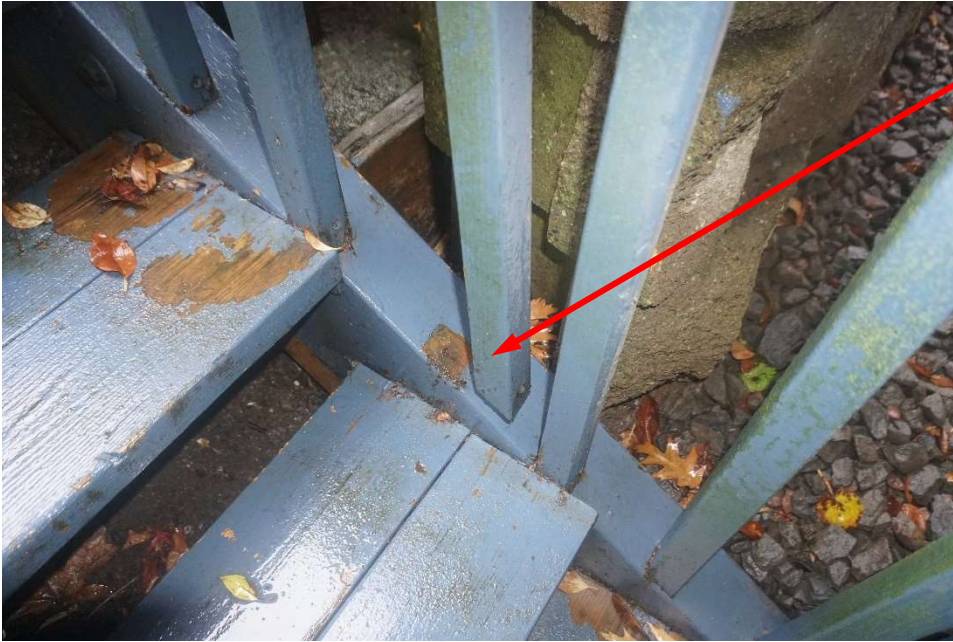
**Photo 33**

**Stair Bank 6**

View of deteriorated railing spindle, fully separated from stair stringer.

This is an unsafe condition.

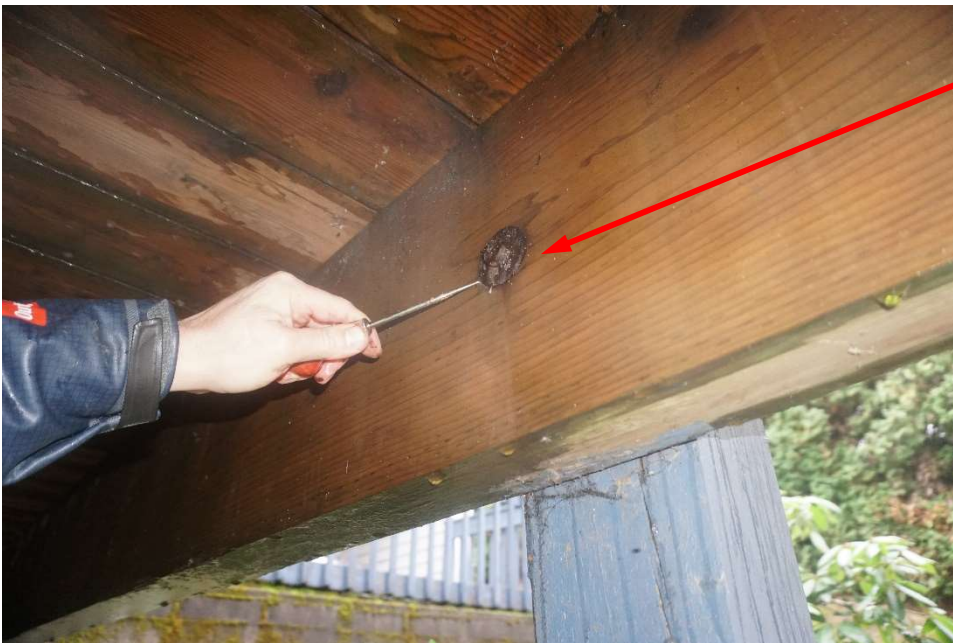
**Photo 34**

**Stair Bank 6**

View of rusted, single fastener connecting elevated walkway framing to post.

This is an improper structural connection.

This is a common condition.

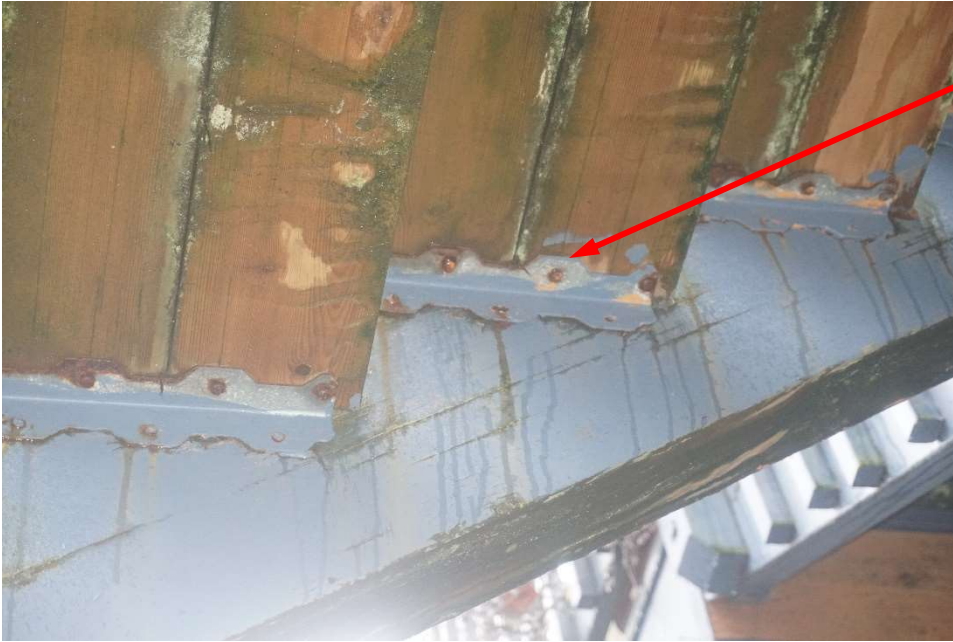
**Photo 35**

**Stair Bank 6**

View of deteriorating stair treads, fasteners, and hardware from below, showing multiple missing fasteners.

This is a common condition.
