**Date:** January 26, 2023

**Project:** JAH200 Bridgeview Condominiums  
Stair Assessment

**Location:** 6700-6748 N Richmond Ave  
Portland, OR 97203

**Document:** Exterior Stair Assessment Report

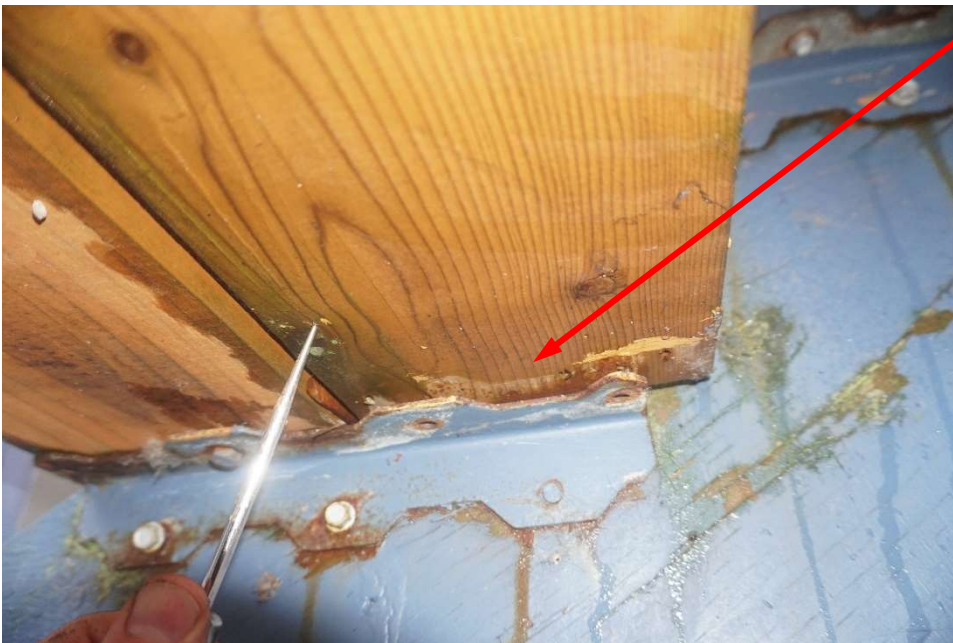
**Photo 36**

**Stair Bank 6**

View of deteriorating hardware from below, showing multiple missing fasteners.

This tread is completely disconnected.

Missing fasteners at the hardware is a common condition.

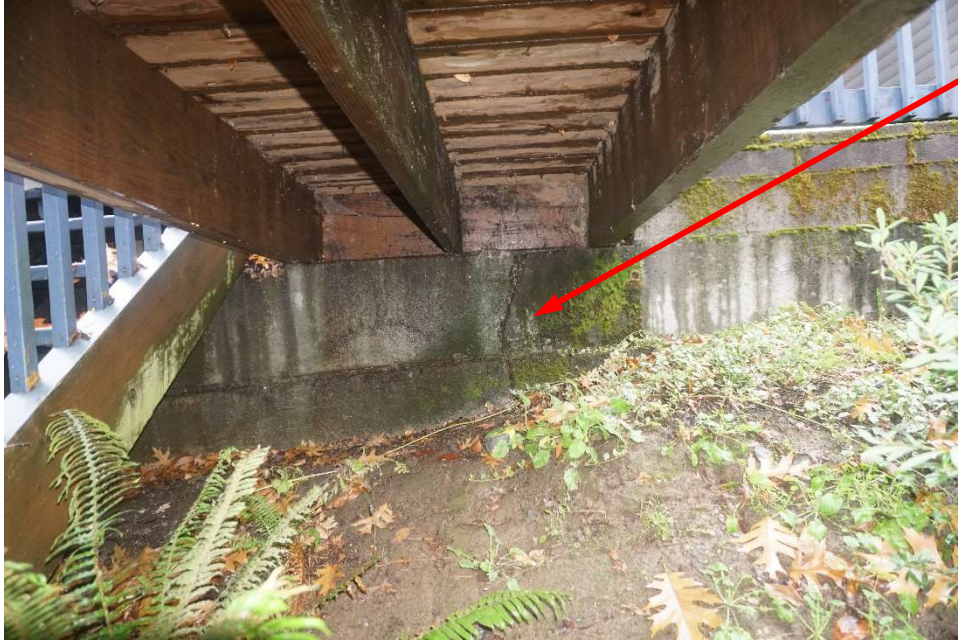
**Stair Bank 6**

View showing a differential settlement fracture within the supporting concrete retaining wall.

It is our recommendation that the scope of the stair replacement also include evaluation of the concrete and wood retaining structures for their ability to support the replacement stairs, and that these elements be modified, repaired, or replaced as required.
