# 2019 Reserve Study & Maintenance Plan

## Ivy Street Condominiums

Portland, OR

March 19, 2019

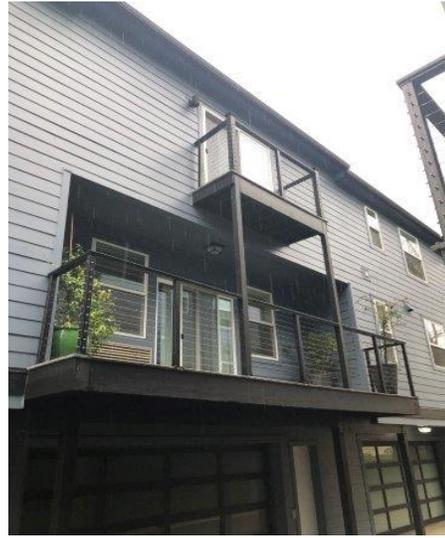
Item Description	# of Items	Unit	Current Item Cost	Future Replacement Cost	Year Built	Useful Life	Year Replace	Life Left	One Time?
Barkdust	1	Total	\$ 300.00	\$ 313	2018	2	2020	2	No
Concrete Safety Repair	1	Total	\$ 1,000.00	\$ 1,133	2019	5	2024	6	No
<p><b>Comments:</b> This is a budget to inspect all flatwork and sidewalks for tripping hazards of 3/8" or more, grind down or remove and replace selected sections as needed over a 5 year period; list year, work done and cost here.</p>									
Deck-Rails-Metal/Wire	238	Ln.Ft.	\$ 65.00	\$ 26,624	2014	30	2044	26	Yes
Deck-Trex-Top Boards	1,264	Sq.Ft.	\$ 18.00	\$ 31,777	2014	20	2034	16	No
Deck-Wood-Substructure	1,264	Sq.Ft.	\$ -	\$ -	2014	40	2054	36	Yes
<p><b>Comments:</b> Useful life greater than 30 years.</p>									
Electrical & Plumbing Systems	1	Total	\$ -	\$ -	2018	50	2068	50	No
<p><b>Comments:</b> It is assumed that the electrical and plumbing systems have been installed in accordance with local building codes/standards. There have been no reports of large scale repair/failure occurring or anticipated.</p> <p>Repairs and replacements of individual components of these systems are completed as needed and paid from Operating Budget. Widespread failure of these systems is uncommon and global replacement is generally not warranted. If it is determined, upon inspection by a professional, that a new system, or major repair/replacement is warranted, the cost and remaining useful life should be added per contractor recommendation.</p>

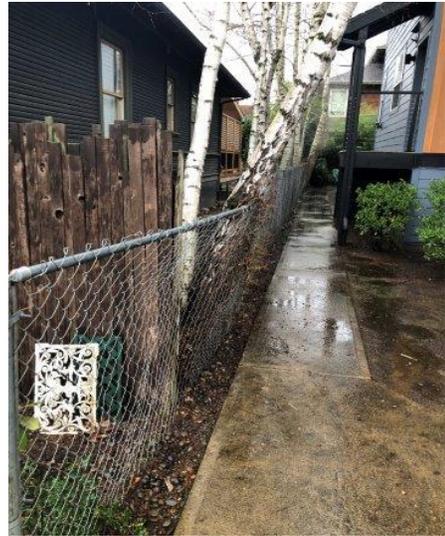
Fencing-Chainlink	190	Ln.Ft.	\$ 18.00	\$ 4,214	1993	35	2028	10	No
<p><b>Comments:</b> 2018: Observed part of fencing on west end needing repair due to tree.</p>									
Garage Doors	6	Total	\$ -	\$ -	2018	50	2068	50	No
<p><b>Comments:</b> Owners responsibility.</p>									
Landscape Renovation	1	Total	\$ 500.00	\$ 555	2018	5	2023	5	No
<p><b>Comments:</b> For landscape projects outside regular maintenance needs such as plant removal/replacement or drainage correction. Renovation work should be recorded here including description of work, year completed and cost to assist with estimating future needs.</p>									
Lights-Exterior	30	Fixtures	\$ 125.00	\$ 5,237	2014	20	2034	16	No
<p><b>Comments:</b> This component will serve as a budget fund for replacement as needed. Recommend that the board make efforts to perform work in lump sums in order to reduce varying useful life and contractor mobilization costs. Also, recommend at the time of replacement board consult vendors to perform a fixture replacement energy audit.</p>

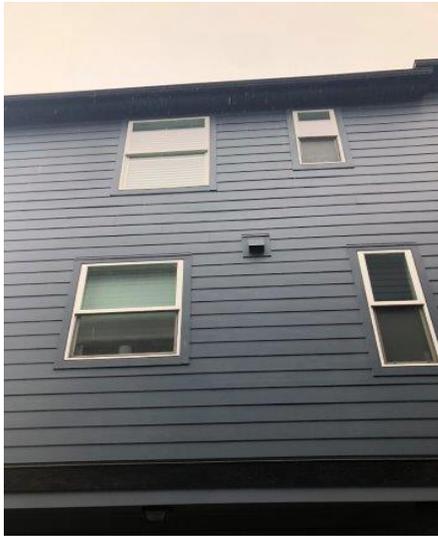
Item Description	# of Items	Unit	Current Item Cost	Future Replacement Cost	Year Built	Useful Life	Year Replace	Life Left	One Time?
Mailboxes	1	Total	\$ -	\$ -	2014	40	2054	36	No
<p><b>Comments:</b> The remaining useful life of this component is expected to be greater than 30 years. To be replaced as needed and paid from Operating Budget.</p>									
Paint/Stain-Exterior	6	Units	\$ 3,400.00	\$ 24,109	2018	8	2026	8	No
Retaining Wall -Repair	1	Total	\$ 1,200.00	\$ 1,479	2018	10	2028	10	No
<p><b>Comments:</b> A full replacement is not anticipated within the next 30 years; however, repair work may be required. This is a budget to perform repair as needed over a 10 year period.</p>									
Roof-Composition-Asphalt	58	Squares	\$ 425.00	\$ 38,216	2014	25	2039	21	No
<p><b>Comments:</b> Budget cost of replacement is based on removal and replacement of single layer roof with a 30 year composition shingle. Also, assumes the roof is kept clean of debris, moss and algae and that each year, a qualified roof maintenance contractor inspects, cleans and repairs the roof as needed. 2018: Roof quantity obtained using satellite imagery (Eagle View Technology) of a typical building extrapolated to derive a total quantity.</p>

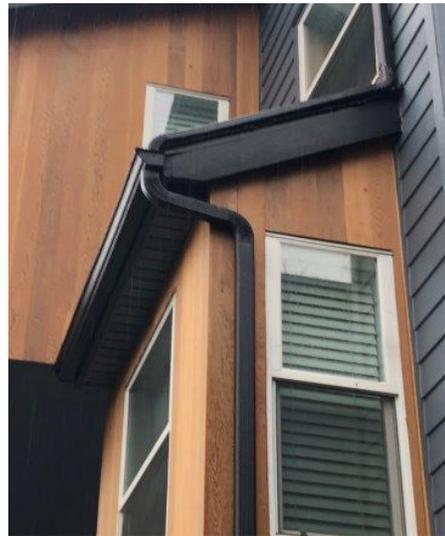
Roof-Gutters & Downspouts	630	Ln.Ft.	\$ 7.00	\$ 7,590	2014	30	2044	26	No
<p><b>Comments:</b> Gutters: 378 lf Downspouts: 252 lf 2018: Gutter and downspout quantity obtained using satellite imagery (Eagle View Technology) of a typical building extrapolated to derive a total quantity.</p>									
Siding & Trim Repair	6	Units	\$ 150.00	\$ 1,064	2018	8	2026	8	No
<p><b>Comments:</b> Prior to performing Paint-Exterior, all siding and trim should be carefully inspected, repaired or replaced as needed. Caulking around all doors, windows and trim should be performed.</p>									
Siding Inspection	1	Total	\$ 3,500.00	\$ 5,314	2018	20	2038	20	Yes
<p><b>Comments:</b> A siding assessment provides information regarding the performance of the building enclosure components, identifies areas of concern and provides the information needed to create appropriate planning for the building's maintenance and repair. If it is deemed that a replacement of the siding (or portions of it) will be necessary within the next 30 years, a replacement line item should be added to the reserve budget.</p>

Gutters and downspouts should be inspected regularly, kept clear of debris, and repaired as needed.

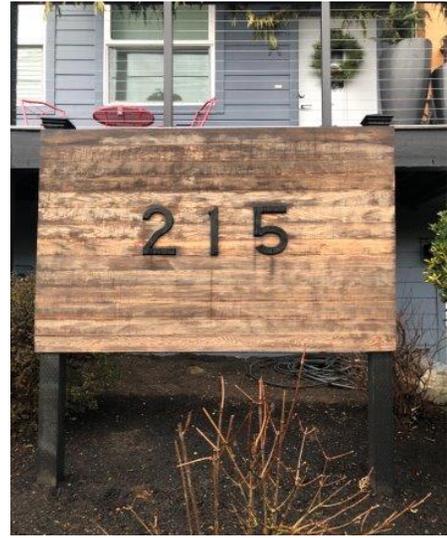
Item Description	# of Items	Unit	Current Item Cost	Future Replacement Cost	Year Built	Useful Life	Year Replace	Life Left	One Time?
Siding Replacement	6	Units	\$ -	\$ -	2018	50	2068	50	Yes
<p><b>Comments:</b> Siding has a long useful life, however, the siding underlayment will eventually lose its protective properties due to water that is able to get behind the exterior cladding. The decision to replace siding is typically driven by either an aesthetical desire or a cost-benefit analysis of installing a superior cladding. As such, the remaining useful life is subject to change based on conditions and the board's desires. Siding replacement typically is warranted after 40-60 years. 2018: Completed at a cost of \$197,000 (\$32,833/unit).</p>									
Signs-Building-Wood	2	Total	\$ 600.00	\$ 1,676	2014	20	2034	16	No
Treework	1	Total	\$ 1,000.00	\$ 1,110	2018	5	2023	5	No
