# Bridgeport Condominiums

## BUILDING ENVELOPE CONDITIONS ASSESSMENT

**Bridgeport Condominiums  
1000 North Holiday Blvd.  
Seaside, OR 97138**

**June 14, 2017**

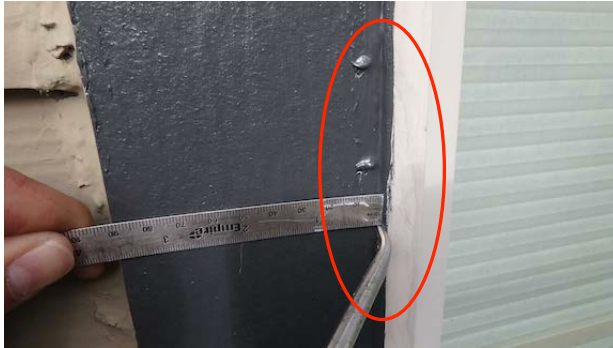
#### 1.2.1. Less than 1/4" clearance between trim and vinyl fenestration frame

Condition fails to allow for installation of properly-dimensioned dynamic sealant joint to accommodate differential thermal movement between dissimilar materials, resulting in premature sealant failure.

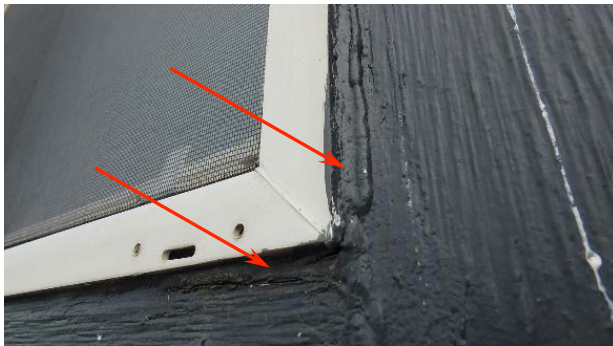
#### 1.2.2. Improperly-constructed and subsequently-failed sealant joint application

Condition facilitates water infiltration into the wall assembly

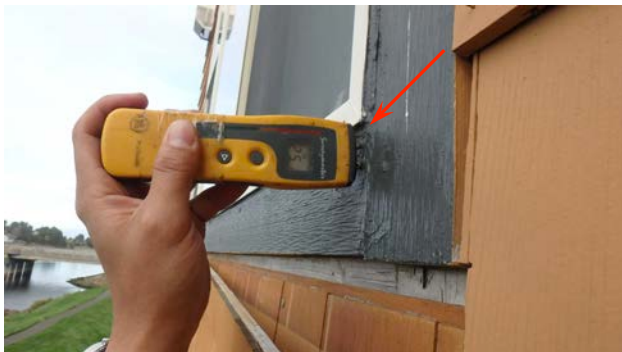
#### 1.2.3. Greater than 19% MC in wall assembly components

25.1% MC measured in trim below failed sealant joint.

Condition results from sustained moisture absorption by exterior wall assembly components due to water leakage and moisture accumulation within exterior wall assembly.

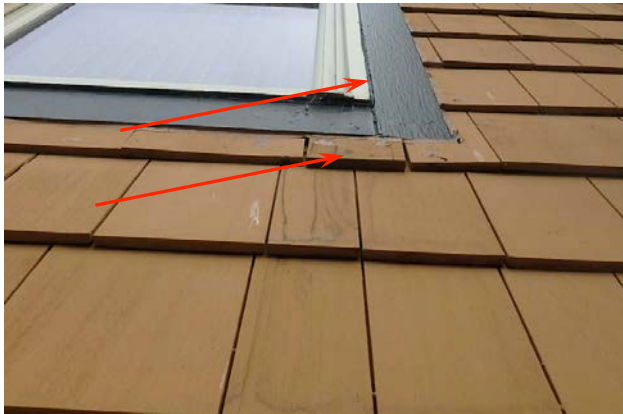
### 1.2.4. Moisture staining emanating from within wall assembly

Condition likely results from moisture egress from within exterior wall assembly.

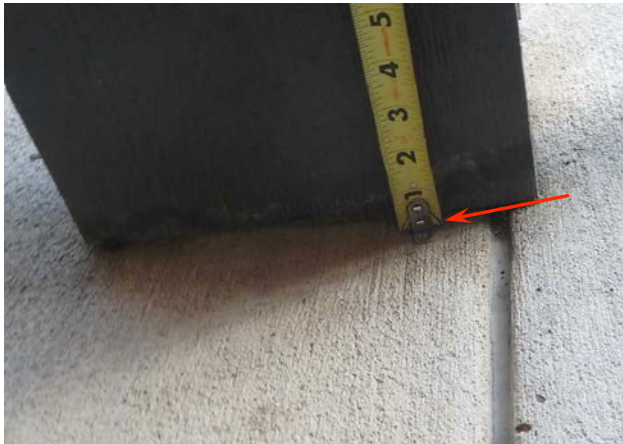
### 1.2.5. Less than 1/2" clearance between trim and paved surface

Condition facilitates moisture absorption and premature deterioration of trim members.

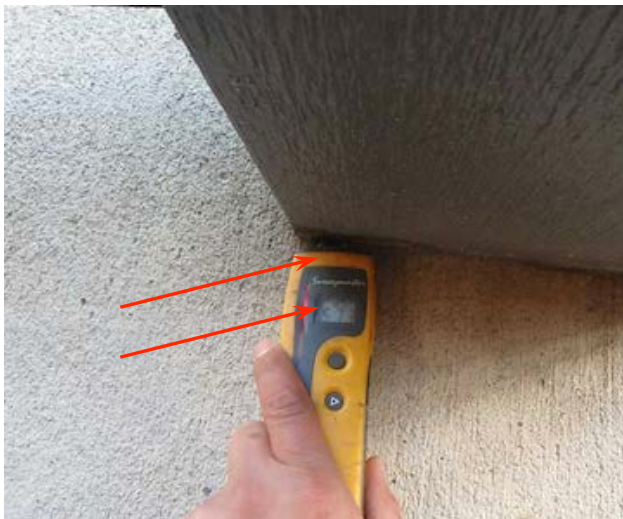
### 1.2.6. Greater than 19% MC in wall assembly components

57.3% MC measured in trim in contact with paved walkway

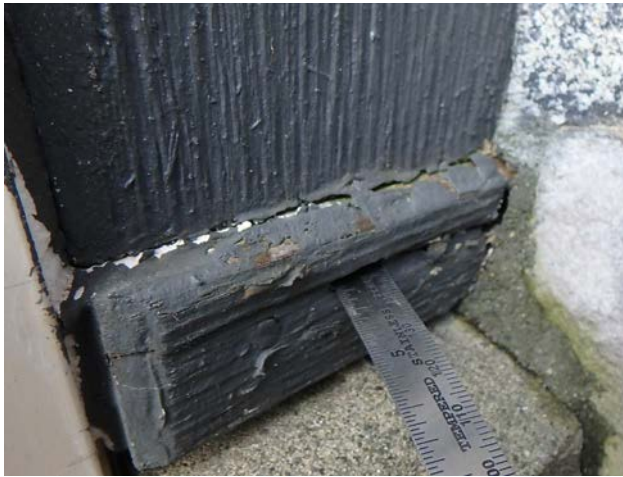
- 1.2.7. Less than 1/4"-3/8" clearance between trim and manufactured stone veneer**

Condition fails to allow for installation of properly-dimensioned dynamic sealant joint to accommodate differential thermal movement between dissimilar materials, resulting in premature sealant failure.

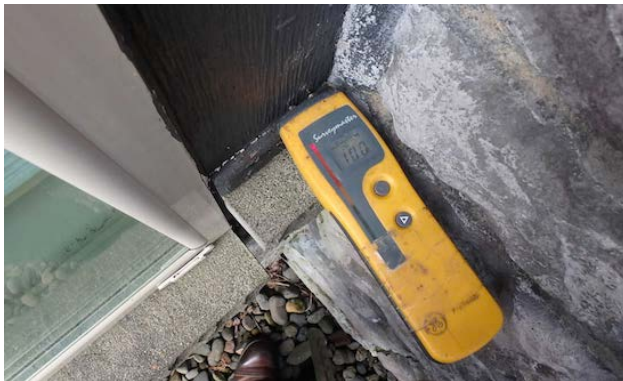
- 1.2.8. Moisture-deteriorated wall assembly components**

- 1.2.9. Greater than 19% MC in wall assembly components**

100% MC measured in trim

Condition results from sustained moisture absorption by exterior wall assembly components due to water leakage and moisture accumulation within exterior wall assembly.

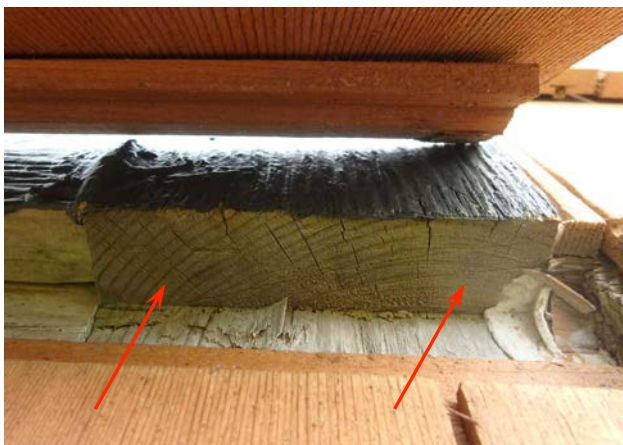
- 1.2.10. Un-primed field cut edges**

Condition facilitates moisture absorption and premature deterioration of trim members.

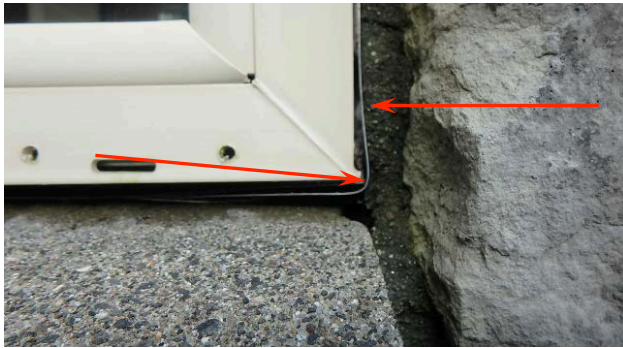
### 1.2.11. Less than 1/4"-3/8" clearance between veneer and vinyl fenestration frame

Condition fails to allow for installation of properly-dimensioned dynamic sealant joint to accommodate differential thermal movement between dissimilar materials, resulting in premature sealant failure.

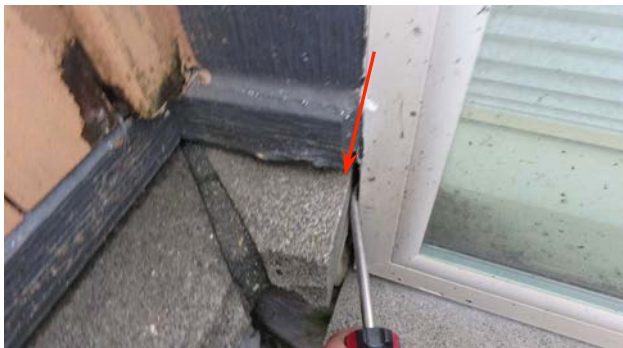
### 1.2.12. Omitted dynamic sealant joint between stone and vinyl fenestration frame

Condition facilitates water infiltration into exterior wall assembly.

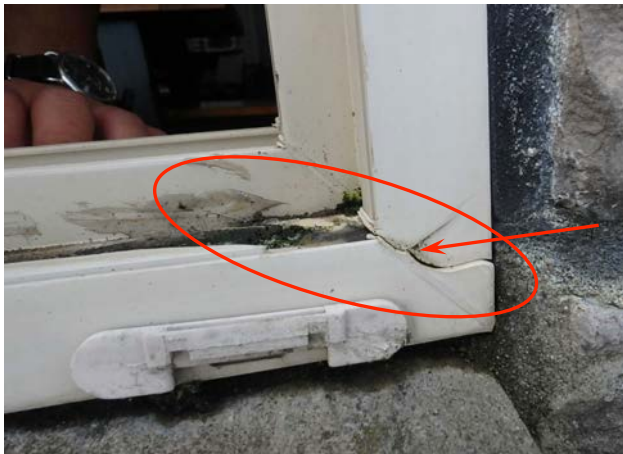
### 1.2.13. Less than 1/4"-3/8" clearance between veneer and vinyl fenestration frame

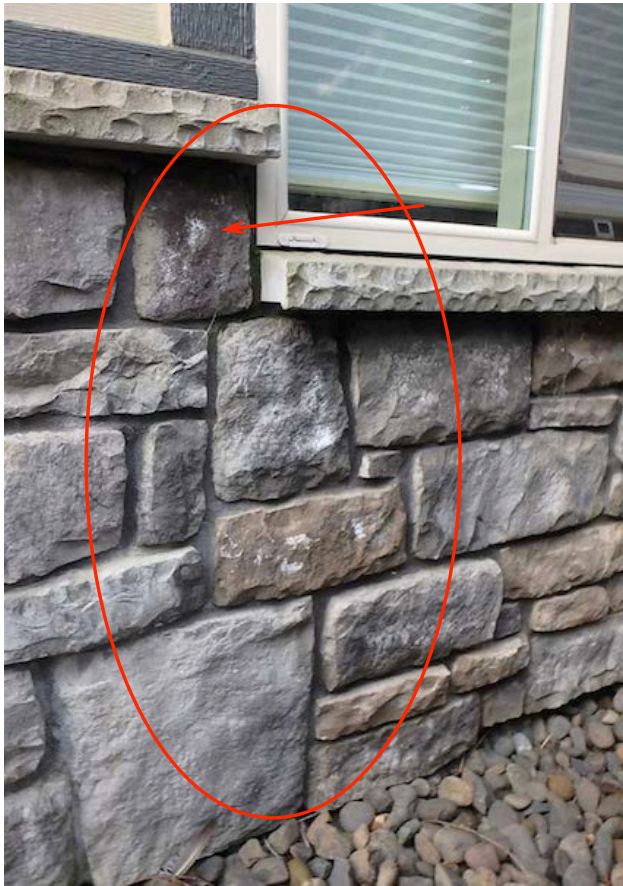
### 1.2.15. Efflorescence or corrosion staining emanating from within wall assembly

Condition likely results from moisture egress from within exterior wall assembly.

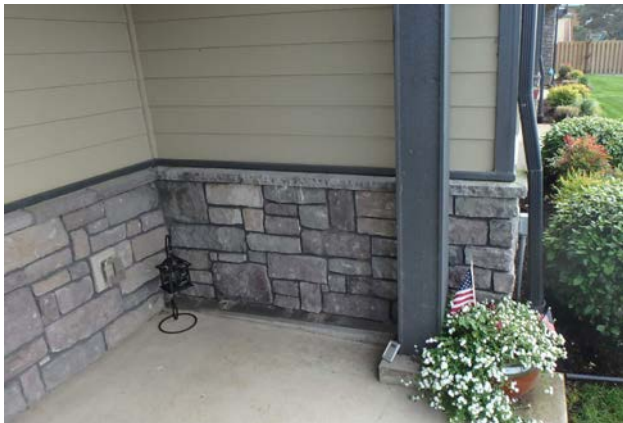
### 1.3.1. Overview of typical stone wainscoting

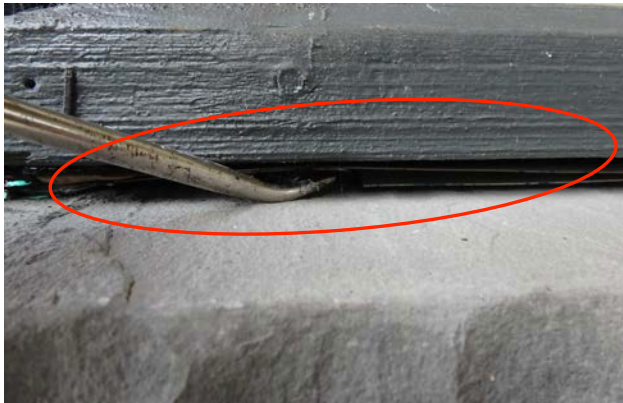
### 1.3.2. Un-sealed metal flashing seam at wainscoting head

Condition facilitates water infiltration into roof assembly.

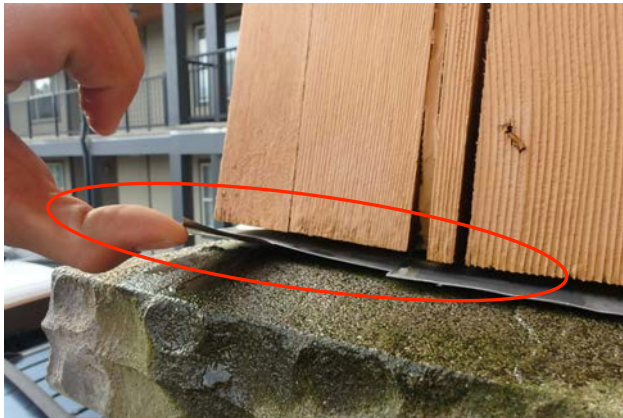
Additional example of condition shown previously

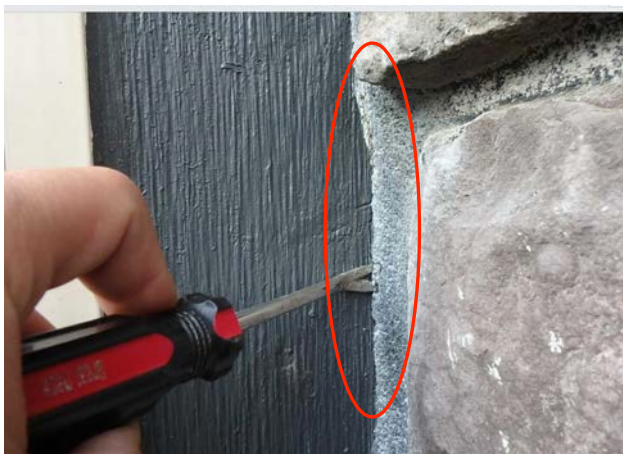
### 1.3.3. Flashing does not extend to the face of the veneer water table

### 1.3.4. Less than 1/4"-3/8" clearance between trim and manufactured stone veneer

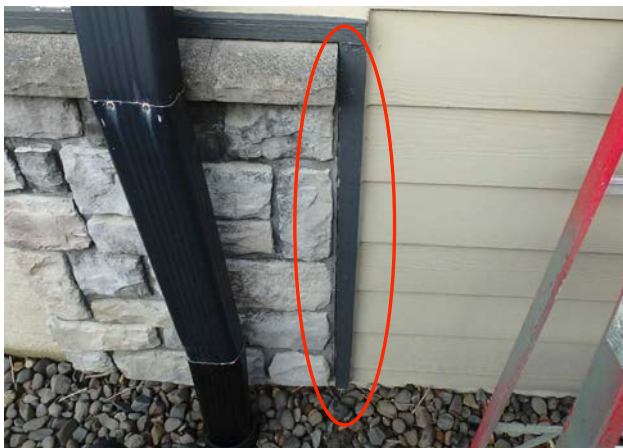
### 1.3.6. Less than 1/4"-3/8" clearance between trim and manufactured stone veneer

Condition fails to allow for installation of properly-dimensioned dynamic sealant joint to accommodate differential thermal movement between dissimilar materials, resulting in premature sealant failure.

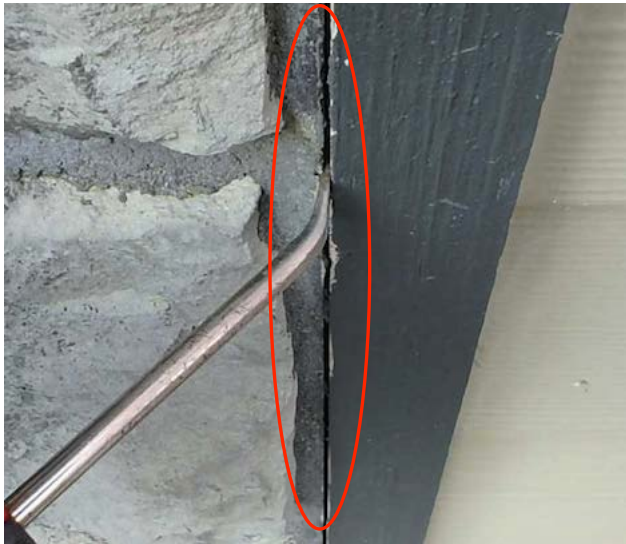
Close-up of location shown previously, illustrating the gap created in the wall assembly

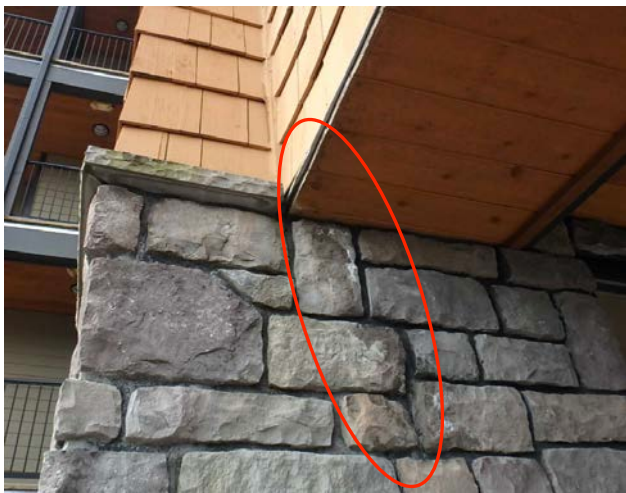
### 1.3.7. Efflorescence emanating from within wall assembly

Condition likely results from moisture egress from within exterior wall assembly.

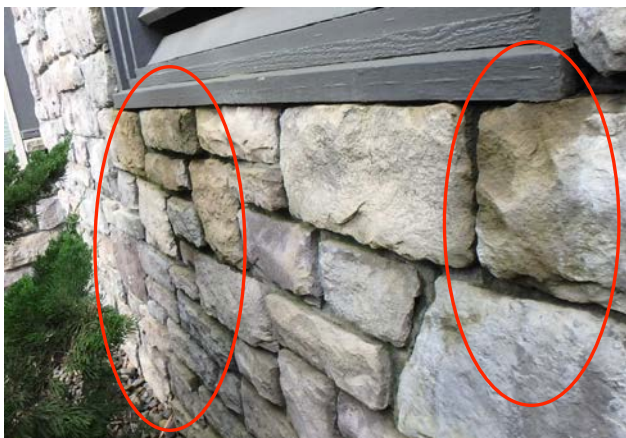
### 1.3.8. Moisture staining emanating from within wall assembly

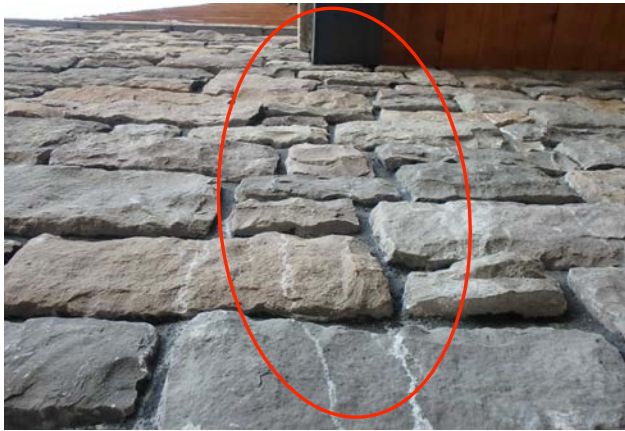
Additional example of condition shown previously

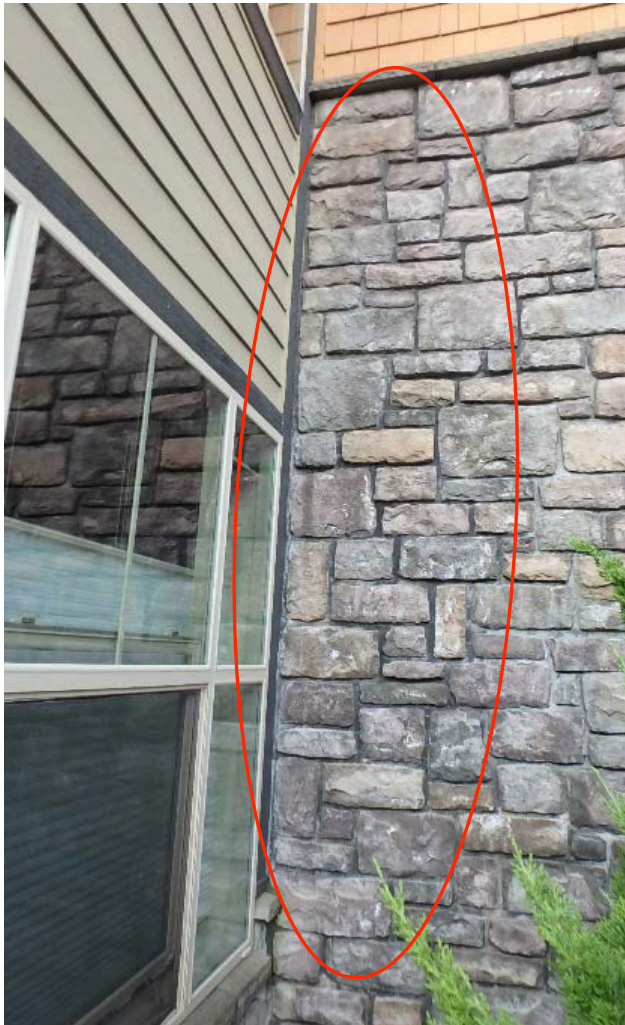
Additional example of condition shown previously

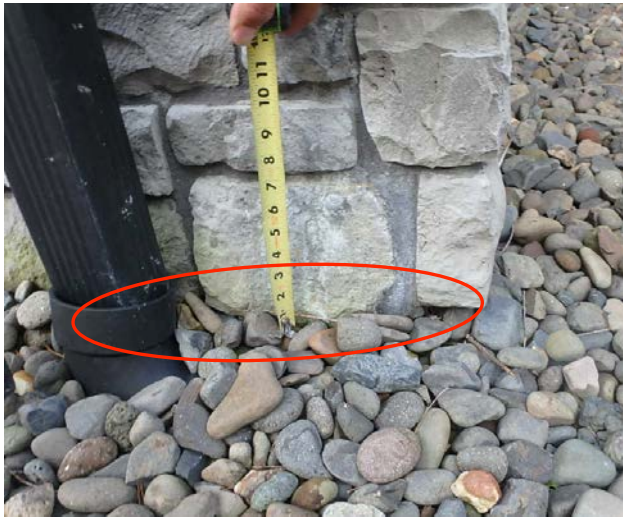
### 1.3.9. Less than 4" clearance between veneer and soil finish grade

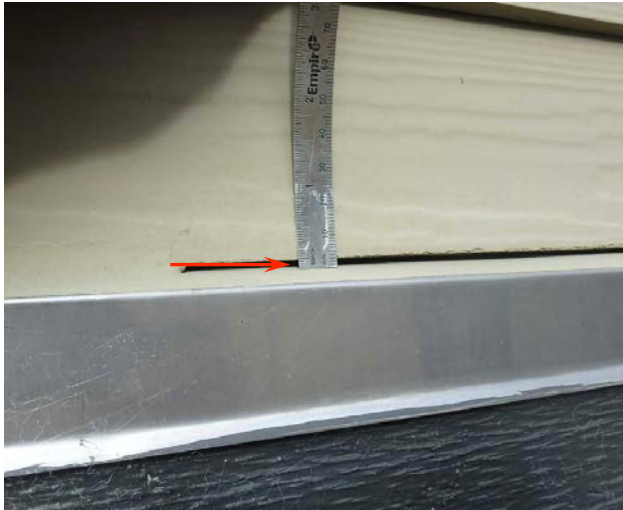
**1.4.2. Less than 1/4"-3/8" clearance between siding and metal flashing surface**

Condition impedes incidental water egress and facilitates moisture accumulation within exterior wall assembly.

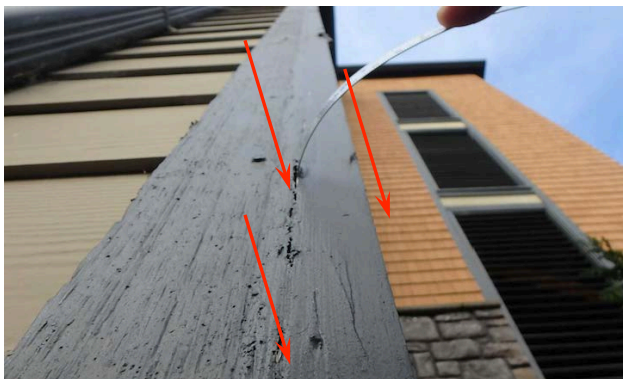
**1.5.1. Improperly-constructed and subsequently-failed sealant joint application**

Condition facilitates water infiltration into wall assembly.

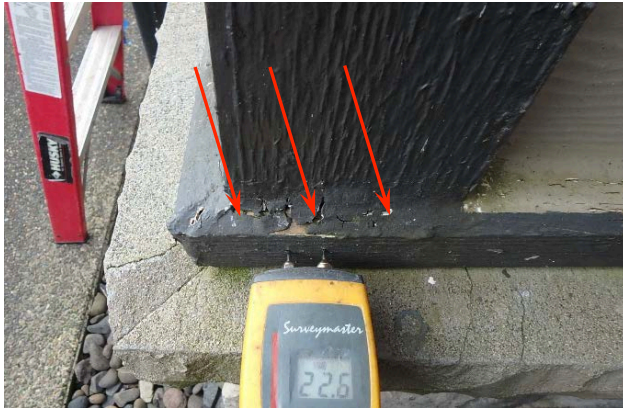
Additional example of condition shown previously, illustrating a failed sealant joint with a MC of 22.6% in the trim below

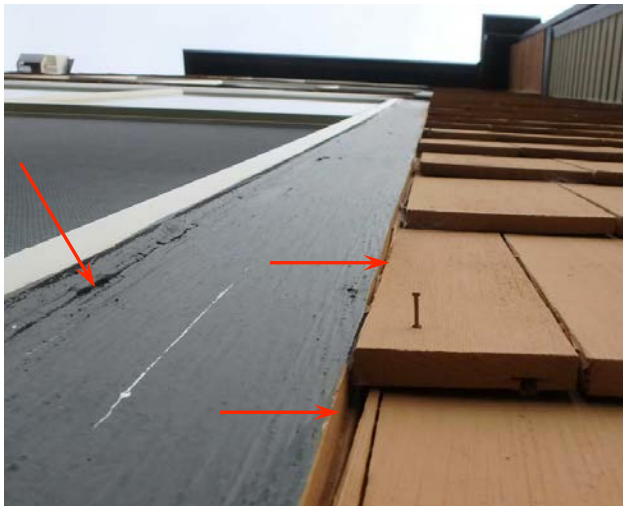
**1.5.3. Improperly-constructed and subsequently-failed sealant joint application**

Note the condition occurs at both the trim to vinyl window transition and trim to cedar siding transition

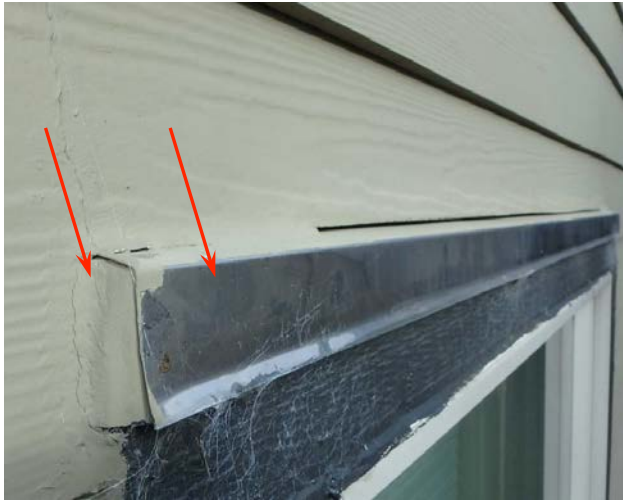
### 1.6.1. Omitted up-turned end dam at butted flashing termination

Condition facilitates moisture absorption and premature deterioration of unprotected trim members.

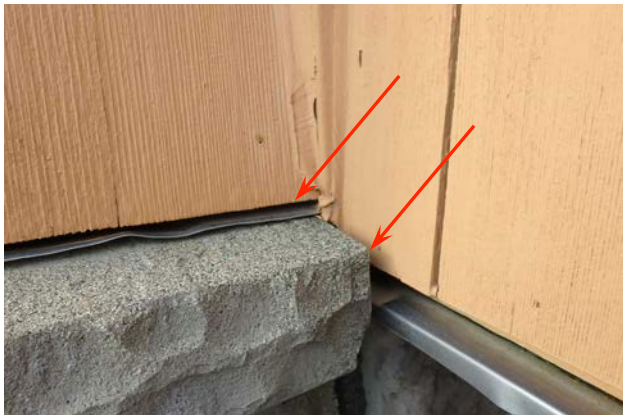
Additional example of condition shown previously

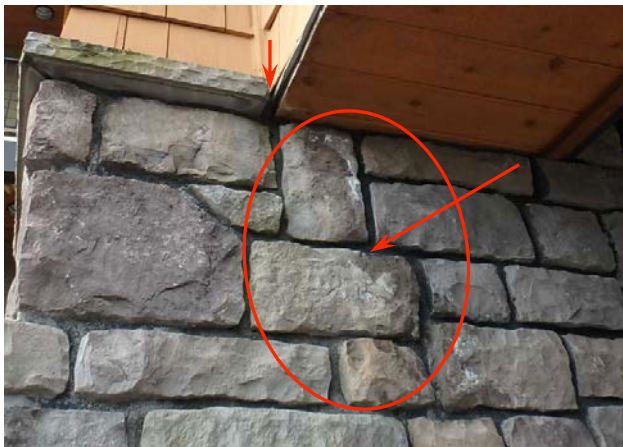
### 1.6.2. Efflorescence emanating from within wall assembly

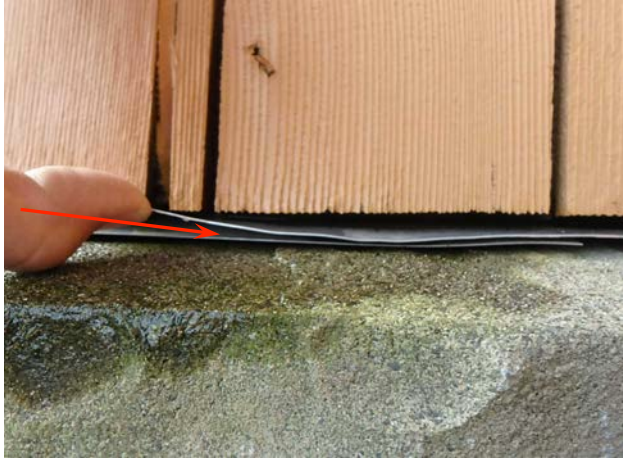
**1.6.3. Un-sealed metal flashing seam**

Condition facilitates water infiltration into roof assembly.

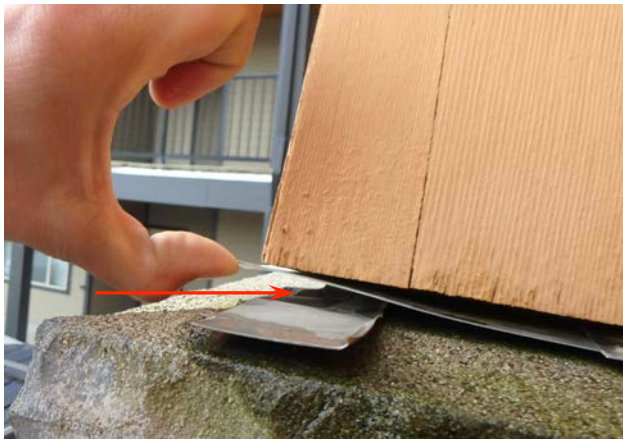
Additional example of condition shown previously

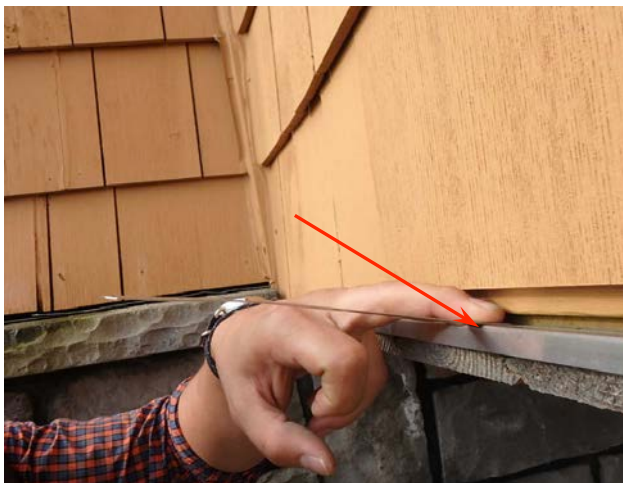
**1.6.4. Less than 5° positive slope on horizontal flashing surface**

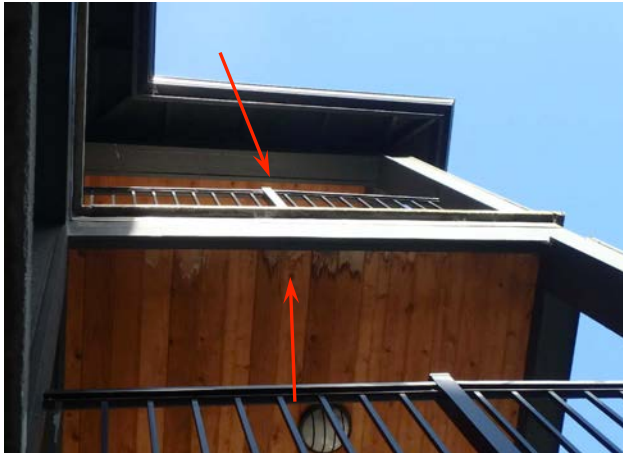
### 1.7.1. Moisture-stained deck assembly components below the rail penetrations

Damage results from sustained presence of moisture due to water leakage through deck assembly and/or moisture accumulation within deck assembly.

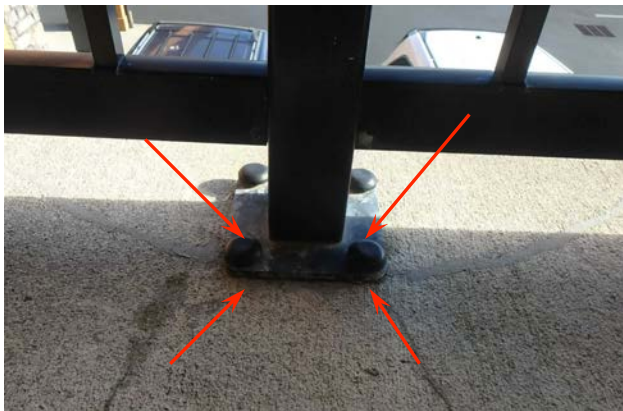
### 1.7.2. Rail fastened through horizontal concrete surface

Condition facilitates water infiltration the waterproof membrane of the assembly

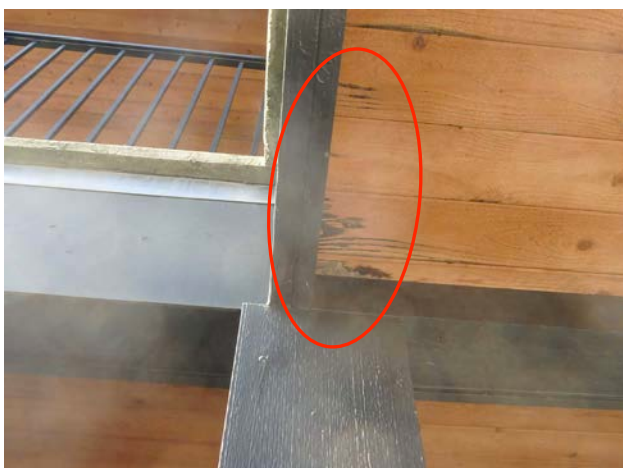
### 1.7.3. Moisture-stained deck assembly components below the beam penetrations

Damage results from sustained presence of moisture due to water leakage through deck assembly and/or moisture accumulation within deck assembly.

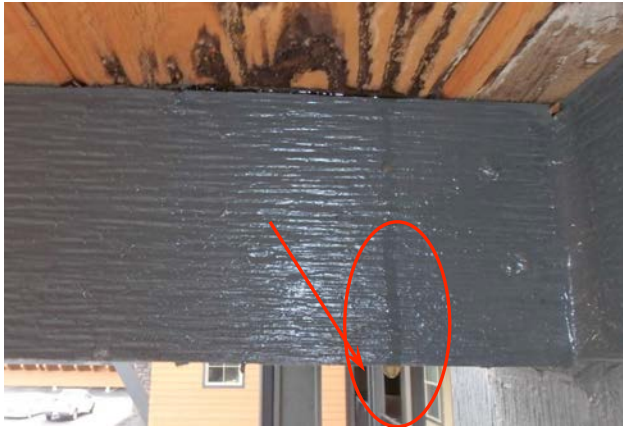
**1.7.4. Visible water leakage through soffit assembly**

Condition results from water leakage through walkway assembly

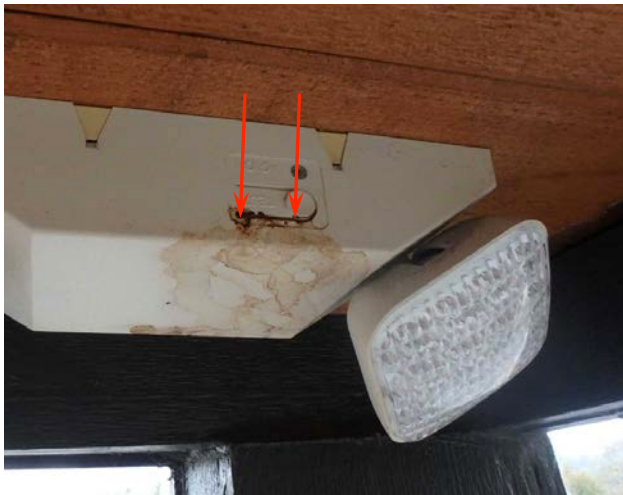
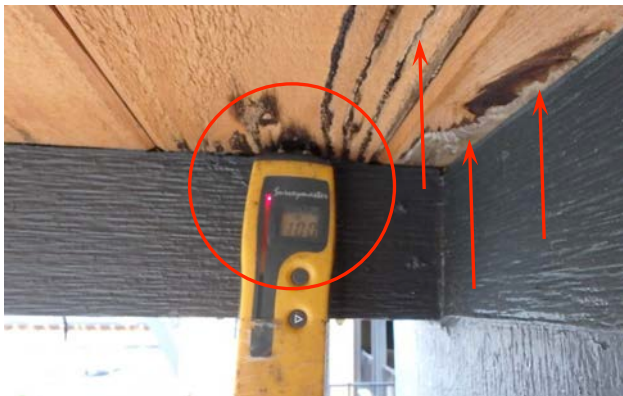
**1.7.5. Greater than 19% MC in soffit components**

100.0% MC measured in cedar soffit material  
Condition results from sustained moisture absorption due to water leakage through walkway

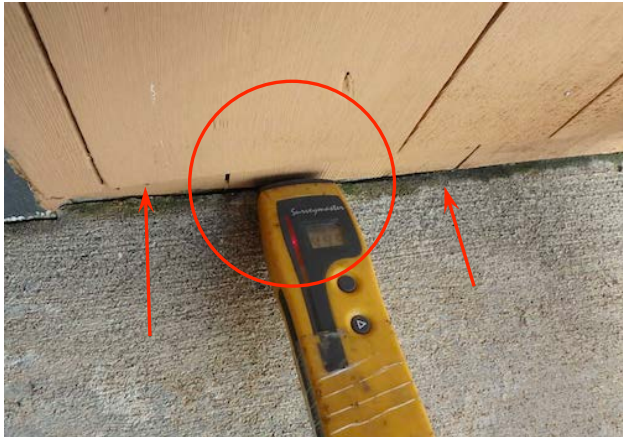
**1.7.6. Greater than 19% MC in cedar base of wall components**

49.9% MC measured in cedar siding at the base of wall

Condition results from sustained moisture absorption due to water leakage at walkway

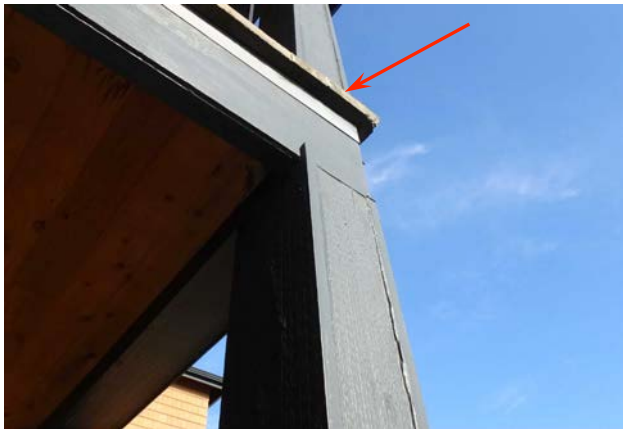
**1.7.7. Overview of outside corner of beam penetration**

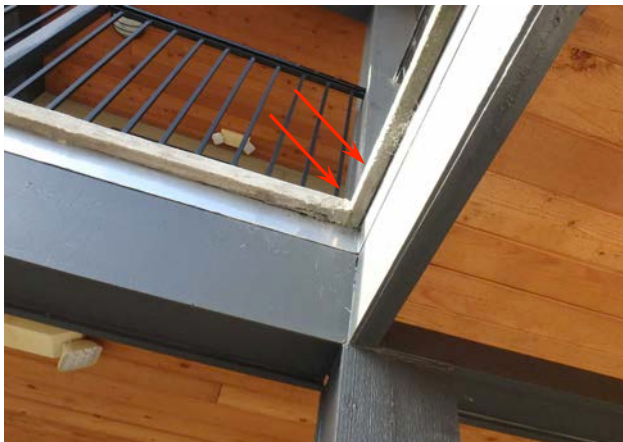
**1.7.8. Overview of inside corner of beam penetration**

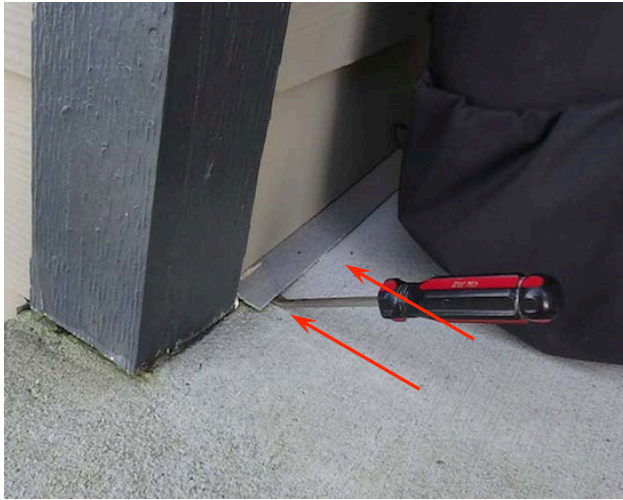
### 1.8.1. Un-sealed metal base of wall flashing

Condition facilitates water infiltration into the deck assembly.

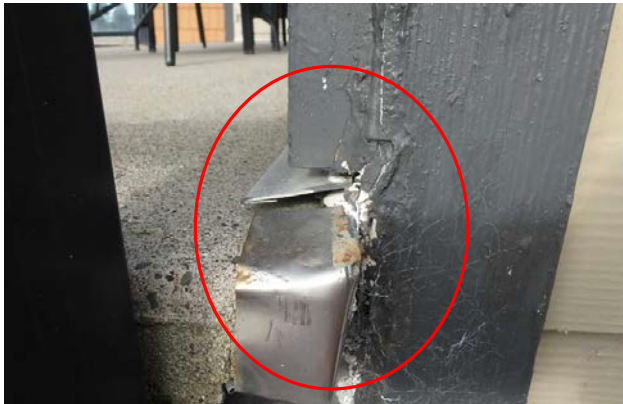
### 1.8.2. Omitted or discontinuous flashing "diverter" at deck-to-wall flashing termination

Condition fails to adequately convey surface drainage away from wall interface and increases likelihood of water infiltration into exterior wall assembly.

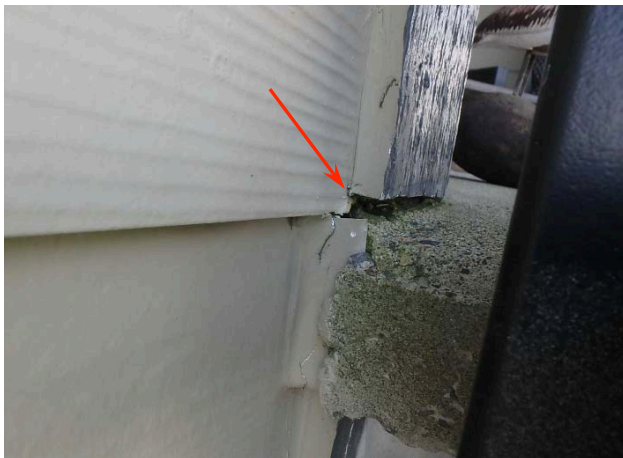
Additional example of condition shown previously

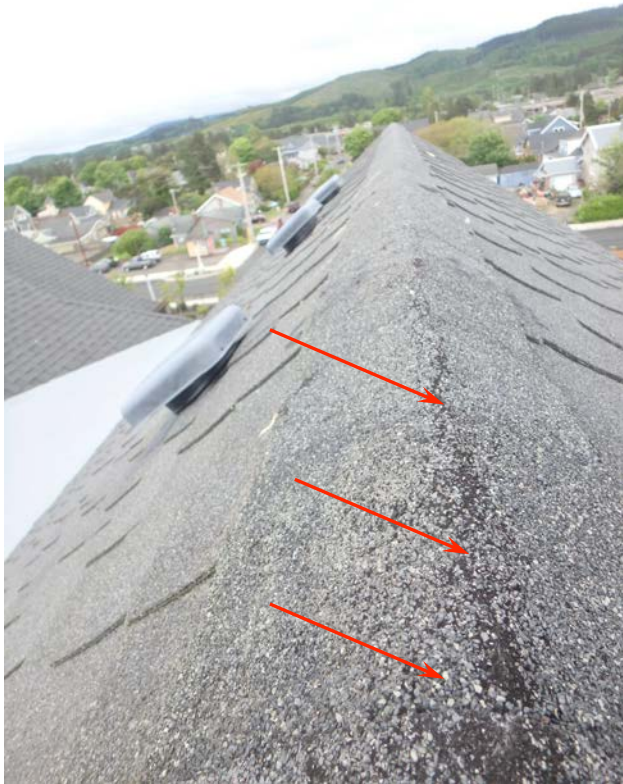
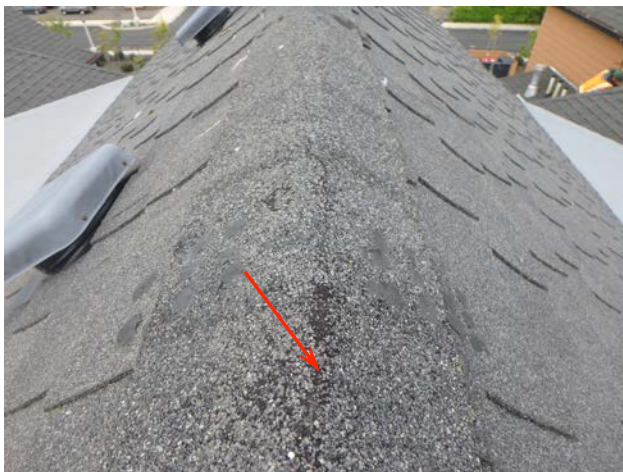
### 1.9.2. Additional example of condition shown previously

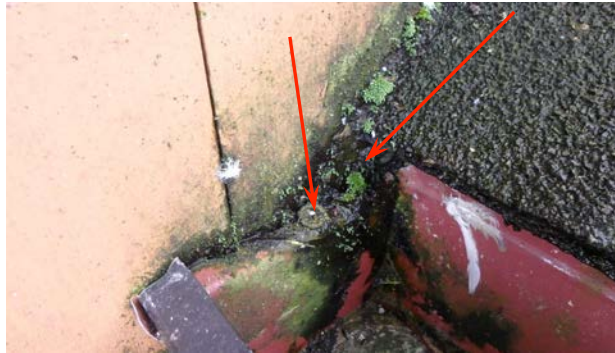
**1.9.3. Omitted or discontinuous kick-out flashing at roof-to-wall step flashing termination**

Condition fails to adequately convey surface drainage away from wall interface and increases likelihood of water infiltration into exterior wall assembly.

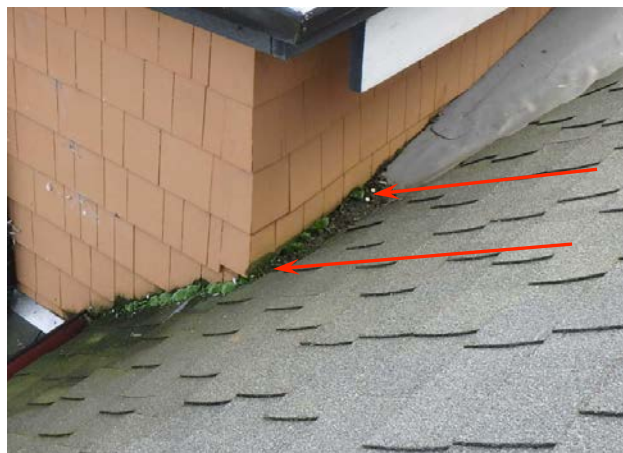
**1.9.4. Discontinuous cricket**

Condition impedes proper conveyance of surface drainage away from structure, increasing likelihood of water infiltration into roof and exterior wall assemblies.

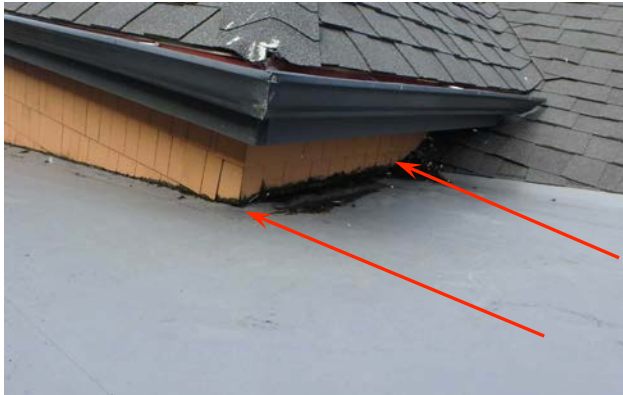
**1.9.5. Omitted cricket**

Condition impedes proper conveyance of surface drainage away from structure, increasing likelihood of water infiltration into roof and exterior wall assemblies.

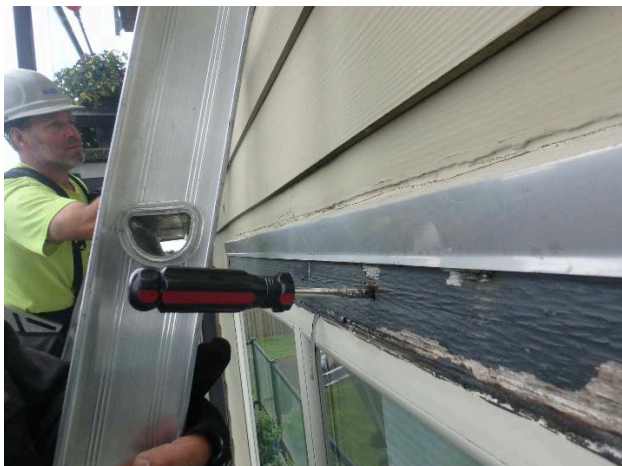
Additional example of condition shown previously, illustrating a similar condition at IO 3

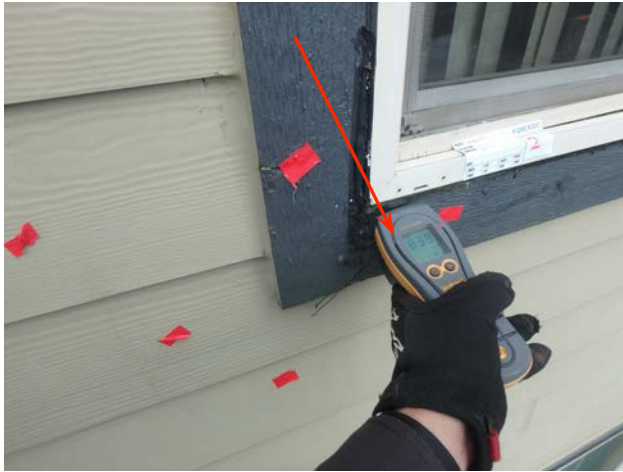
**2.1.3. Greater than 19% MC in wall assembly components**

83.9% MC measured in trim at sill to jamb transition. IO 2

Condition results from sustained moisture absorption by exterior wall assembly components due to water leakage and/or moisture accumulation within exterior wall assembly.

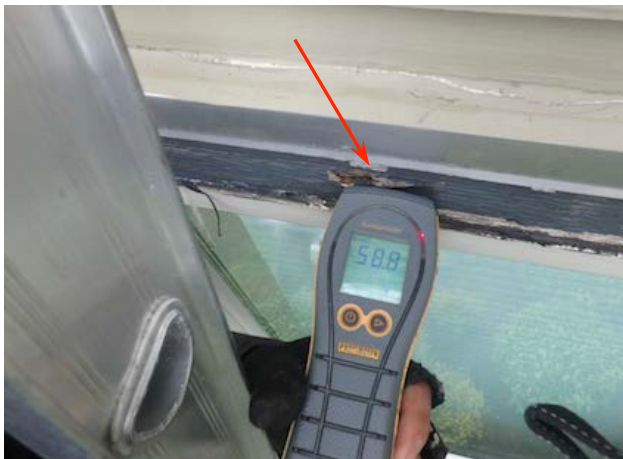
Additional example of condition shown previously, illustrating a 58.8% MC in the trim at the head of a window at IO 3

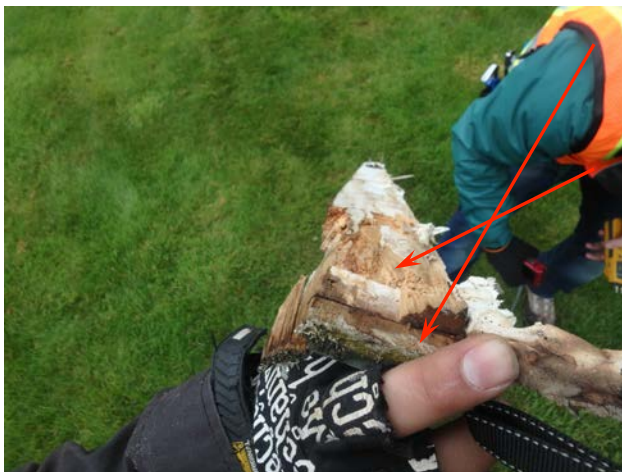
**2.1.6. Un-primed field cut edges**

Condition facilitates moisture absorption and premature deterioration of trim members. Condition observed at IO 2

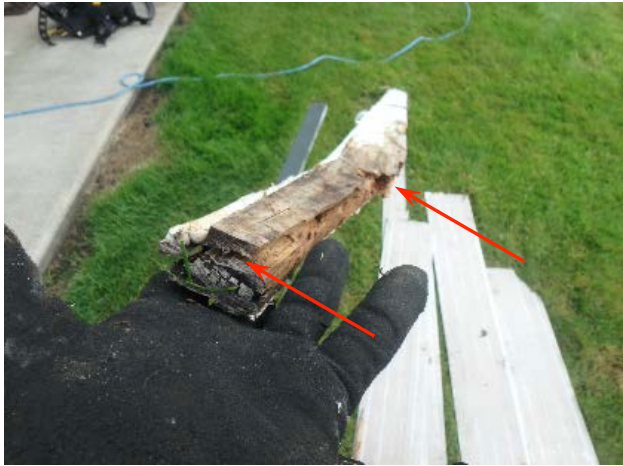
Additional example of condition shown previously, illustrating the above two conditions at IO 3

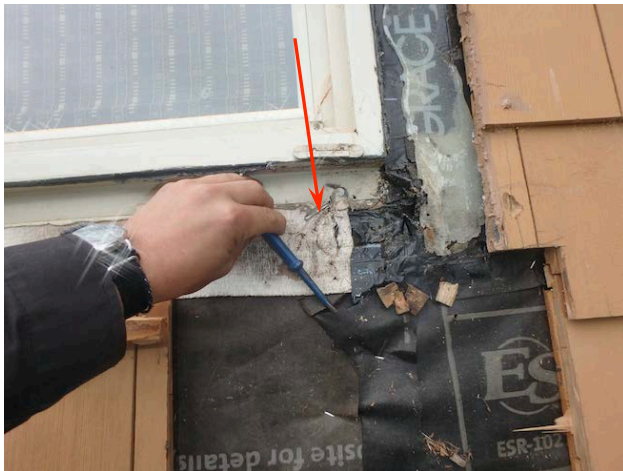
**2.1.8. Reverse-lap of lower WRB layer over upper WRB layer**

Condition impedes incidental water egress and facilitates moisture accumulation within exterior wall assembly. Condition observed at IO 1

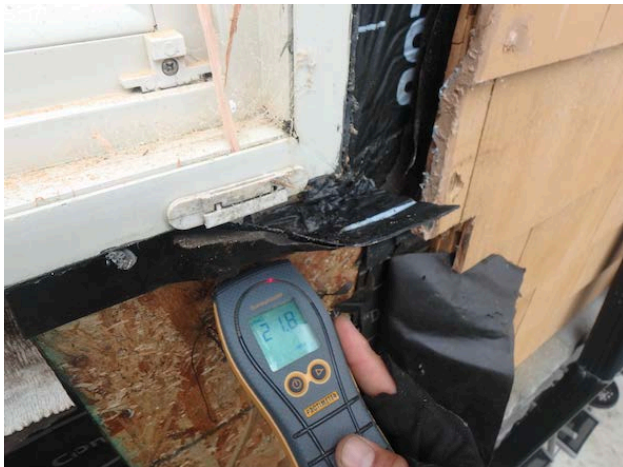
**2.1.12. Greater than 19% MC in wall assembly components at IO 1**

21.8% MC measured in OSB sheathing at window sill

Condition results from sustained moisture absorption by exterior wall assembly components due to water leakage within exterior wall assembly.

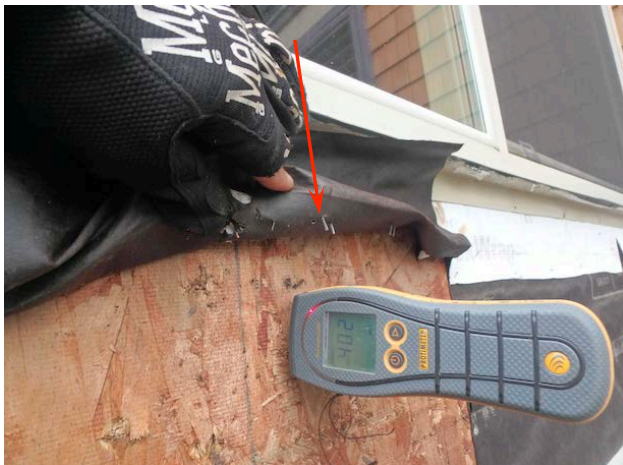
**2.1.13. Greater than 19% MC in wall assembly components at IO 6**

40.2% MC measured in OSB sheathing at window sill.

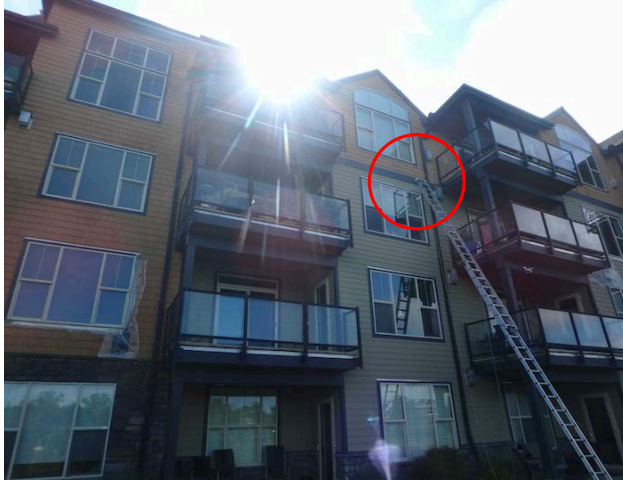
**2.1.14. Overview of IO 15 at third floor window head**

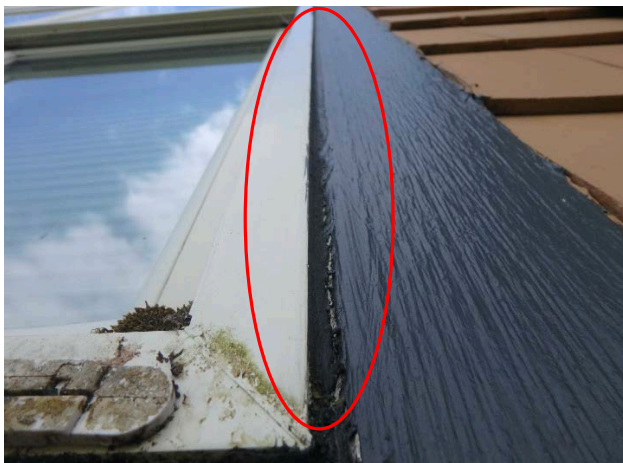
**2.1.15. Overview of fenestration condition on the fourth floor above IO 15**

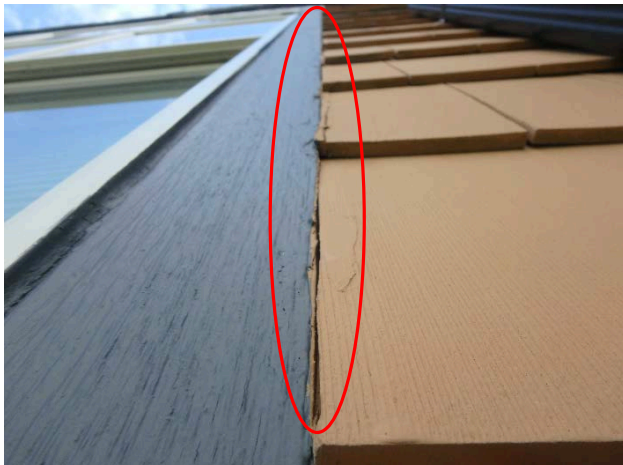
Additional example of condition shown previously, illustrating the condition at the trim to cedar shake siding

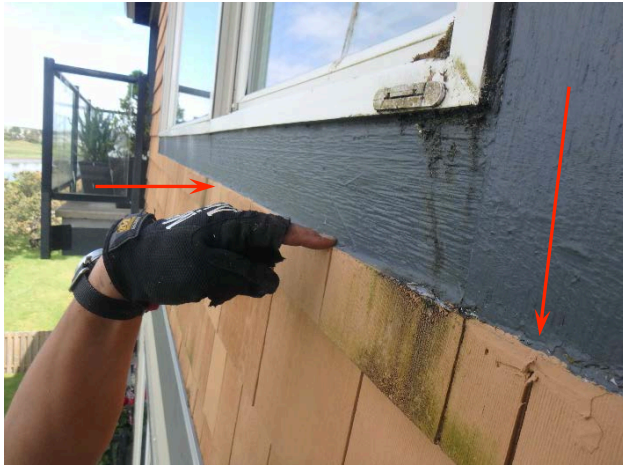
**2.1.17. Siding sitting proud of trim**

Condition facilitates water infiltration into the wall assembly

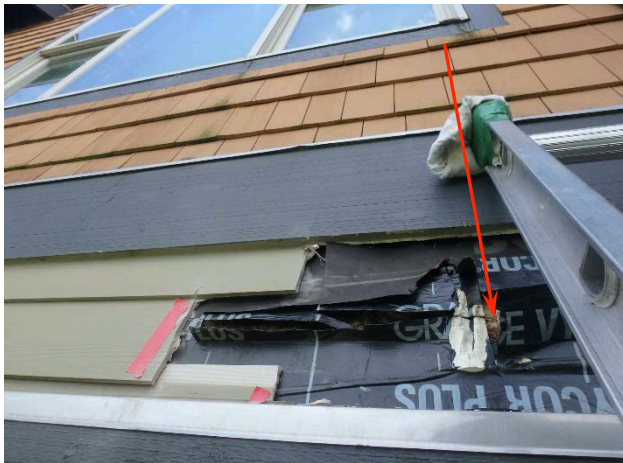
**2.1.18. Overview of the IO in relation to the above mentioned conditions**

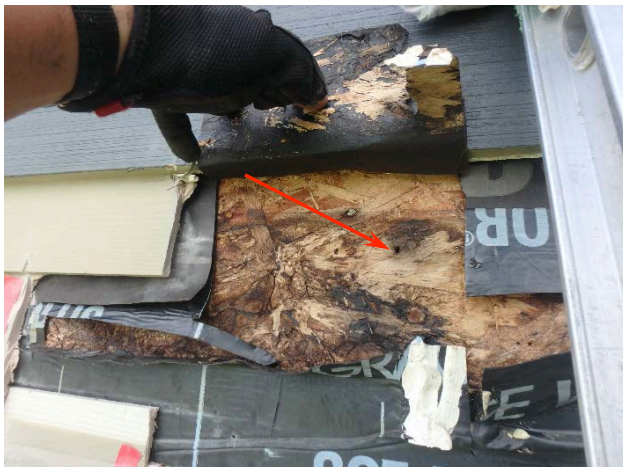
**2.1.19. Moisture-deteriorated wall assembly components**

OSB sheathing exhibits damage at window head at fastener penetration through WRB and flexible flashing.

Damage results from sustained presence of moisture due to water leakage and/or moisture accumulation within exterior wall assembly.

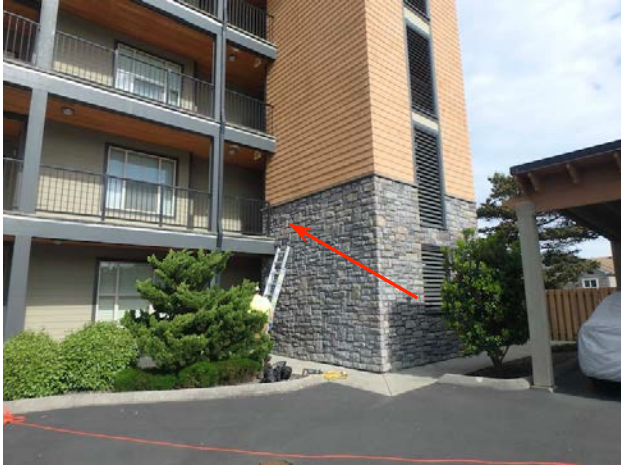
### 2.2.2. Moisture and corrosion staining emanating from within front walkway beam to stone

Condition likely results from moisture egress from within front entry and stone assemblies.

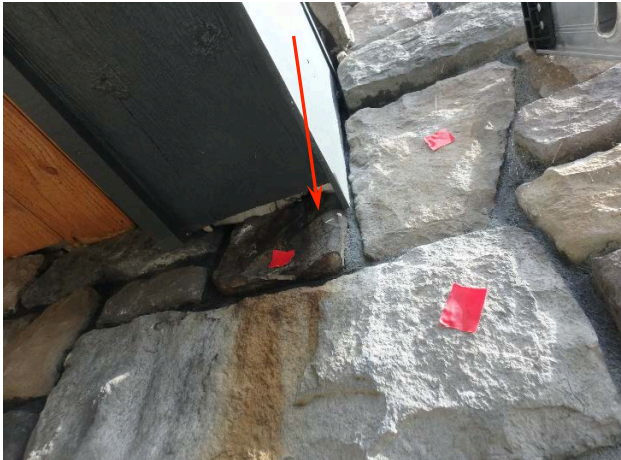
### 2.2.3. Omitted dynamic sealant joint between dissimilar cladding components

Condition facilitates water infiltration into the wall assembly.

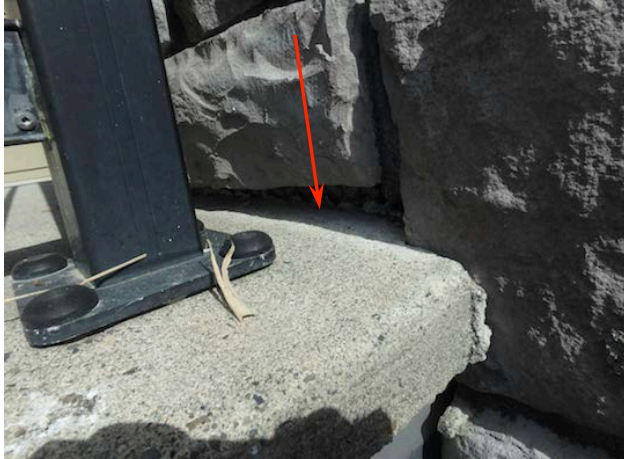
**2.2.4. Omitted base of wall and diverter flashing**

Condition facilitates water infiltration into wall assembly.

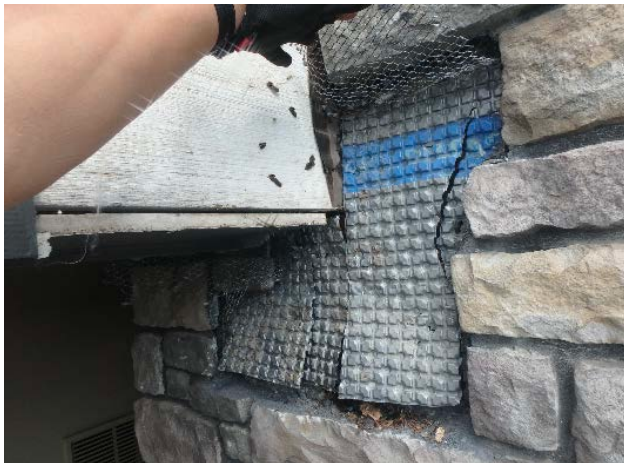
**2.2.5. Overview of drainage mat behind the metal lath of the stone**

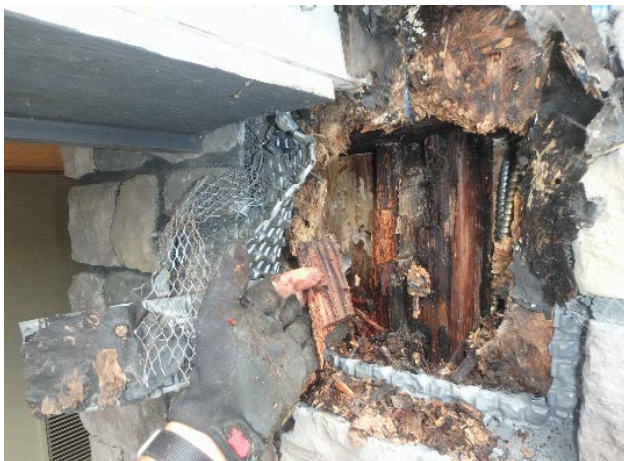
**2.2.6. Moisture-deteriorated wall assembly components**

OSB sheathing and framing exhibits severe damage at below the walkway beam to stone wall transition

Damage results from sustained presence of moisture due to water leakage and/or moisture accumulation within exterior wall assembly.
