# Bridgeport Condominiums

## BUILDING ENVELOPE CONDITIONS ASSESSMENT

**Bridgeport Condominiums  
1000 North Holiday Blvd.  
Seaside, OR 97138**

**June 14, 2017**

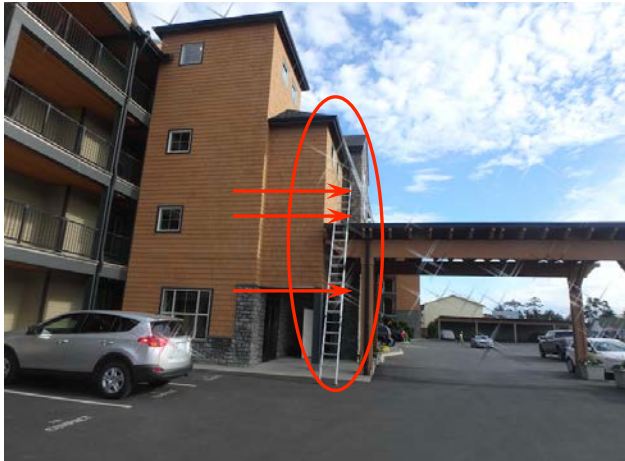
**2.2.8. Moisture staining emanating from roof to wall transition**

Condition likely results from moisture egress from within roof assembly.

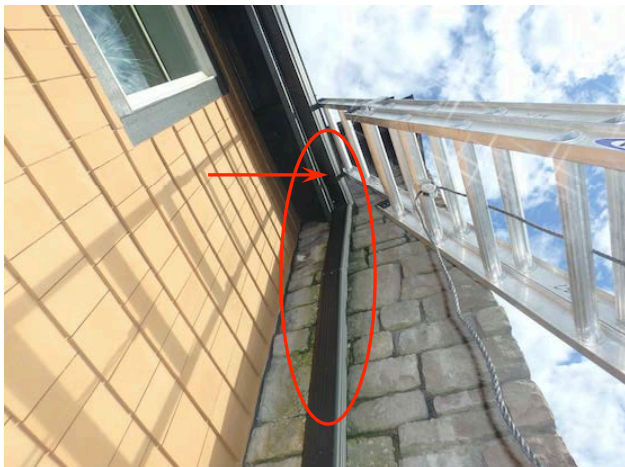
**2.2.9. Omitted or discontinuous kick-out flashing at roof-to-wall step flashing termination**

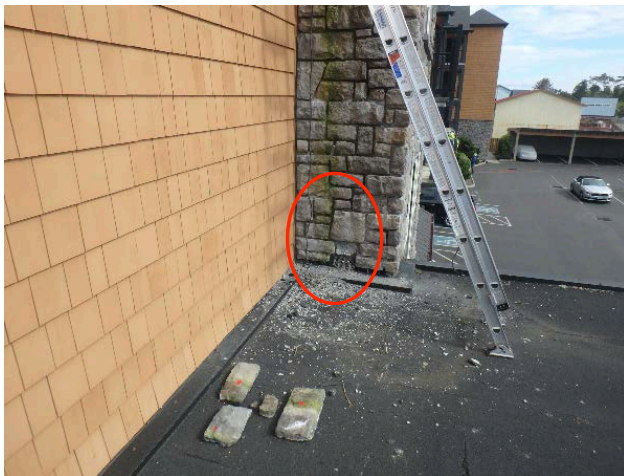
**2.2.13. Overview of the second opening in IO 12**

Opening was created at the base of wall to the flat roof transition below the above roof to wall opening

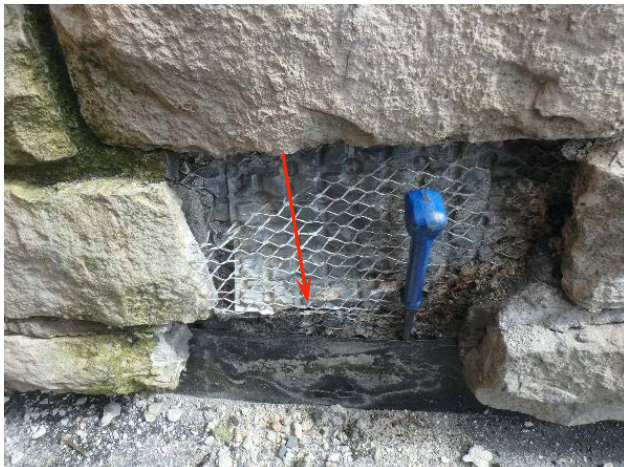
**2.2.14. Reverse-lap of flashing vertical back leg over metal lath drainage mat and WRB**

Condition impedes incidental water egress and facilitates moisture accumulation within exterior wall assembly.

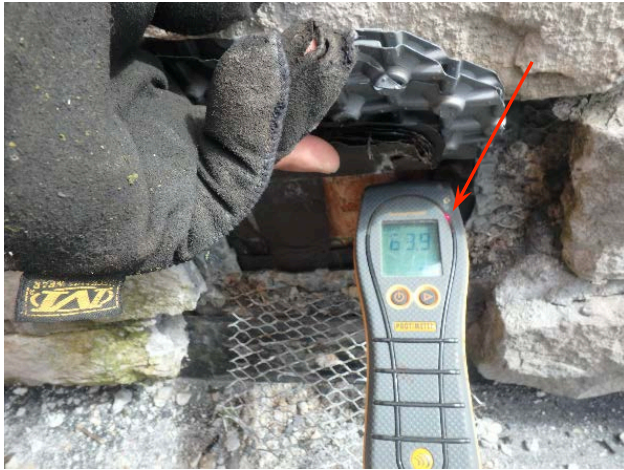
**2.2.15. Greater than 19% MC in wall assembly components**

63.9% MC measured in OSB sheathing.

Condition results from sustained moisture absorption by exterior wall assembly components due to water leakage and/or moisture accumulation within exterior wall assembly.

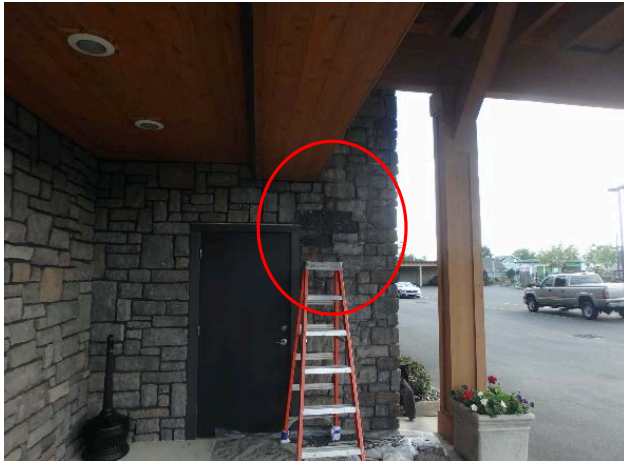
**2.2.16. Overview of the third opening in IO 12**

Opening was created below the above flat roof to wall opening

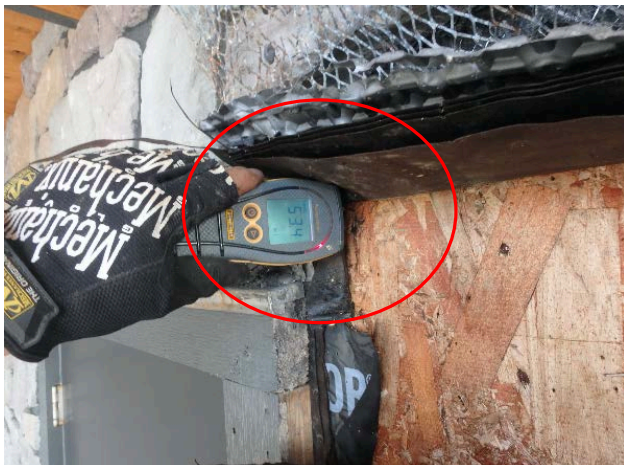
**2.2.17. Greater than 19% MC in wall assembly components**

53.4% MC measured in OSB sheathing.

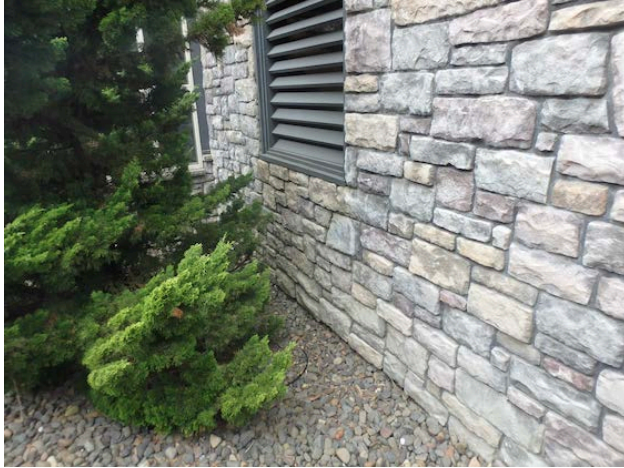
**2.2.18. Overview of the exterior of IO 7**

Louver penetration at the south stair well

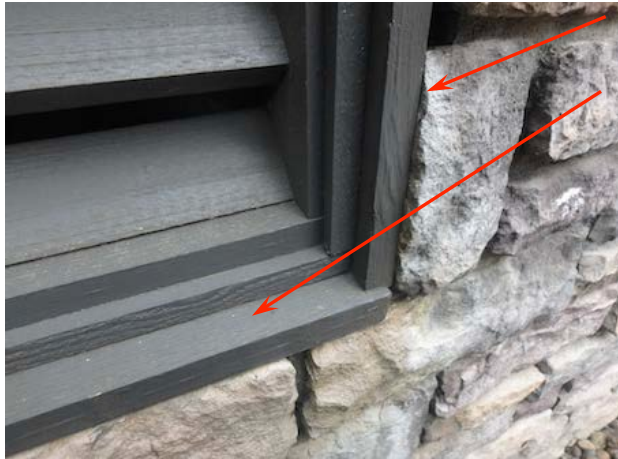
**2.2.19. Omitted dynamic sealant joint between dissimilar cladding components**

**2.2.20. Omitted sill flashing assembly**

Condition facilitates water infiltration into the wall assembly.

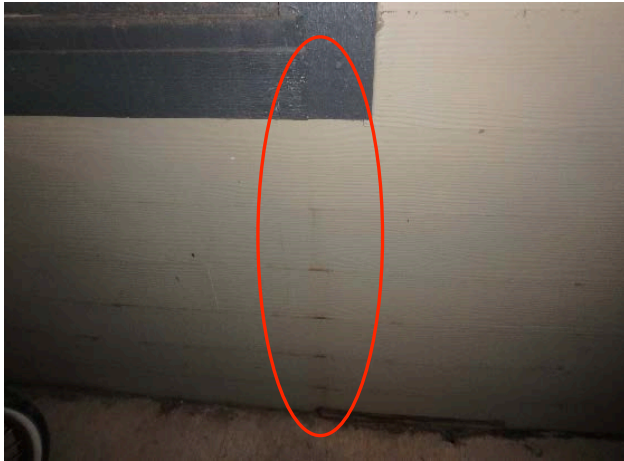
**2.2.22. Organic growth or moisture staining emanating from within wall assembly to the interior of the stairwell tower**

Condition likely results from moisture egress from within exterior wall assembly.

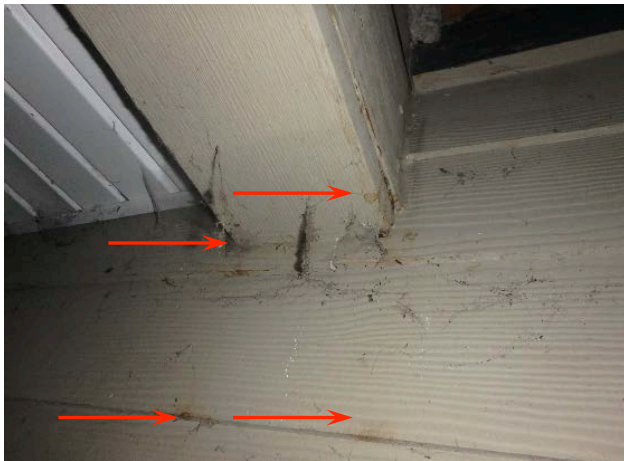
Additional example of condition shown previously, illustrating the condition at the left jamb of the louver

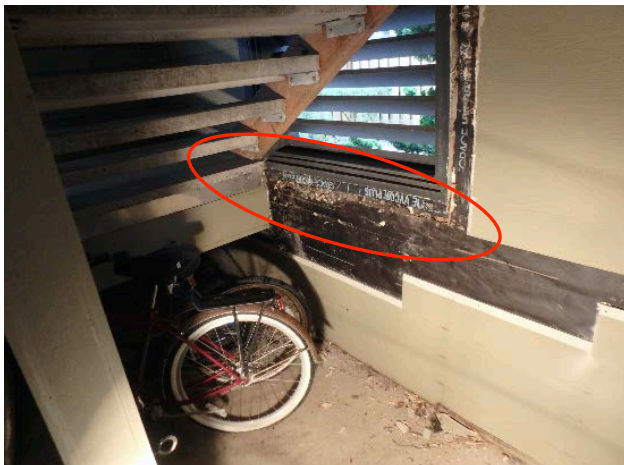
**2.2.23. Moisture-deteriorated wall assembly components**

**2.2.24. Moisture- or microbial-affected interior finishes**

WRB and gypsum sheathing exhibits damage at below the louver rough opening

Damage results from sustained presence of moisture due to water leakage and/or moisture accumulation within exterior wall assembly.

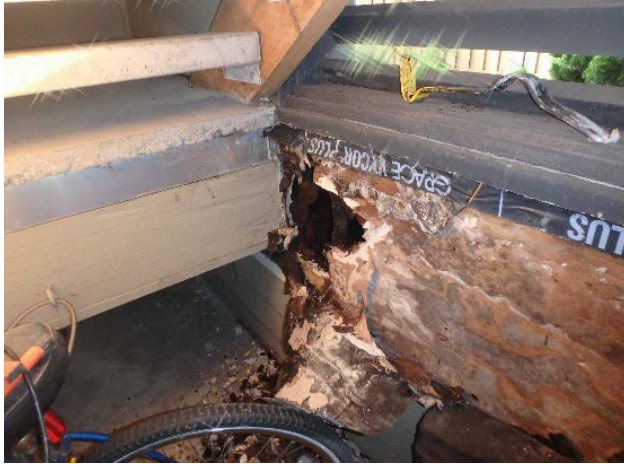
Close-up of location shown previously, illustrating the extent of the damage

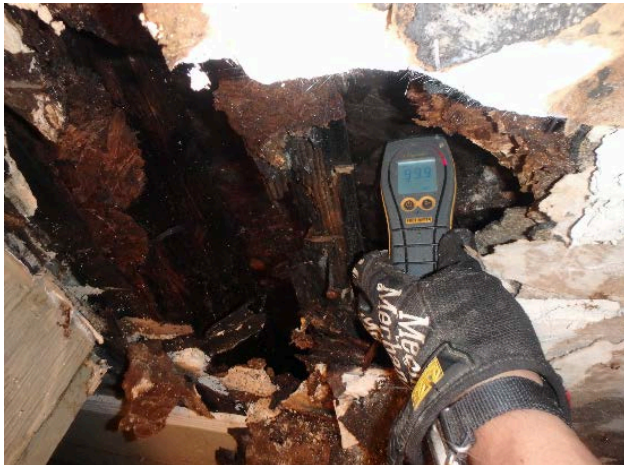
**2.2.26. Greater than 19% MC in outside wall OSB sheathing**

99.9% MC measured

Condition results from sustained moisture absorption by exterior wall assembly components due to water leakage and/or moisture accumulation within exterior wall assembly.

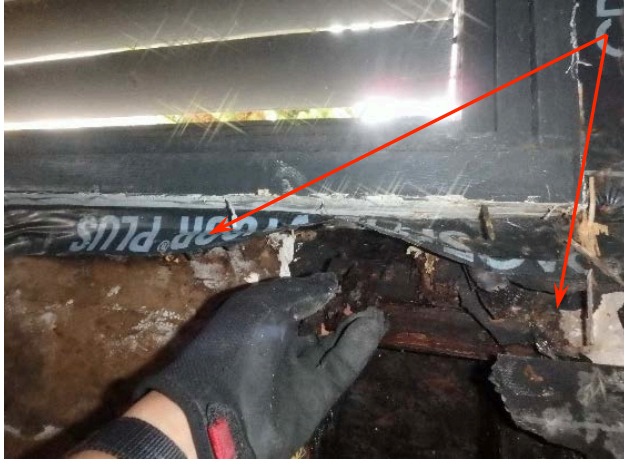
**2.2.27. Omitted sill pan and saddle flashing assembly**

Condition facilitates water infiltration into the wall assembly.

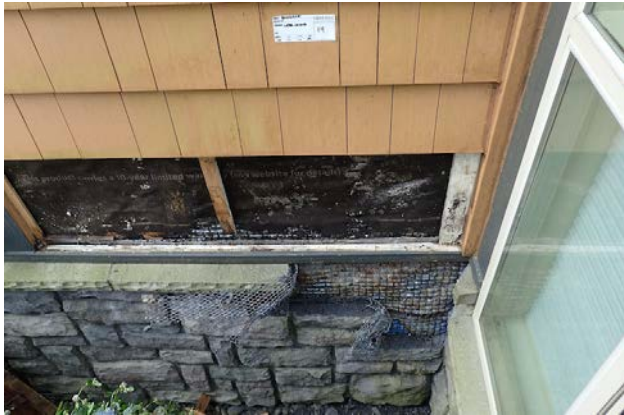
**2.2.28. Moisture-deteriorated framing components**

Framing member exhibits damage at below the louver rough opening

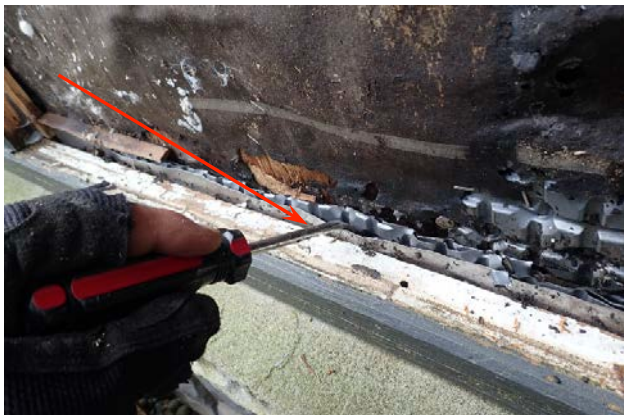
**2.2.30. Reverse-lap of flashing vertical back leg over drainage mat and WRB**

Condition impedes incidental water egress and facilitates moisture accumulation within exterior wall assembly.

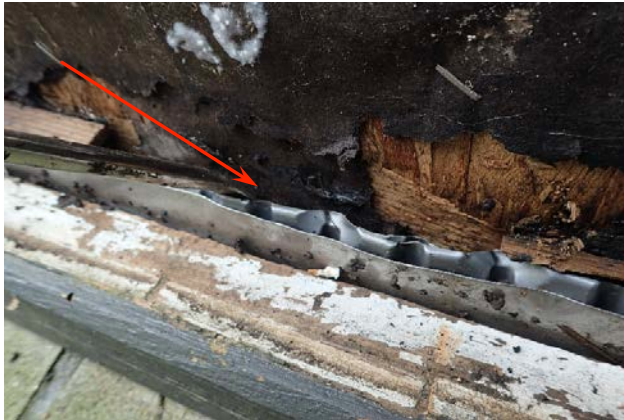
Close-up of location shown previously, illustrating the reverse lap

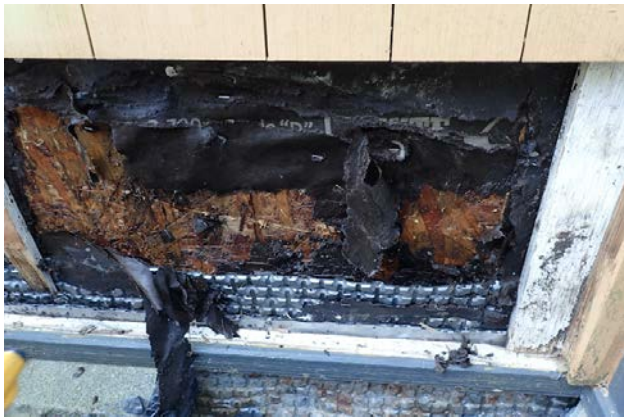
**2.2.31. Moisture-deteriorated wall assembly components**

**2.2.32. Moisture and microbial-affected interior finishes**

OSB sheathing exhibits damage at north tower outside wall

Damage results from sustained presence of moisture due to water leakage and/or moisture accumulation within exterior wall assembly.

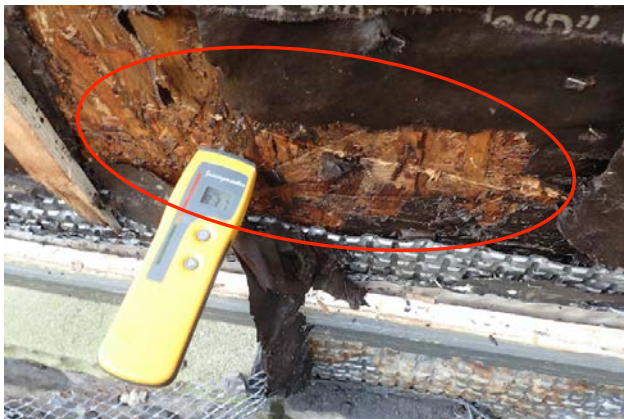
**2.2.33. Greater than 19% MC in wall assembly components**

93.7% MC measured in OSB sheathing

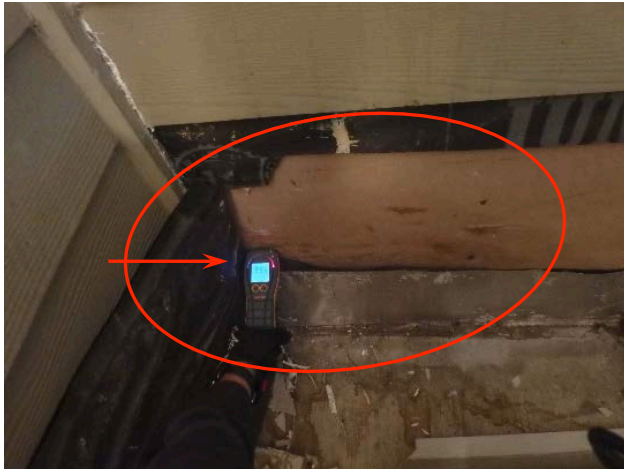
**2.2.36. Greater than 19% WME in gypsum-based wall assembly components**

99.9% MC measured in gypsum sheathing at the base of wall

Condition results from sustained moisture absorption by exterior wall assembly components due to water leakage within exterior wall assembly.

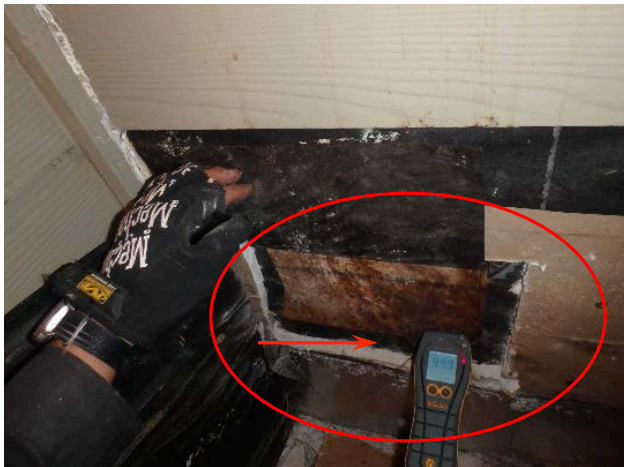
**2.2.37. Greater than 19% MC in OSB sheathing**

99.9% MC measured behind the gypsum wall

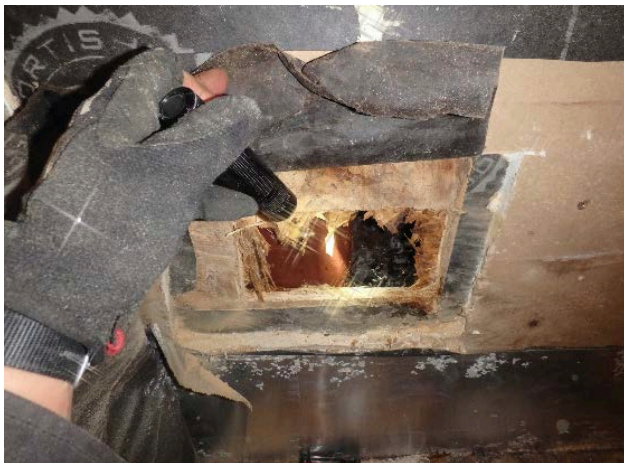
**2.2.38. Microbial-affected wall assembly components**

**2.2.39. Moisture-saturated and deteriorated wall assembly components**

Removal of the interior wall OSB exposed the exterior wall OSB to be saturated, deteriorated and containing heavy microbial growth.

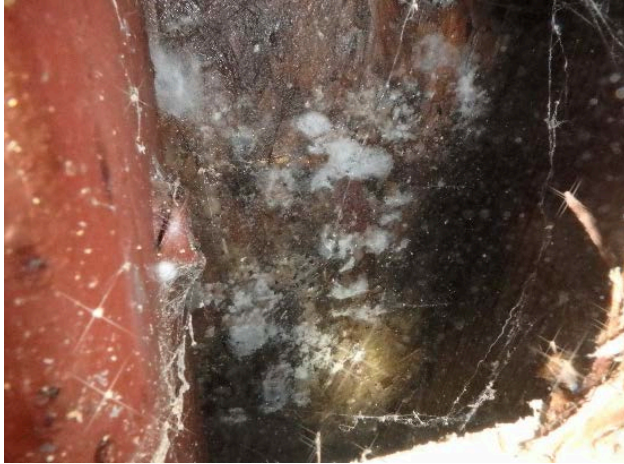
Close-up of location shown previously

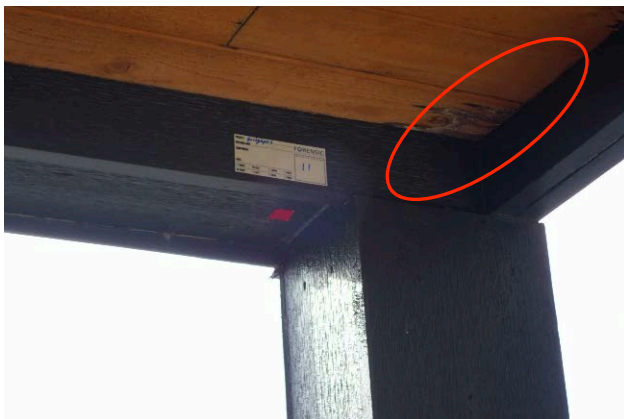
**2.3.2. Soffit view of IO 11**

Note the staining on the soffit boards

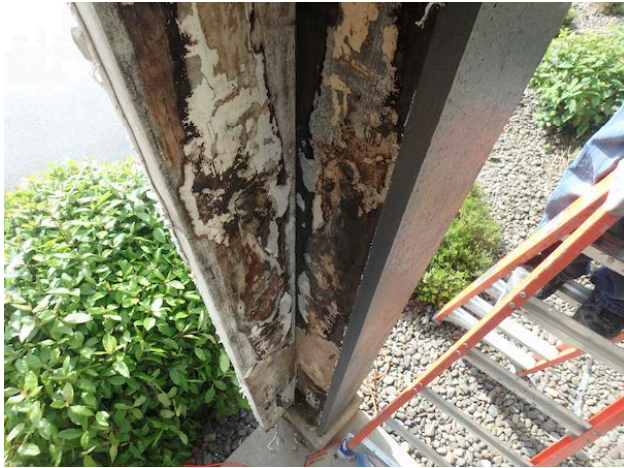
**2.3.3. Microbial-affected wall assembly components**

**2.3.4. Moisture-deteriorated wall assembly components**

Front walkway support post's trim and gypsum sheathing exhibits damage at IO 11

Damage results from sustained presence of moisture due to water leakage within exterior wall assembly.

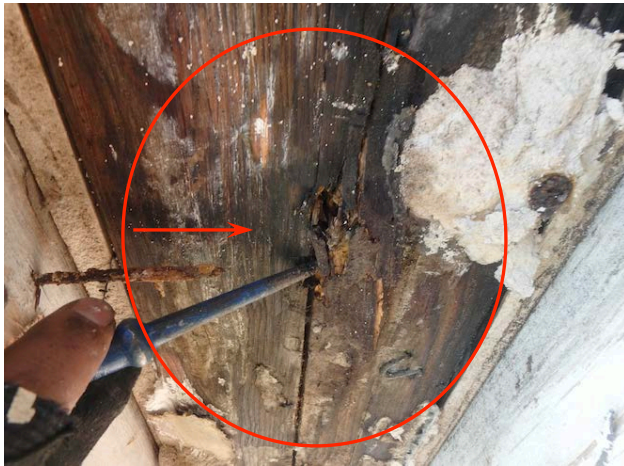
**2.3.6. Moisture-deteriorated beam assembly**

Front walkway support post itself exhibits damage at IO 11

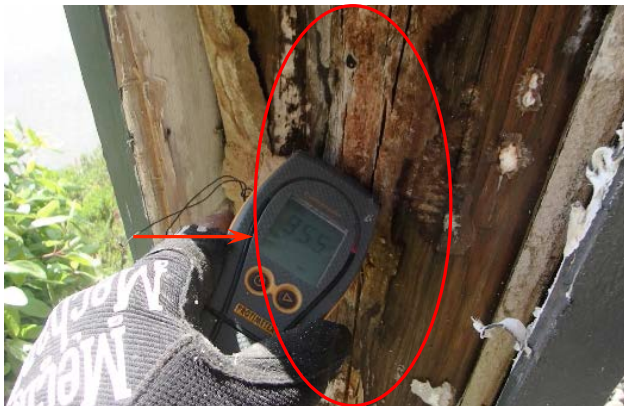
**2.3.7. Greater than 19% MC in wall assembly components**

95.5% MC measured in front entry structural post.

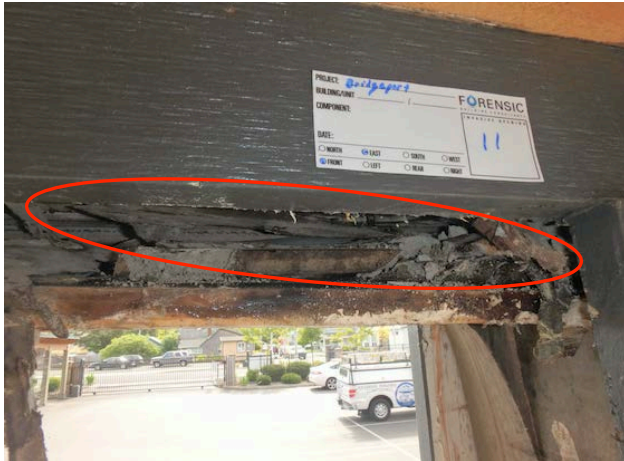
**2.3.8. Moisture-deteriorated gypsum sheathing below structural beam assembly**

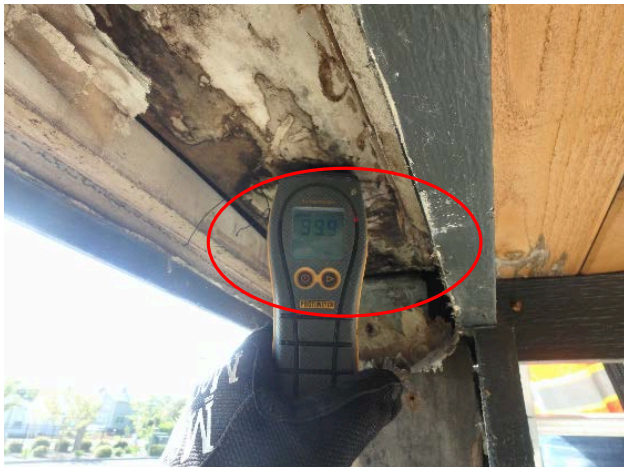
**2.3.9. Greater than 19% MC in front walkway structural beam**

99.9% MC measured in structural beam

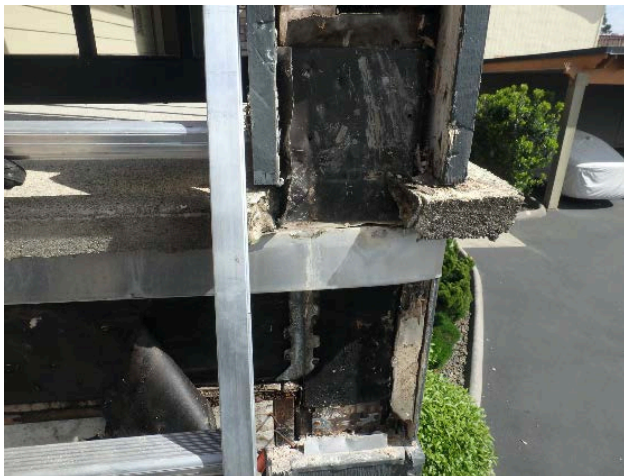
**2.3.10. Overview of saturated beams below the walkway assembly**

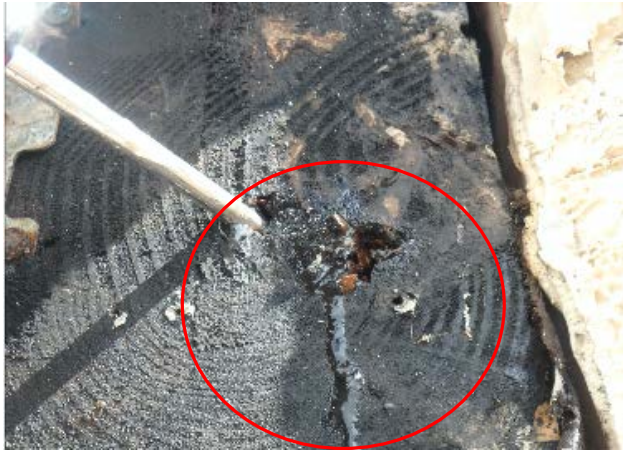
Close-up of location shown previously, illustrating the saturation level of the structural beam

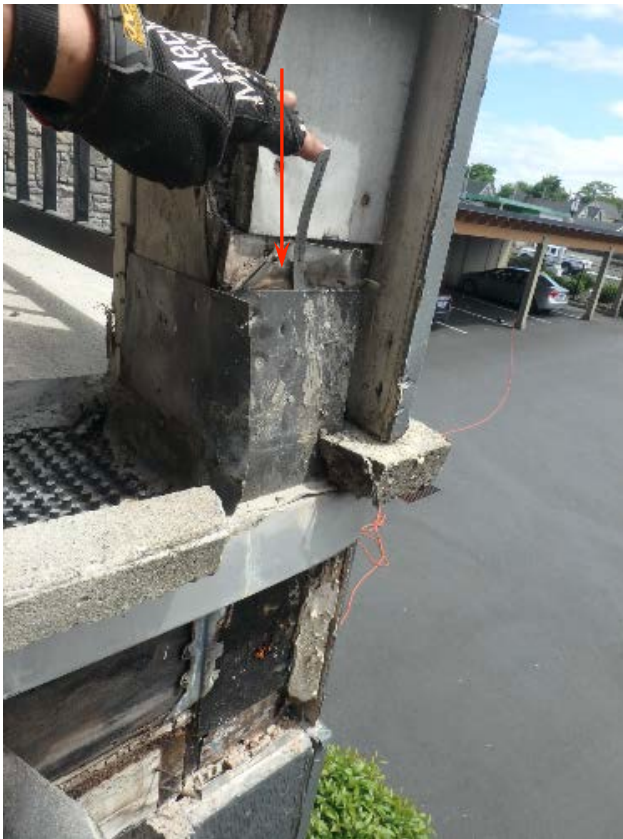
**2.3.11. Reverse-lap of flashing vertical back leg over gypsum sheathing**

Condition impedes incidental water egress and facilitates moisture accumulation within exterior wall assembly.

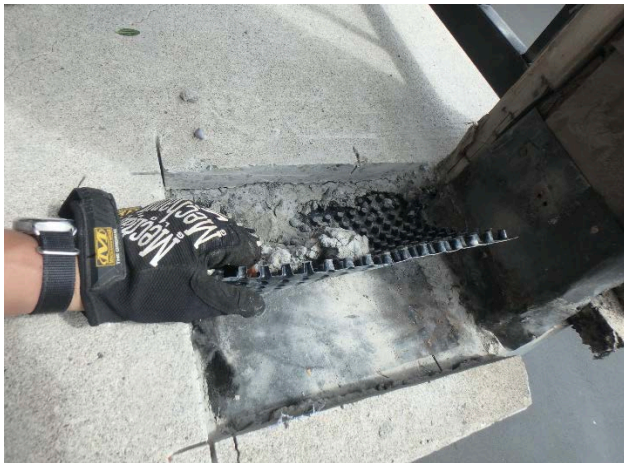
**2.3.14. Drainage mat layer installed over waterproofing membrane**

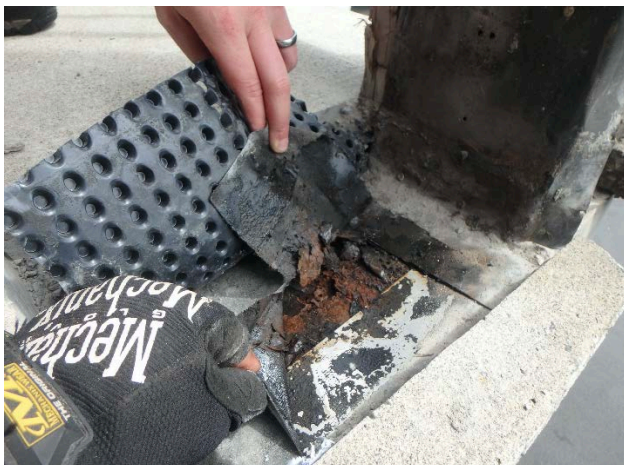
**2.3.15. Waterproofing membrane not adhered to drip edge flashing**

Condition fails to provide adequate incidental water protection for underlying walkway sheathing

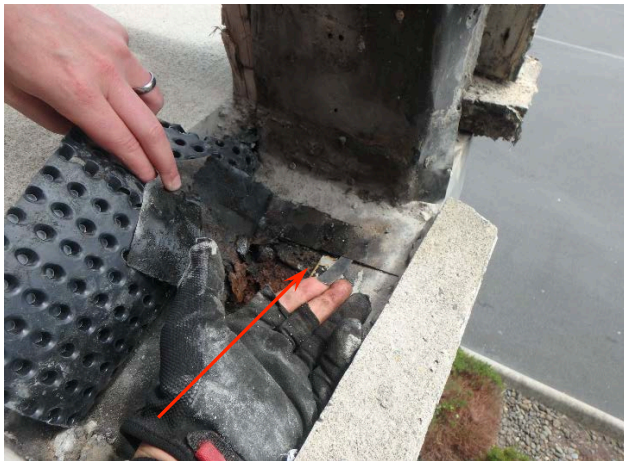
Close-up of location shown previously, illustrating the lack of proper adhesion of the waterproof membrane

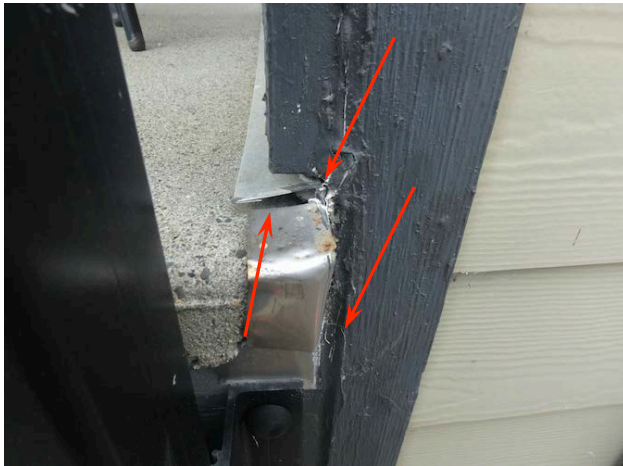
### 2.4.2. Omitted or discontinuous flashing "diverter" at deck-to-wall flashing termination

Condition fails to adequately convey surface drainage away from wall interface and increases likelihood of water infiltration into exterior wall assembly.

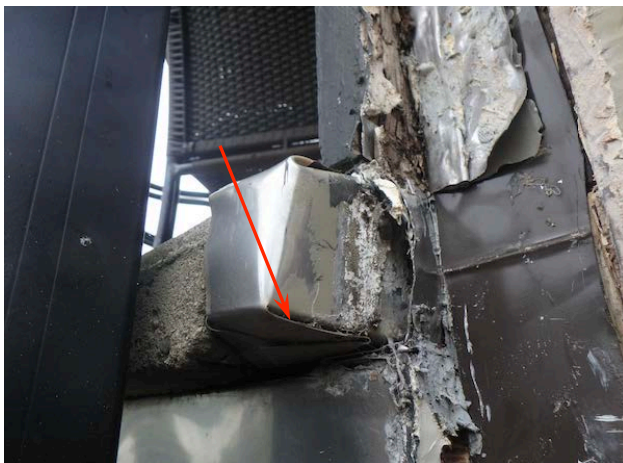
Condition facilitates water infiltration into deck and wall assembly.

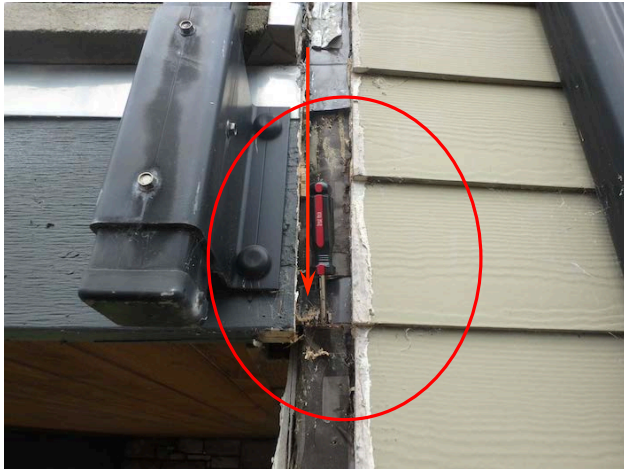
Close-up of location shown previously, illustrating the assembly after trim was removed

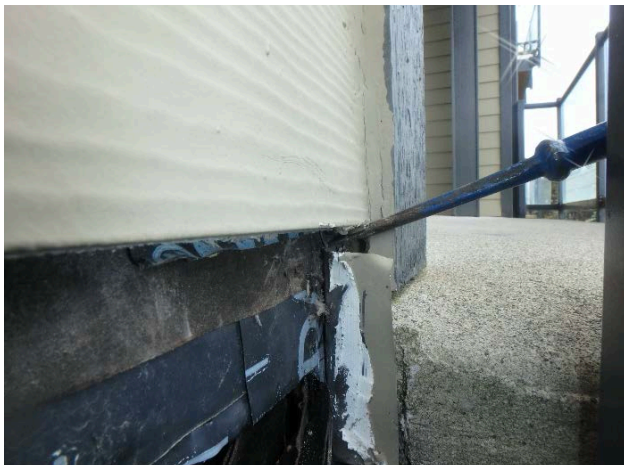
**2.4.8. Omitted or discontinuous flashing “diverter” at deck-to-wall flashing termination**

Condition fails to adequately convey surface drainage away from wall interface and increases likelihood of water infiltration into exterior wall assembly.

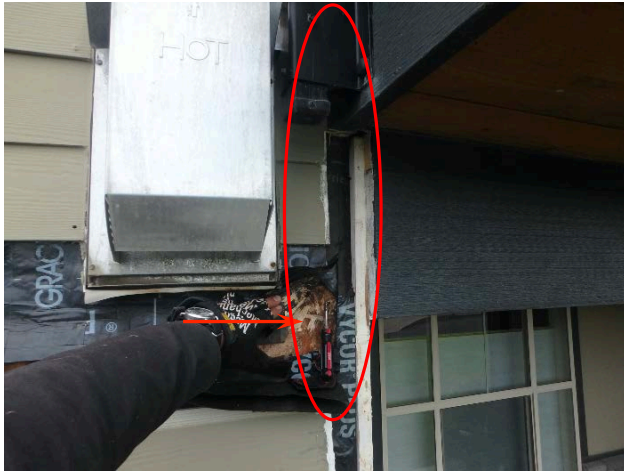
**2.4.9. Reverse-lap of flashing vertical back leg over WRB**

Condition impedes incidental water egress and facilitates moisture accumulation within exterior wall assembly.

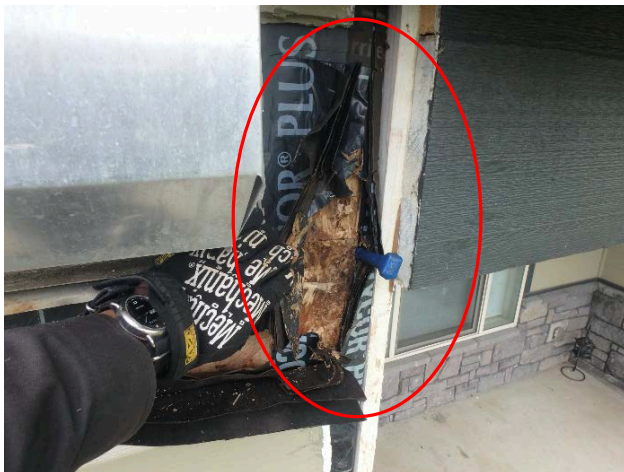
Close-up of location shown previously, illustrating the extent of the damage

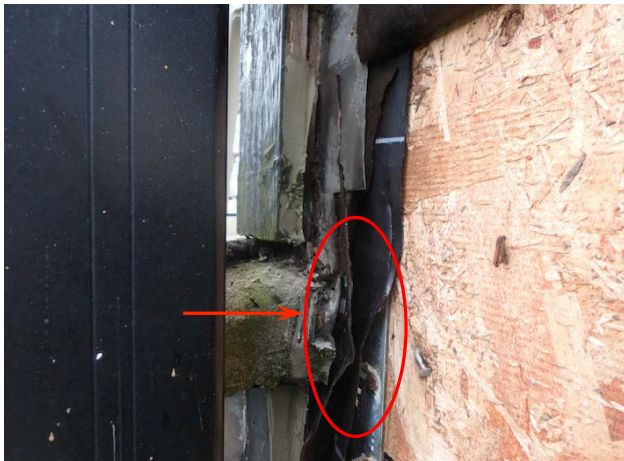
**2.4.12. Omitted or discontinuous flashing "diverter" at deck-to-wall flashing termination**

**2.4.13. Un-sealed metal flashing at concrete surface**

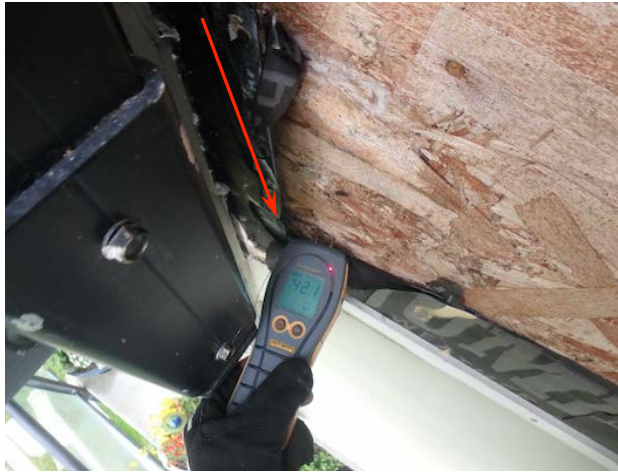
Close-up of location shown previously, illustrating the assembly after trim was removed and flashing was pushed to the side

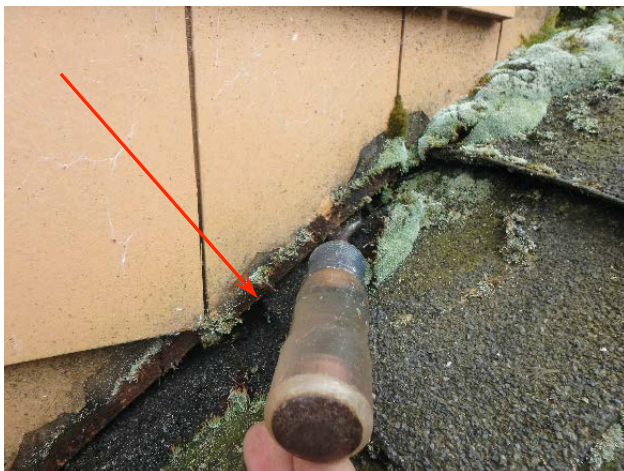
Close-up of location shown previously, illustrating the moss growth and wicking of water into the cedar cladding

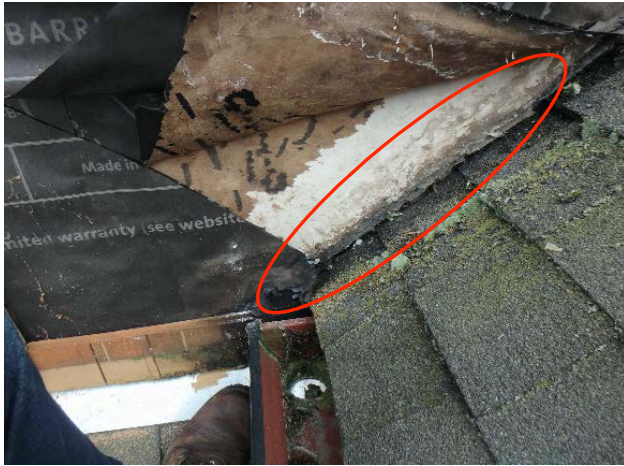
### 2.5.2. Less than 1'-2" clearance between shingle and roof surface

Condition facilitates moisture absorption and premature deterioration of cedar shingles.

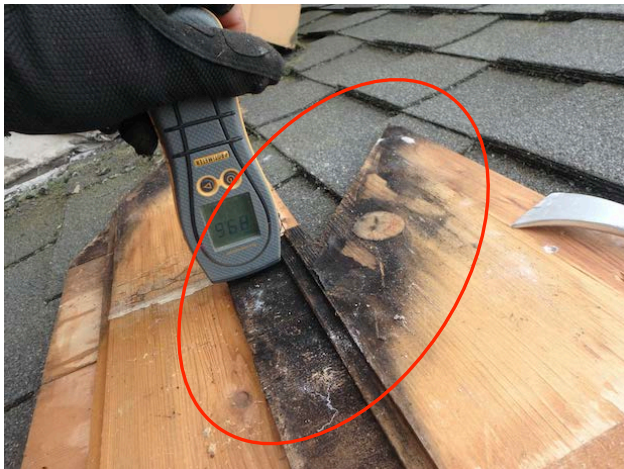
**2.5.3. Moisture-deteriorated gypsum sheathing at roof to wall transition**

Damage results from sustained presence of moisture due to wicking of water

Note the gypsum was installed over the roof to wall step flashing

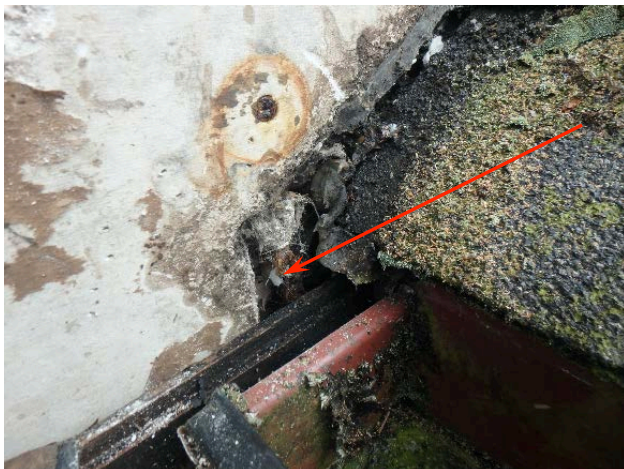
**2.5.4. Microbial-affected wall assembly components**

Cedar shake siding exhibits damage at roof to cladding.

Note the elevated MC of 89.6%.

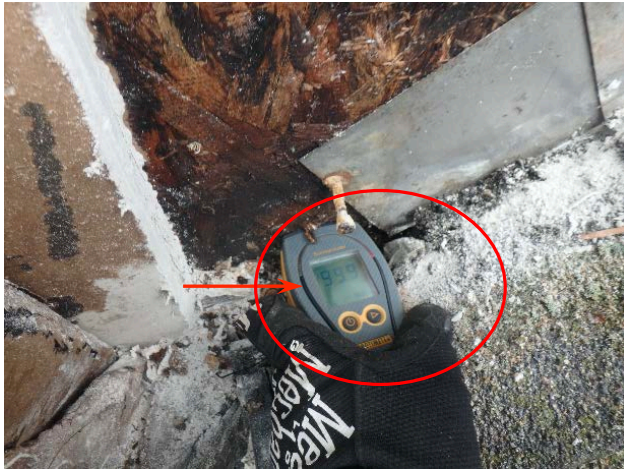
**2.5.5. Omitted or discontinuous kick-out flashing at roof-to-wall step flashing termination**

Condition fails to adequately convey surface drainage away from wall interface and increases likelihood of water infiltration into exterior wall assembly.

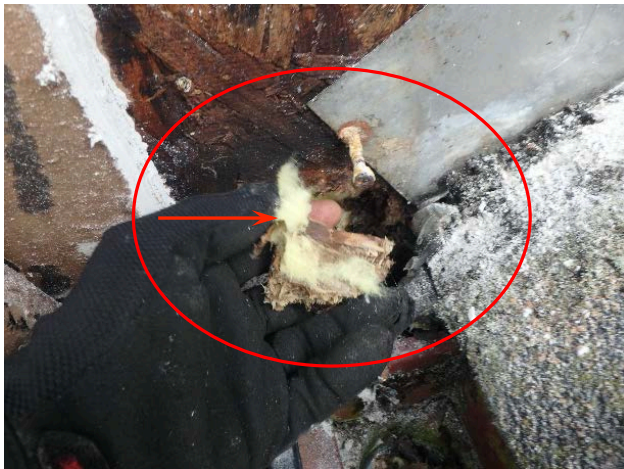
**2.5.6. Greater than 19% MC in wall assembly components**

99.9% MC measured in OSB sheathing at roof to wall juncture

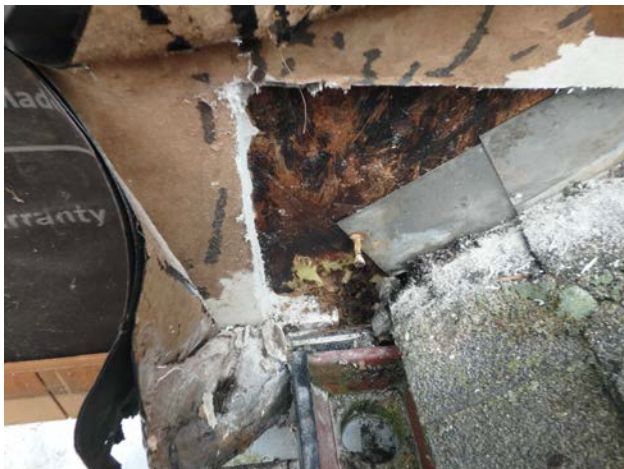
**2.5.7. Moisture-deteriorated wall assembly components**

OSB sheathing exhibits damage at at roof to wall junction.
