BRIDGEPORT CONDOMINIUMS

1000 N Holladay Drive
Seaside, OR 97138

PRELIMINARY BUILDING ENCLOSURE AND LIMITED STRUCTURAL ASSESSMENT

J2 Project #5151201

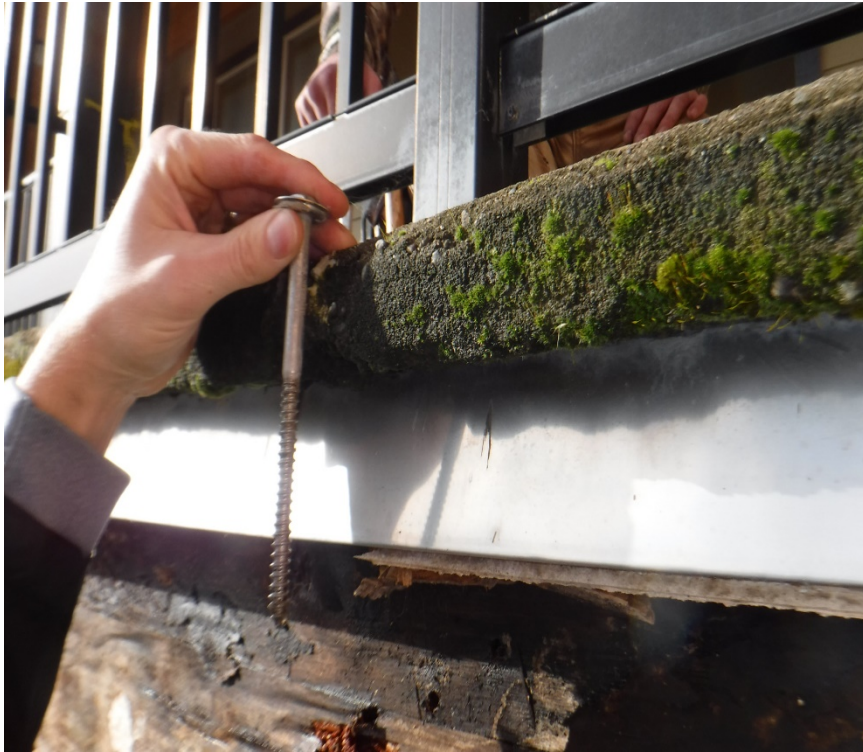
1.6 – Opening #1

Guardrail post is top mounted. Lag bolts penetrate beam approx. 2".

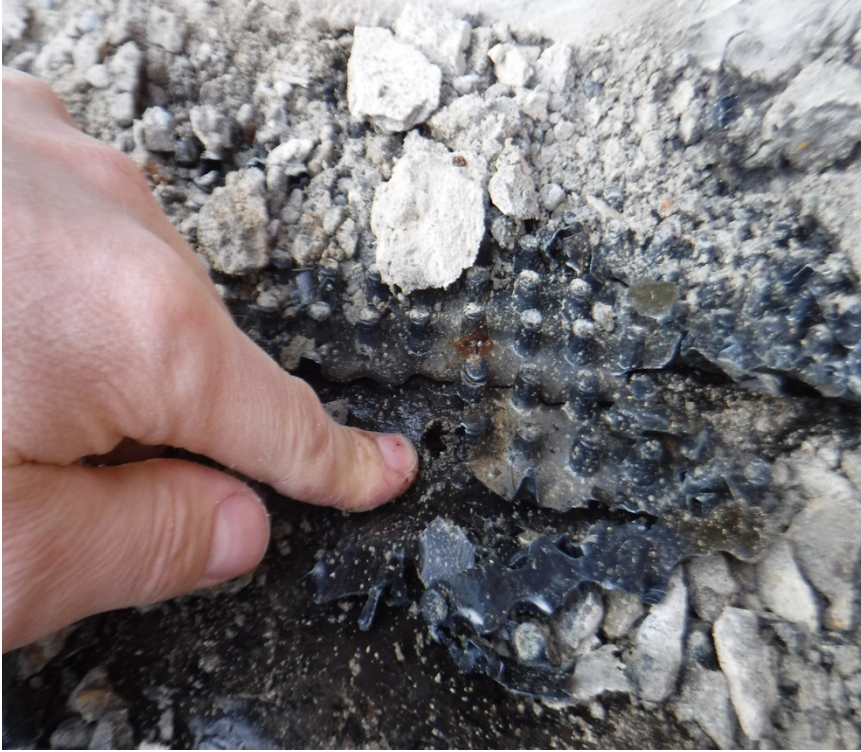
1.8 – Opening #1

Lag bolt hole present in waterproofing.

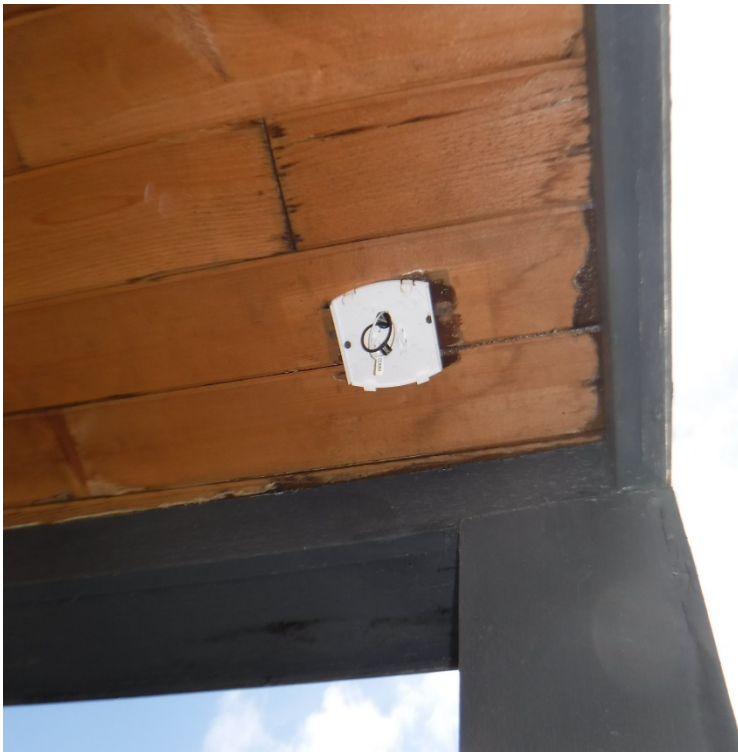
2.1 – Opening #2

Overview of third floor soffit above Opening #2 at second floor column near Unit 209 on east elevation.

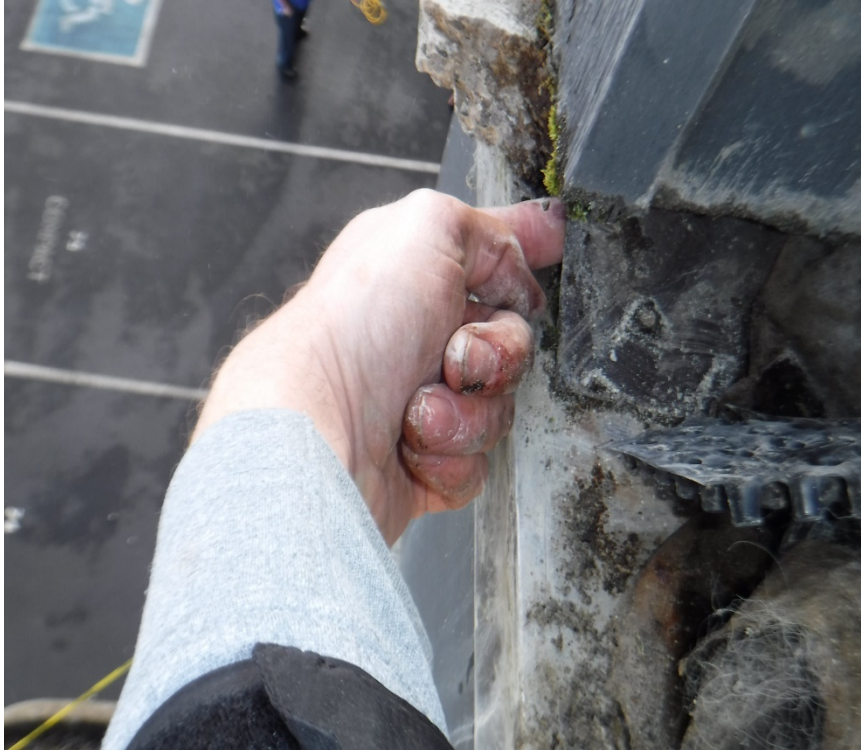
3.3 – Opening #3

Column base metal flashing is open at corners.

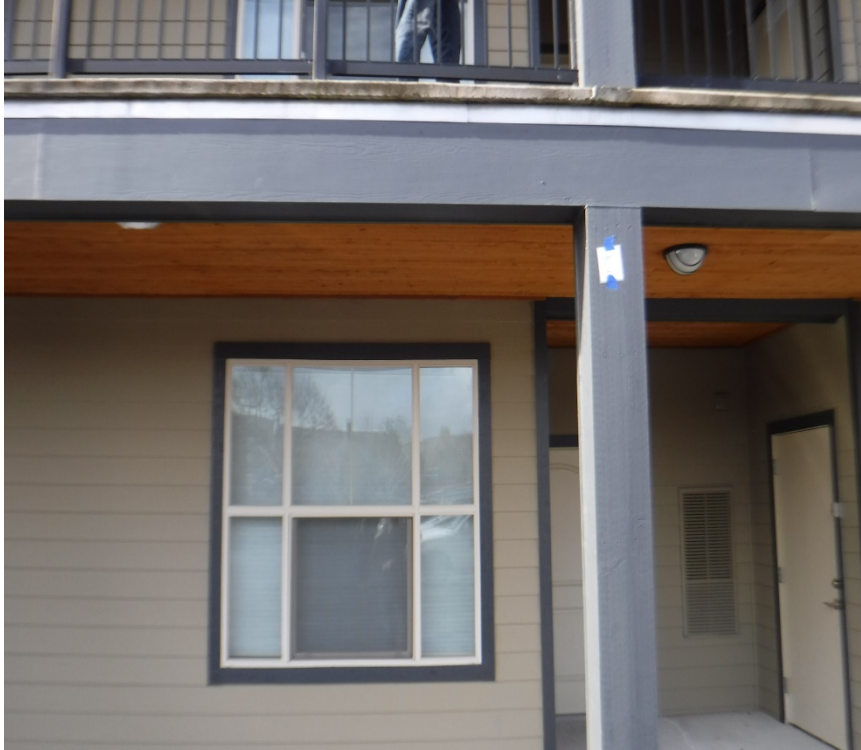
4.1 – Opening #4

Overview of Opening #4 at front landing beam near Unit 103 on east elevation.

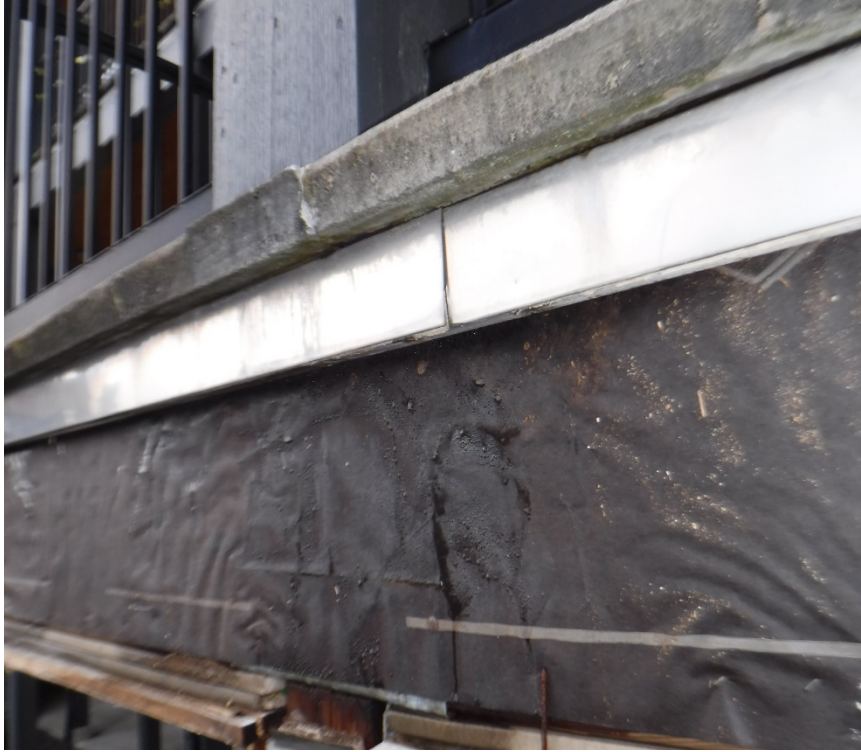
5.2 – Opening #5

Liquid water on WRB, below landing column above. Note WRB does not continue to column below and column is wet.

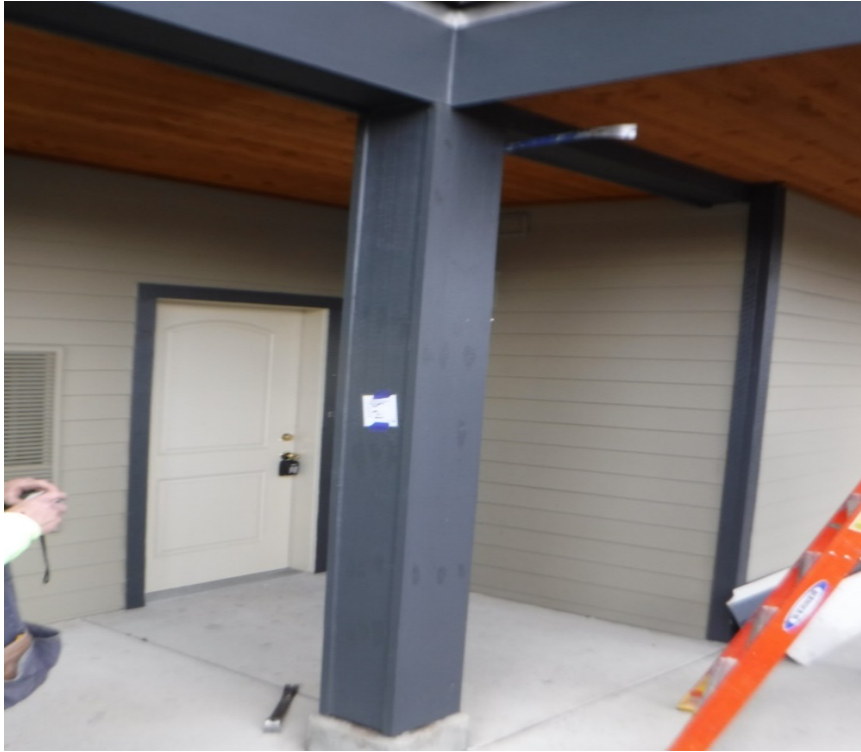
6.1 – Opening #6

Overview of Opening #6 at column wrap near Unit 108 on east elevation.

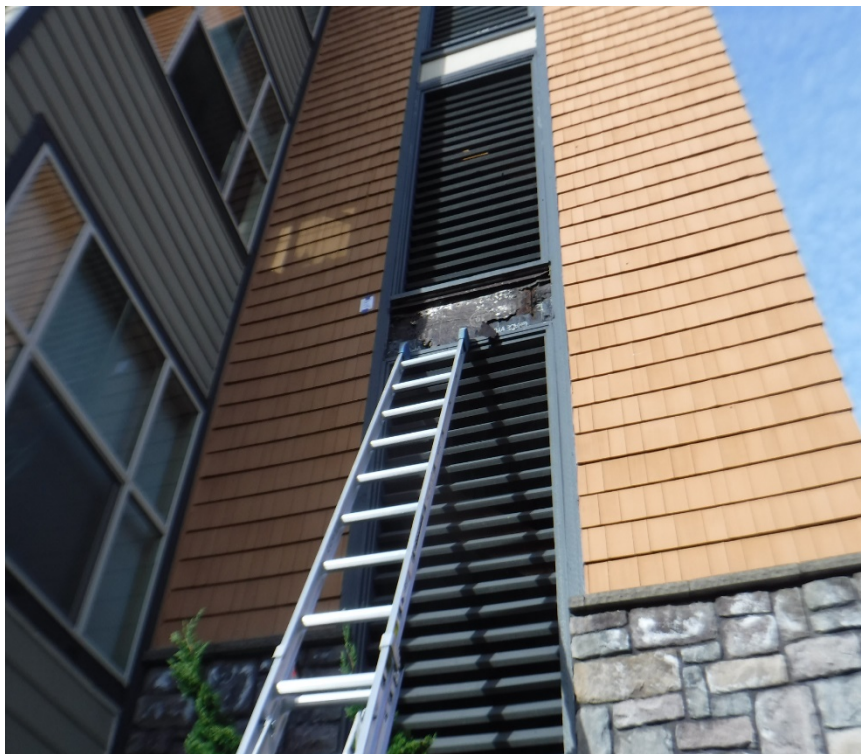
7.1 – Opening #7

Overview of Opening #7 between fresh air louvers on south stair tower on south elevation.

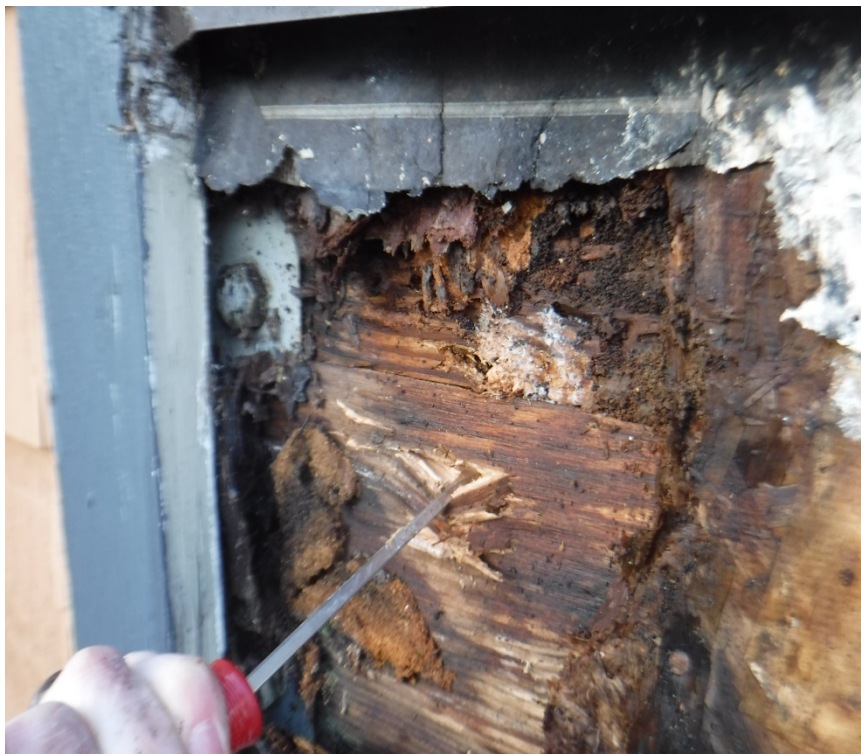
7.3 – Opening #7

GLB is severely detached. Note that the purpose of this beam is to support out-of-plane loads, as well as gravity loads, since the stair landings do not act as a diaphragm at this location.

7. Guardrails are inadequately attached to the building.
8. Water damage has occurred to the glulam girts supporting the stair towers. This is due to inadequate weatherization of the rough openings of the fresh air louvers.

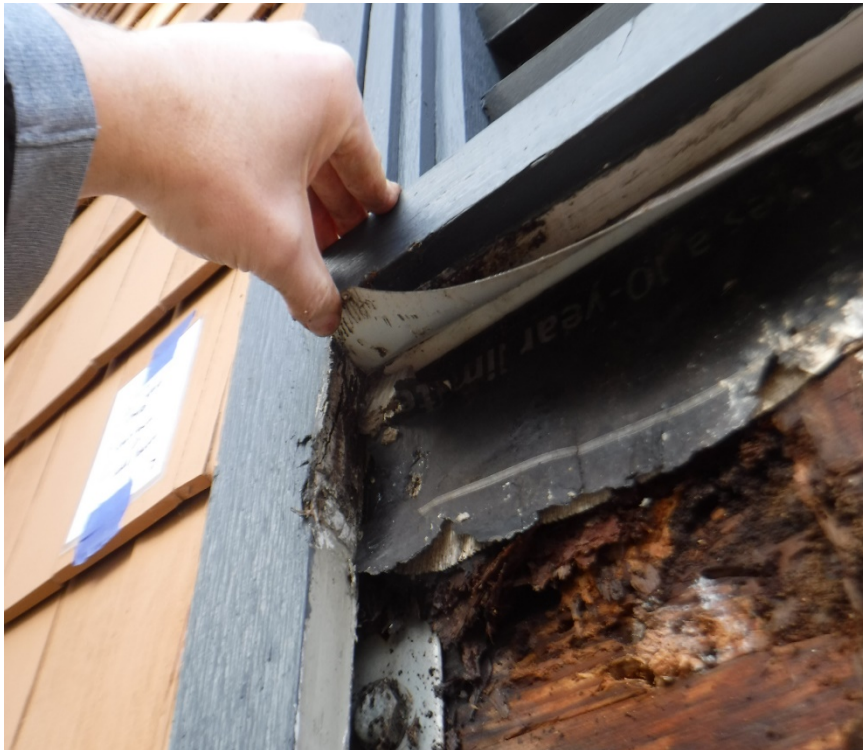
7.4 – Opening #7

WRB is reverse lapped over flexible SAMF. There is an open seam and no saddle at metal flashing above.

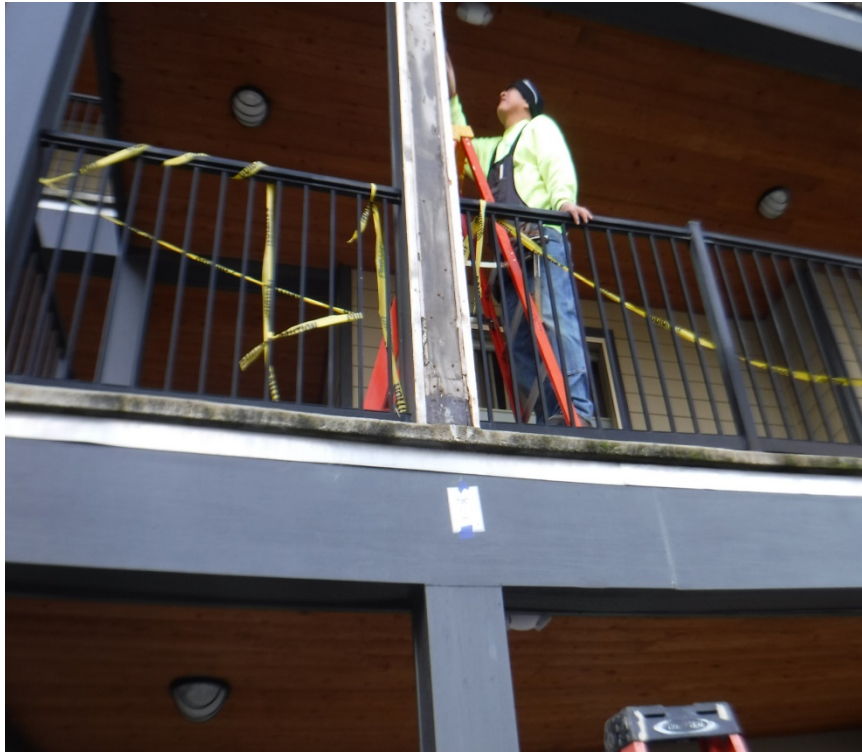
8.1 – Opening #8

Overview of Opening #8 at column near Unit 208 on east elevation.

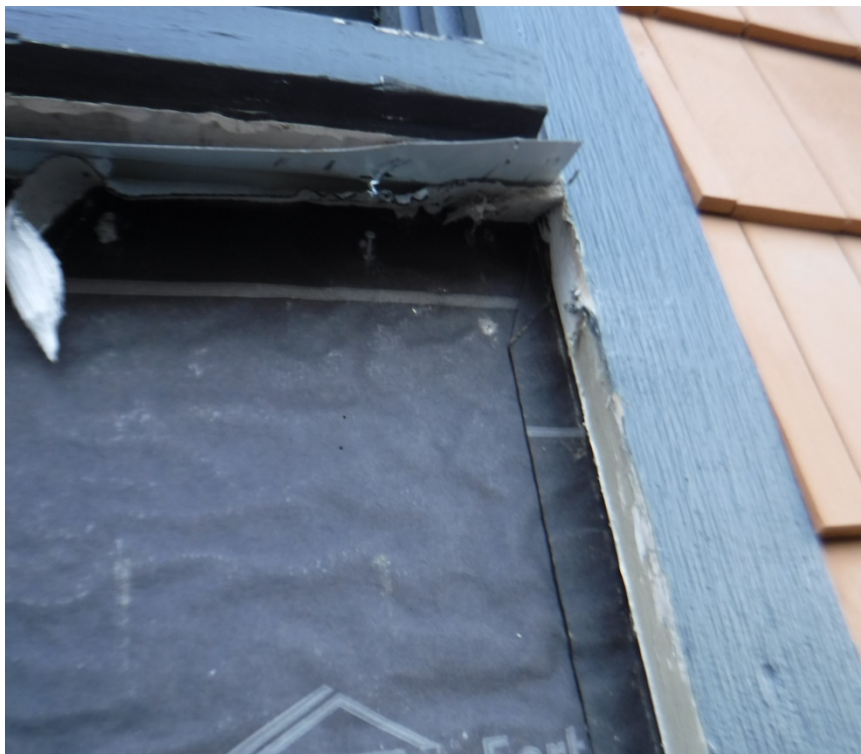
9.4 – Opening #9

WRB is properly lapped under flexible sill SAMF.

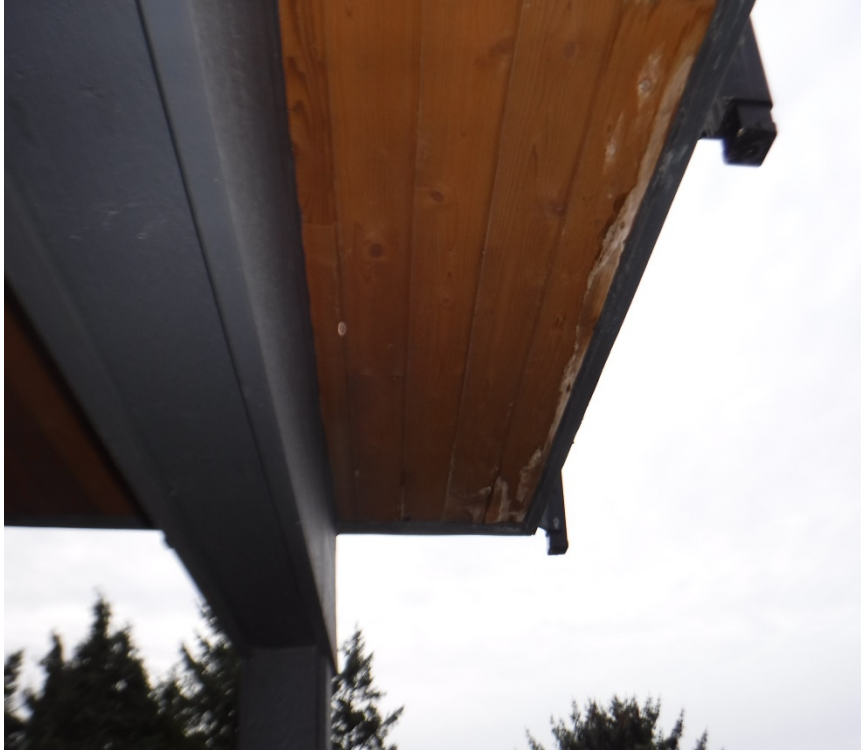
10.1 – Opening #10

Overview of soffit prior to Opening #10 at deck of Unit 301 on west elevation.

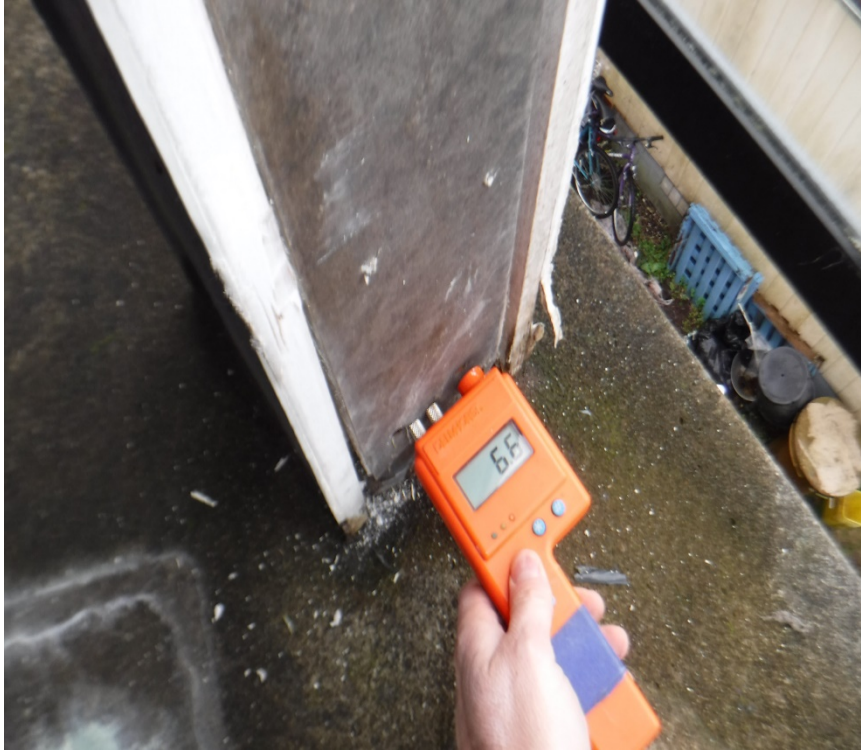
10.3 – Opening #10

GWB on column is saturated (6.6 mass percent).

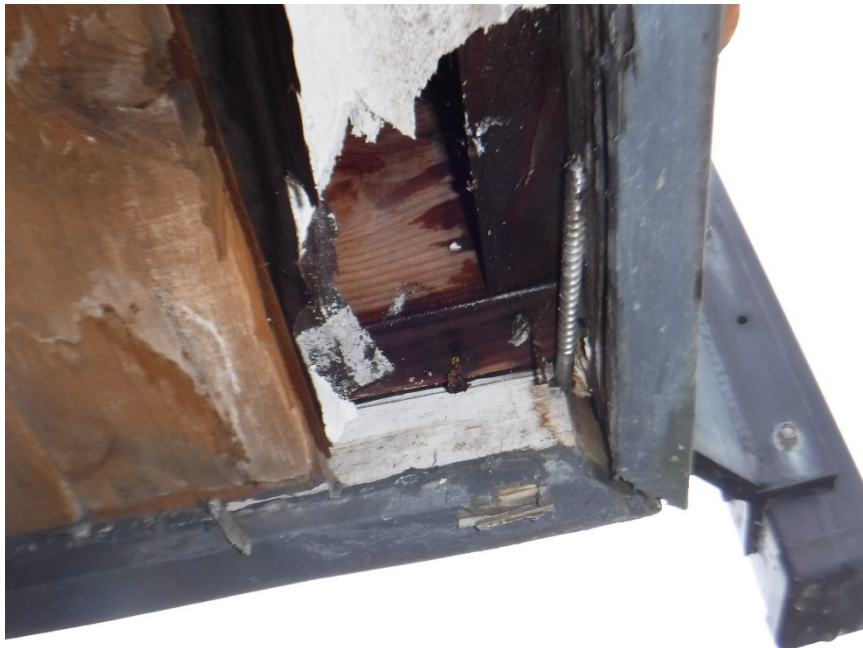
10.6 – Opening #10

Guardrail lag bolt only penetrates fascia, not framing.

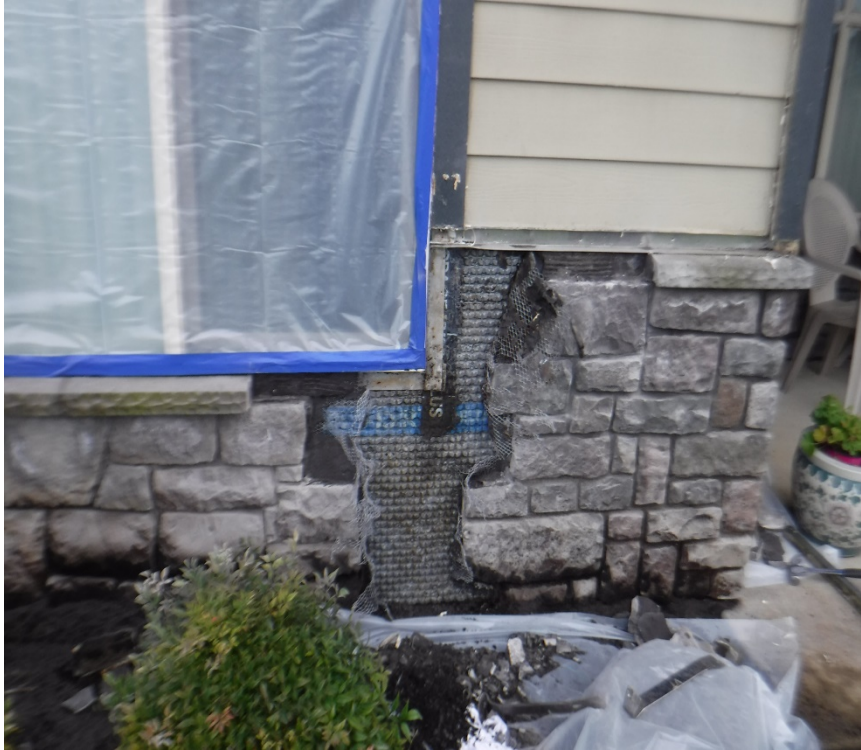
11.1 – Opening #11

Overview of Opening #11 at concrete masonry veneer at Unit 102 on west elevation.

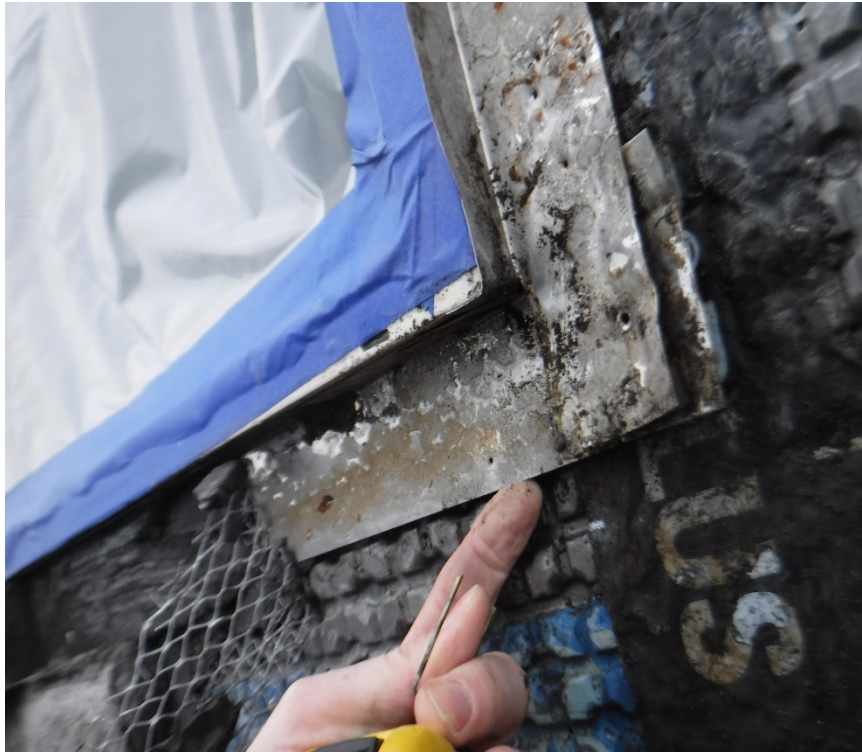
11.3 – Opening #11

“L” metal is tight to window, and there is no expansion joint between veneer and window frame.

10. The concrete masonry veneer is installed too tight to window frames, the lath is improperly fastened, and transition flashings are not installed in a weatherboard manner.

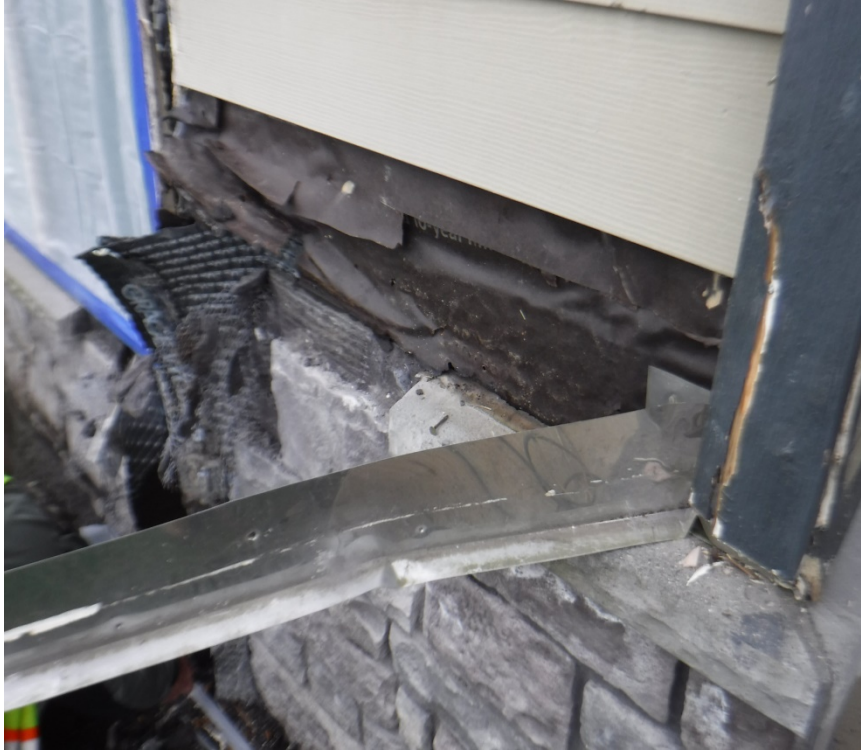
11.5 – Opening #11

Metal flashing above stone shelf is not integrated with WRB.

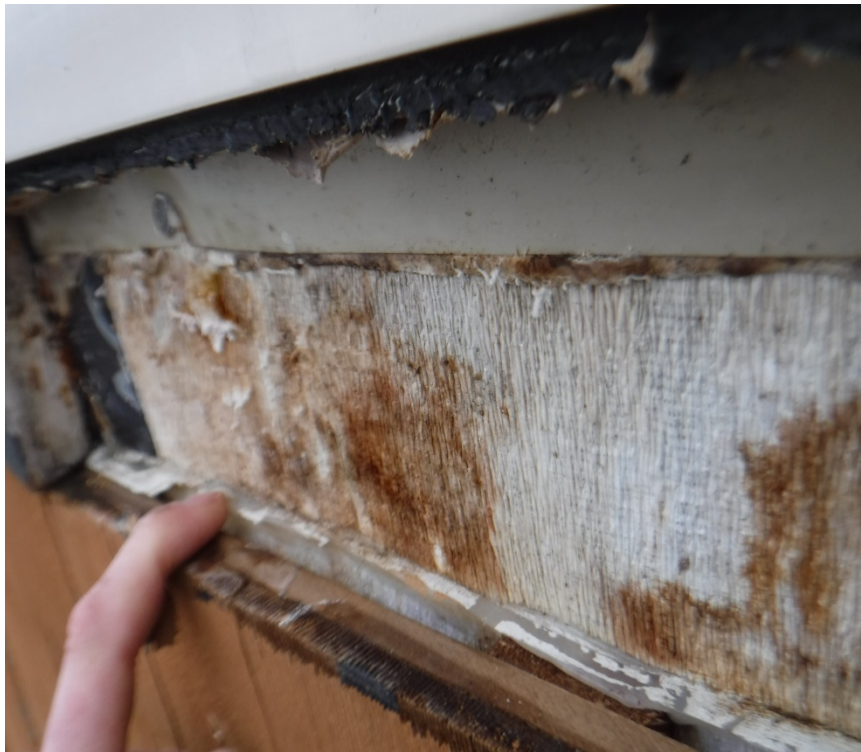
12.4 – Opening #12

Silicon back-caulking behind wood sill trim.

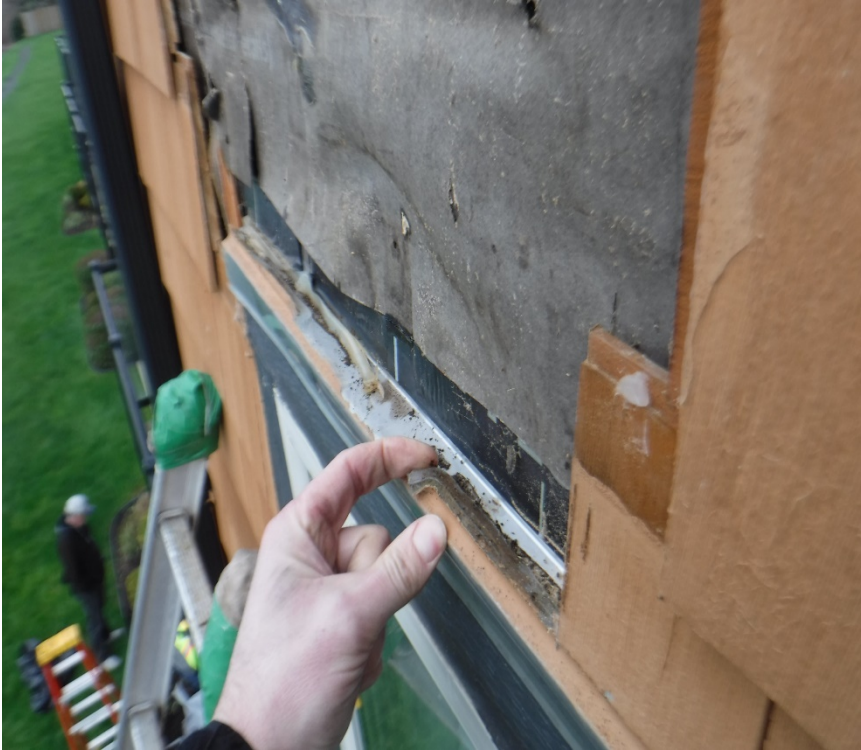
12.5 – Opening #12

Siding is sealed to metal head flashing.

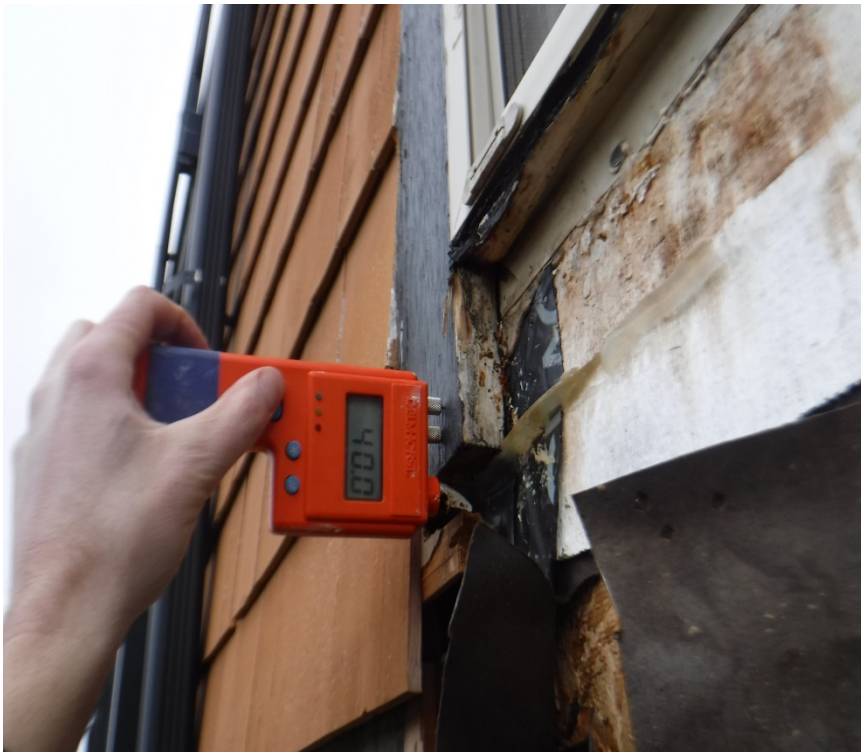
12.6 – Opening #12

Wood trim is saturated (40 mass percent).

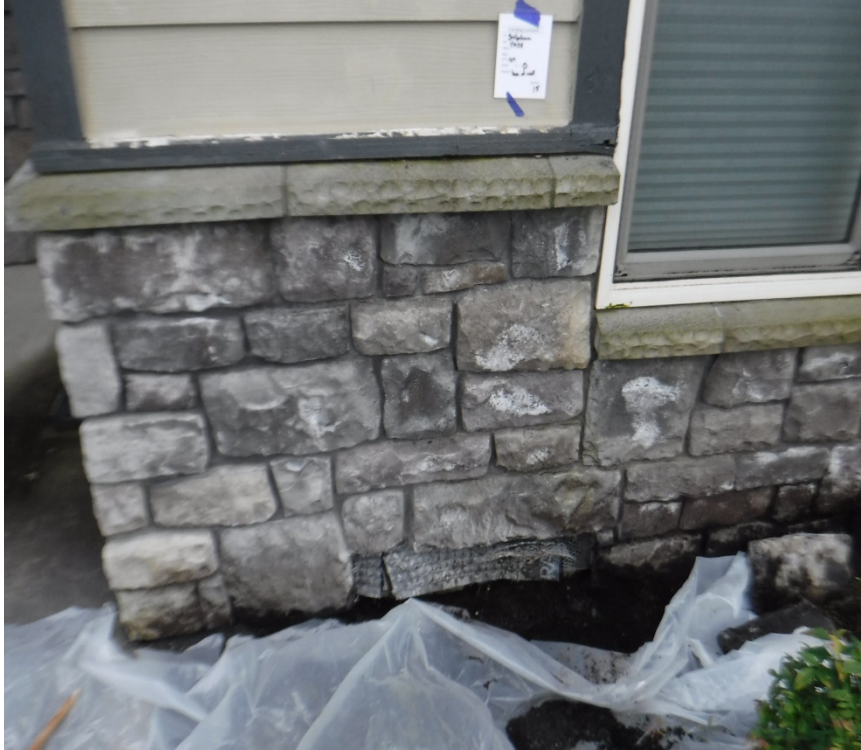
15.1 – Opening #15

Overview of masonry veneer prior to Opening #15 at Unit 107 on west elevation.

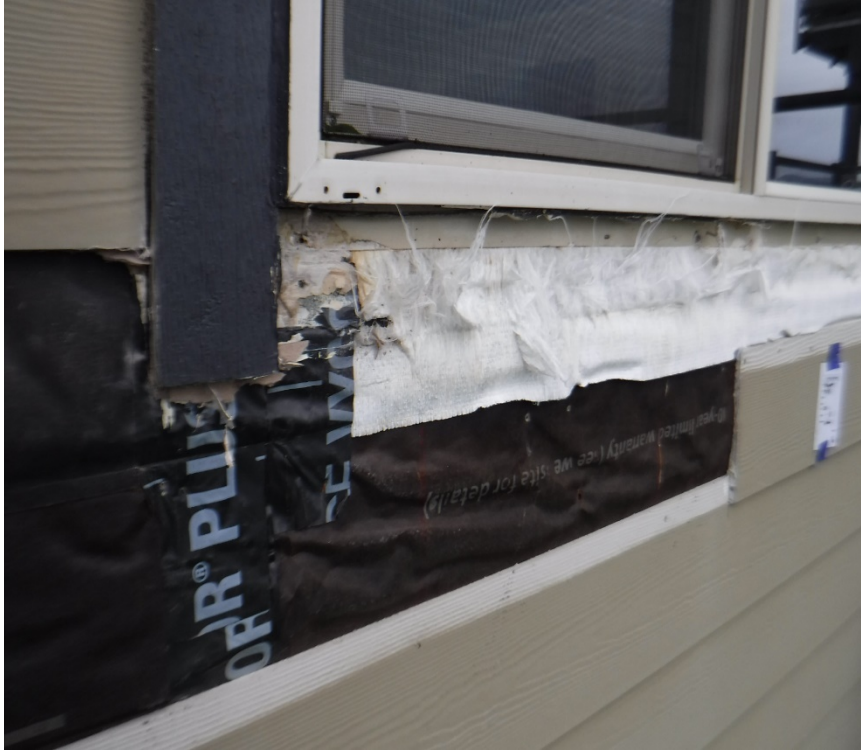
16.1 – Opening #16

Overview of Opening #16 below second floor window at Unit 210 on west elevation.

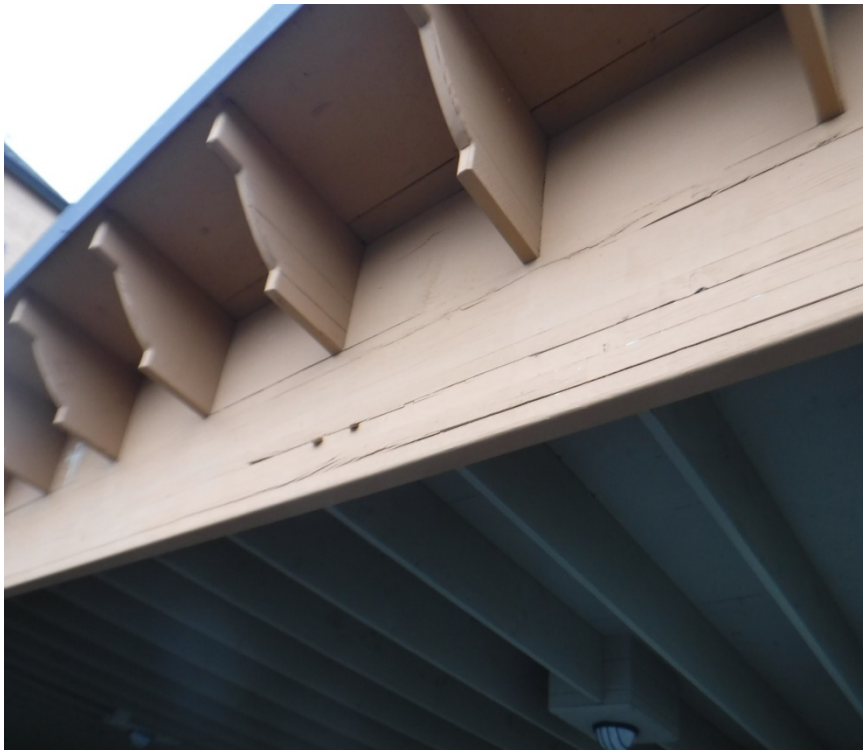
17.1 – Misc.

GLB is delaminated/checked at carport. Mushrooms are growing between laminations.

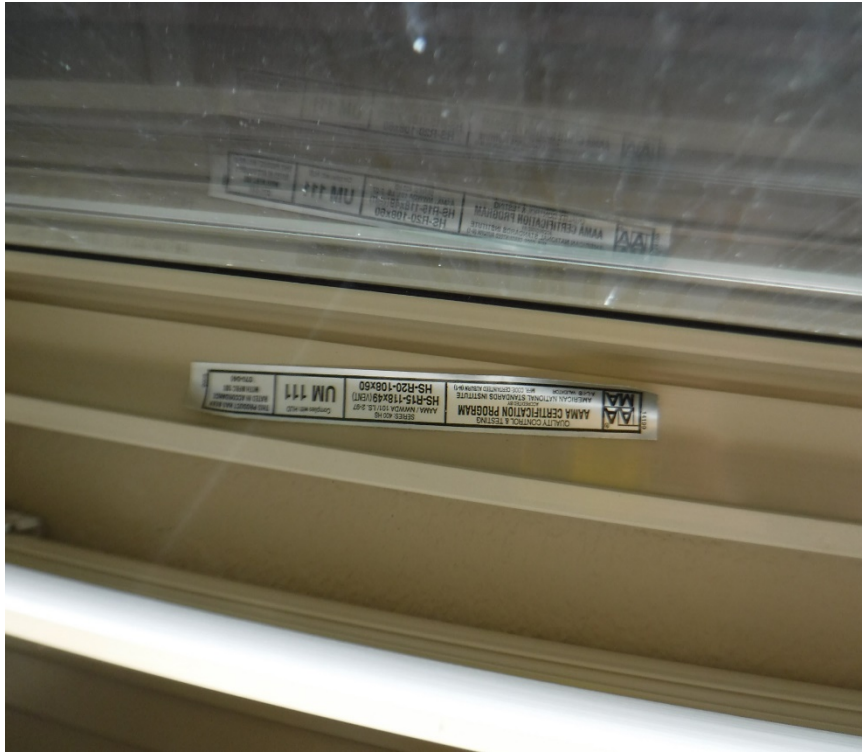
17.5 – Misc.

Smaller, single hung windows rated R20.

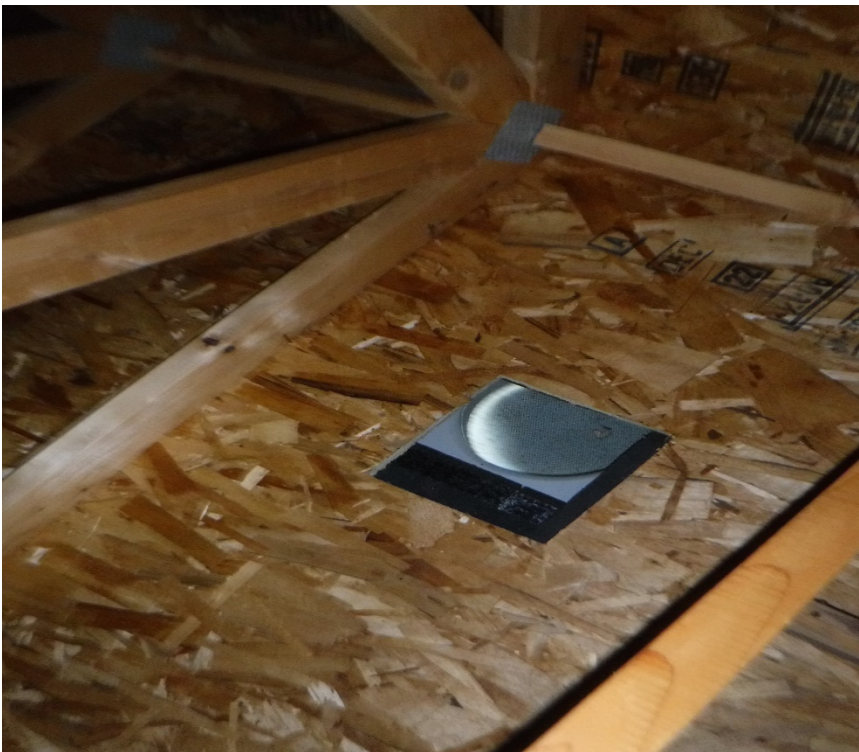
17.13 – Misc.

Attic vent cut out is misaligned with vent. Also, there is a lack of eave vents and no cross ventilation.

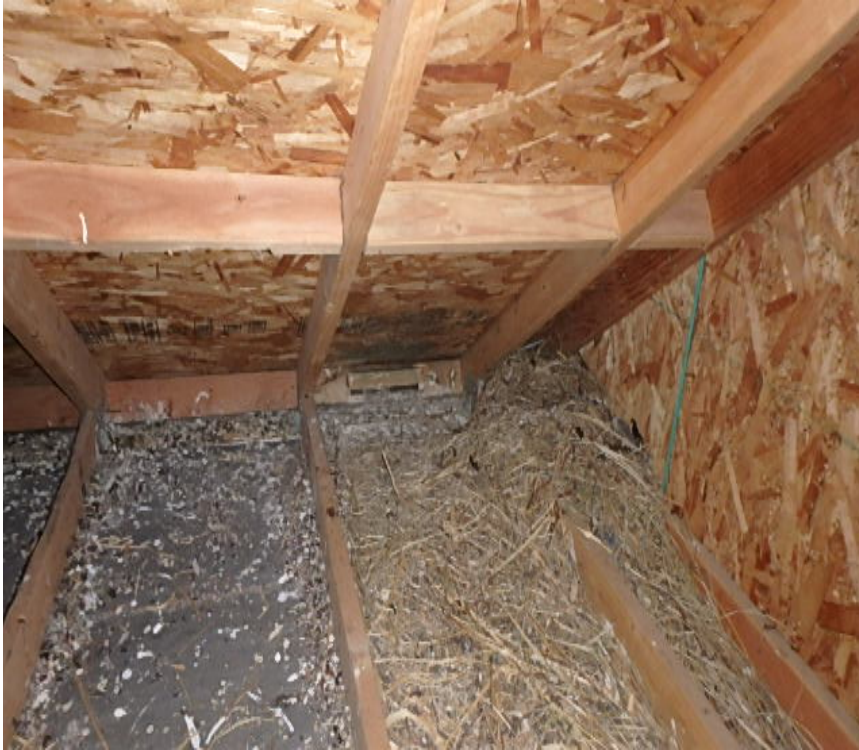
17.14 – Misc.

Bird nests in attic.

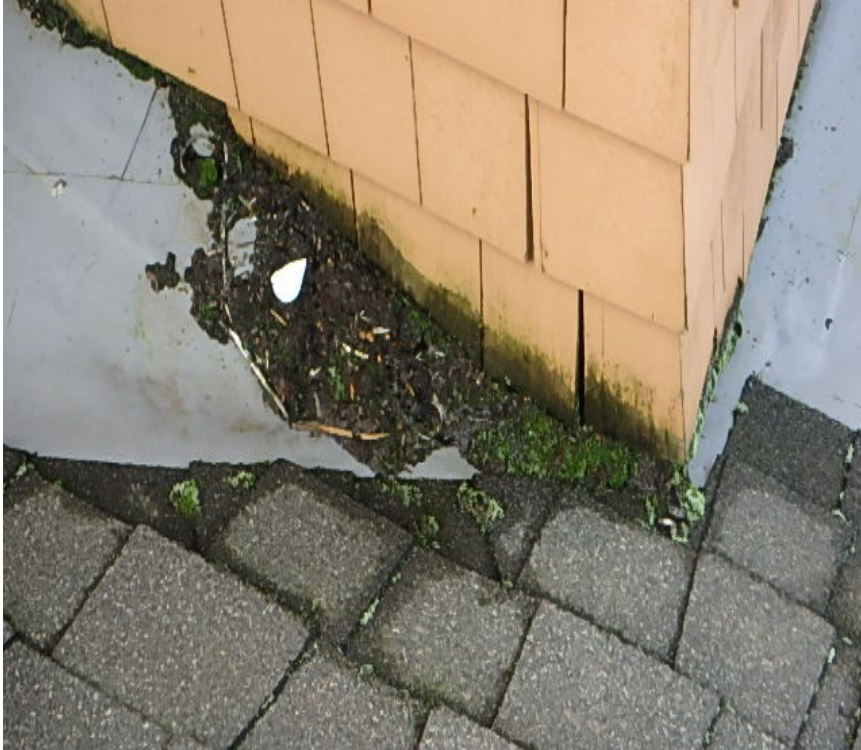
17.16 – Misc.

Low slope cricket is directing water and debris against vertical wall/siding.

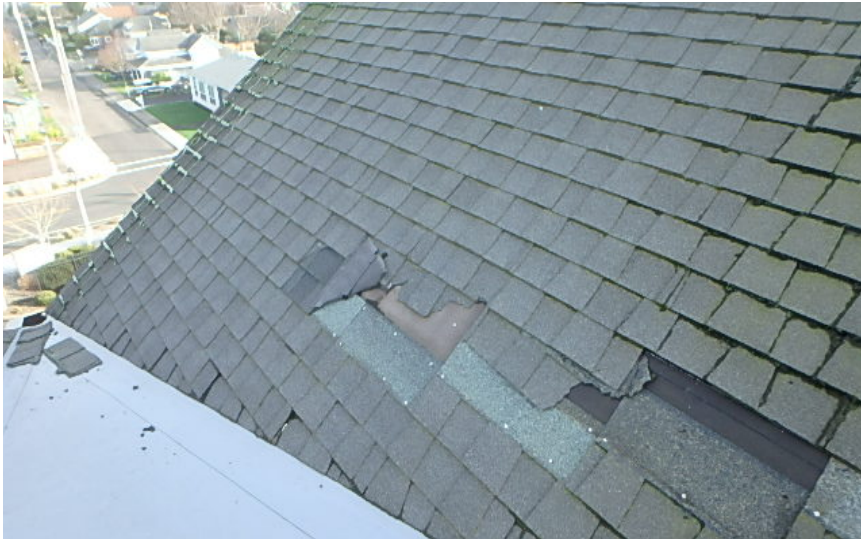
17.17 – Misc.

Shingles have blown off.

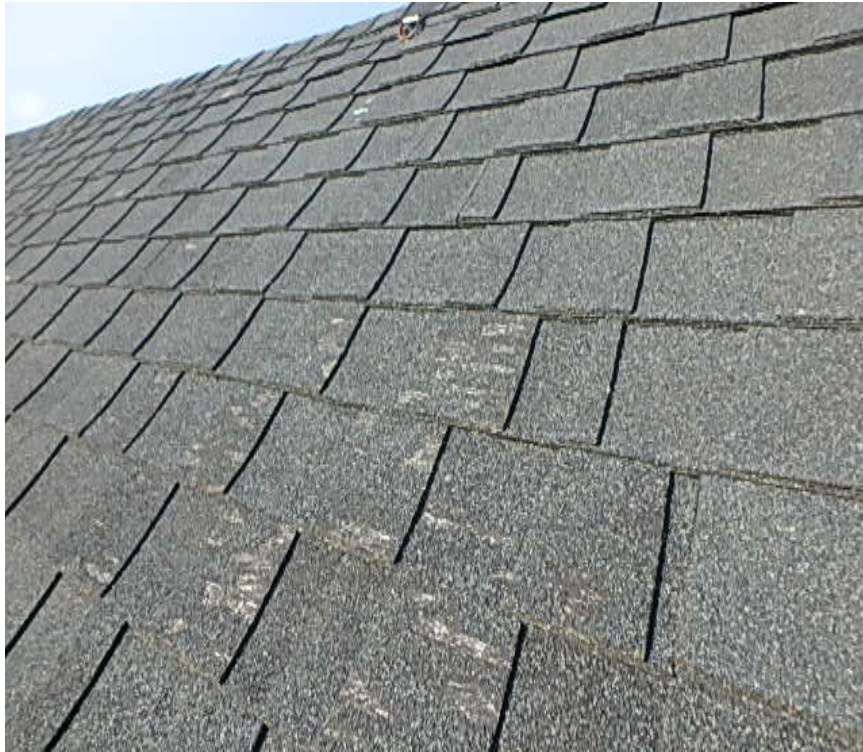
17.18 – Misc.

Loss of granules.

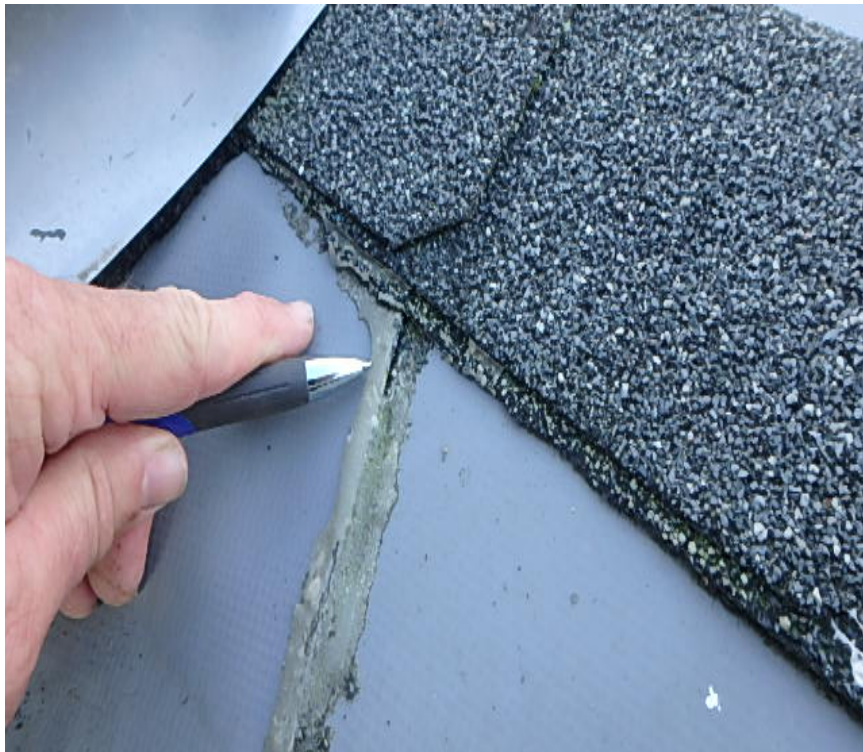
17.19 – Misc.

Seam is open in low slope roof membrane.
